# Inspection Report

**Property Address:**  
1 New Home  
Heaven on earth NY 11111

**New Home Inspectors LLC**

<b>Date:</b> 9/4/2015	<b>Time:</b> 12:00 AM	<b>Report ID:</b>
<b>Property:</b> 1 New Home Heaven on earth NY 11111	<b>Customer:</b> John Donut	<b>Real Estate Professional:</b>

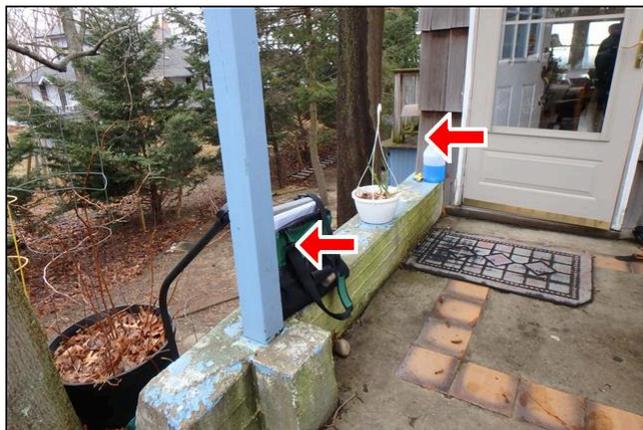
Missing railing on the front porch. Installing one for safety sake is recommended,

1.2 Item 1(Picture) Missing railing on the front porch

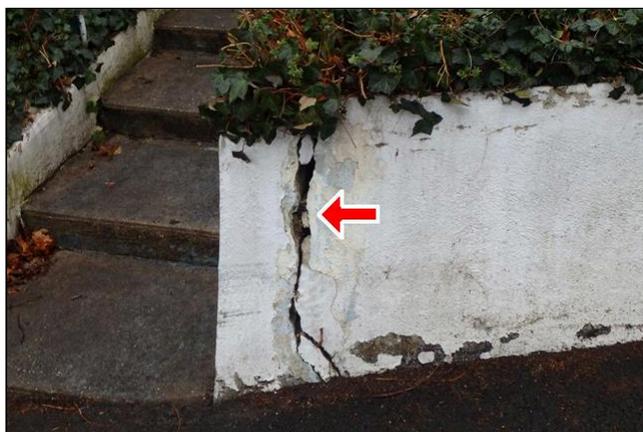
1. Retaining walls are deteriorated on the south side of the house
2. The wood retaining wall is rotted to the left of the deck

1.3 Item 1(Picture) Retaining walls are deteriorated

Having a qualified contractor evaluate and repair as needed is recommended,

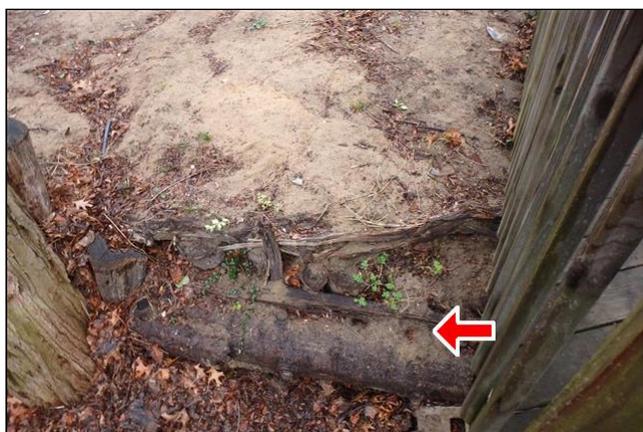
1.3 Item 3(Picture) The wood retaining wall is rotted to the left of the deck

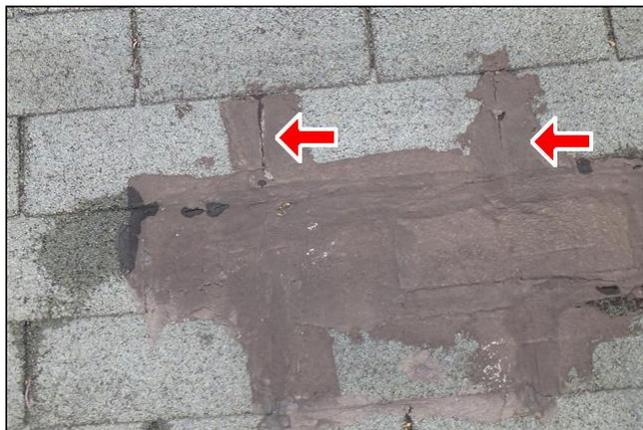
There are some tared repairs to the roof that are deteriorated and need to be evaluated and corrected by a qualified roofer.

2.0 Item 1(Picture) There are some tared repairs to the roof that are deteriorated

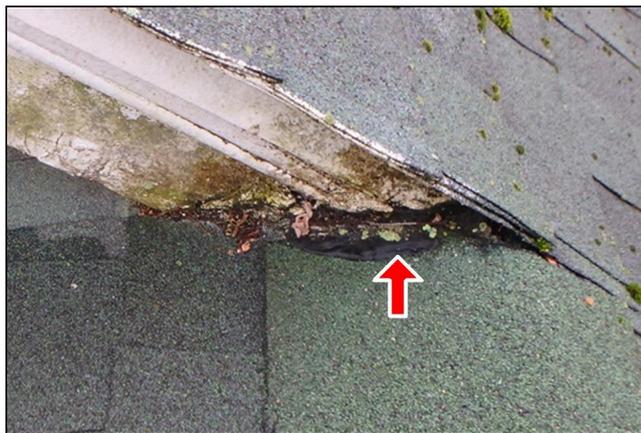
1. There is deteriorated trim scattered around the house.
2. The lower level apartment door is un-professionally installed
3. The garage doors need repair
4. There is no glass present in the attic window
5. Deteriorated trim on the south east corner of the house

3.0 Item 1(Picture) There is deteriorated trim scattered around the house

Having a qualified contractor evaluate and repair as needed is recommended,

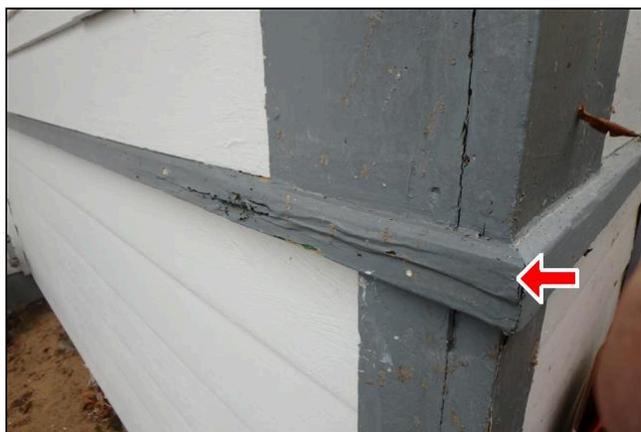
3.0 Item 5(Picture) Deteriorated trim on the south east corner of the house

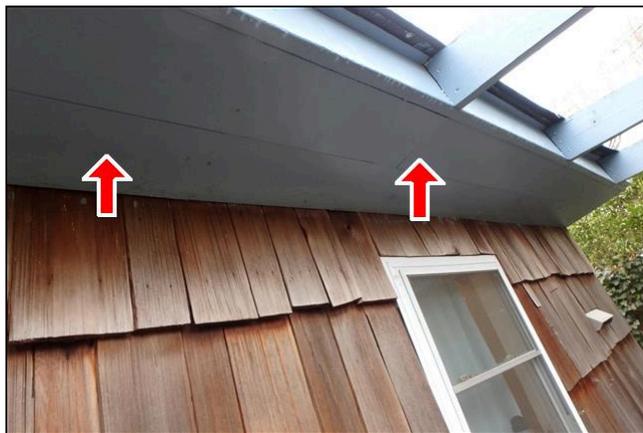
The inspector noticed a lack of soffit vents around the house. Installing soffit vents is recommended to help increase attic ventilation and increase roof life.

3.1 Item 1(Picture) The inspector noticed a lack of soffit vents around the house.

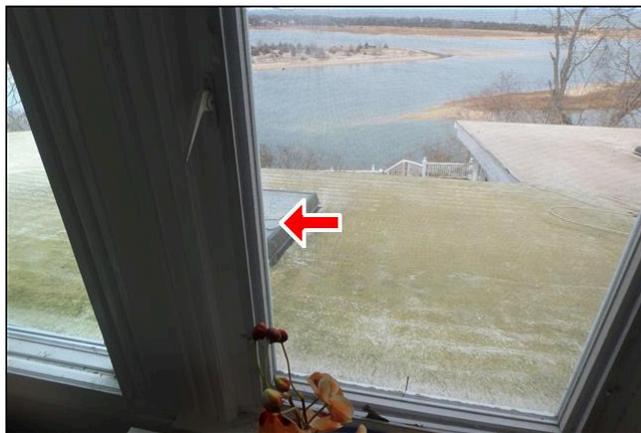
3.5 Item 3(Picture) The windows in the upper north bedroom would not open

Having a qualified contractor evaluate and repair as needed.

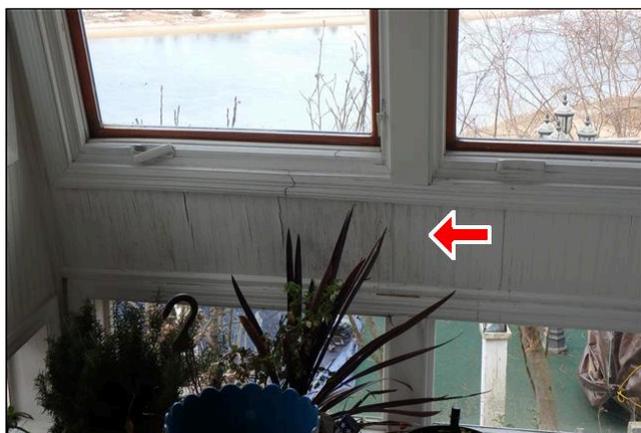
3.5 Item 5(Picture) There is an active leak in the bathroom windows on the 1st floor facing north

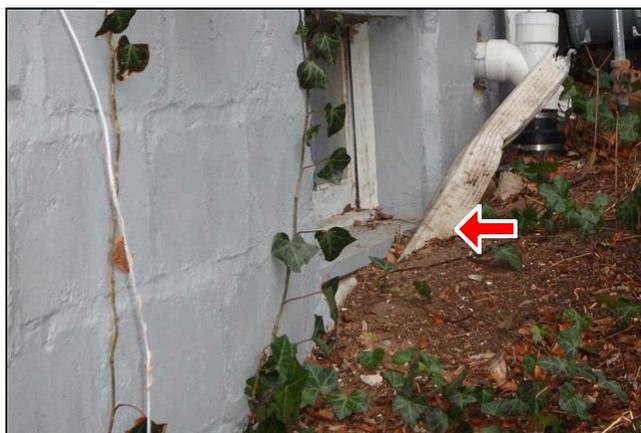
Installing window wells on the guest house to create the 6 inch soil clearance is recommended. This will help prevent water infiltration and insect damage.

3.6 Item 1(Picture) Installing window wells on the guest house to create the 6 inch soil clearance is recommended.

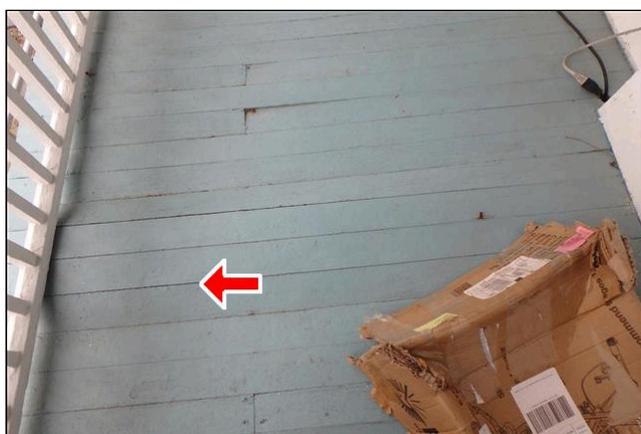
There are buckling and rotted deck boards on the front porch. Replacing the boards is recommended

4.1 Item 1(Picture) There are buckling and rotted deck boards on the front porch

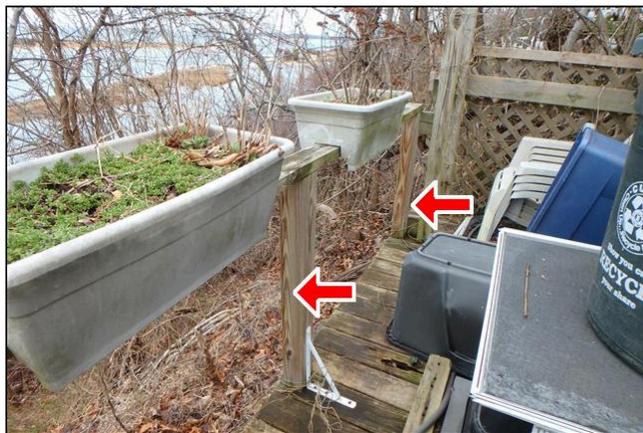
4.2 Item 1(Picture) The inspector noticed that the railing baluster spacing is beyond the current recommended 4 inch standard.

Contacting a qualified carpenter to evaluate and repair the railing is recommended.

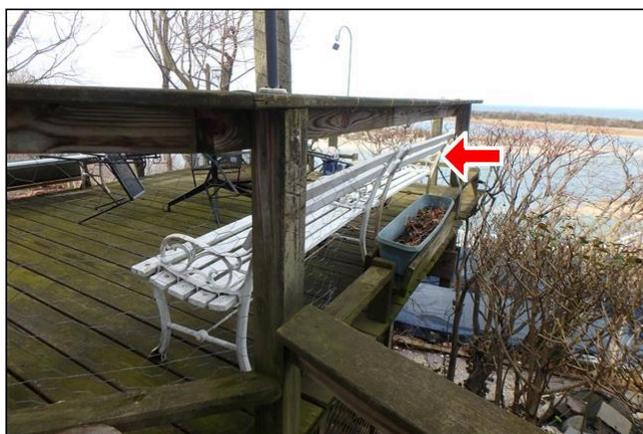
4.2 Item 3(Picture) The inspector noticed that the railing baluster spacing is beyond the current recommended 4 inch standard.

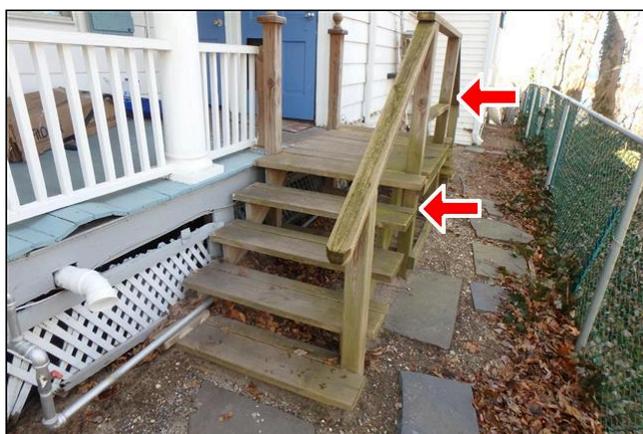
4.2 Item 5(Picture) The inspector noticed that the railing baluster spacing is beyond the current recommended 4 inch standard on the east side stairs

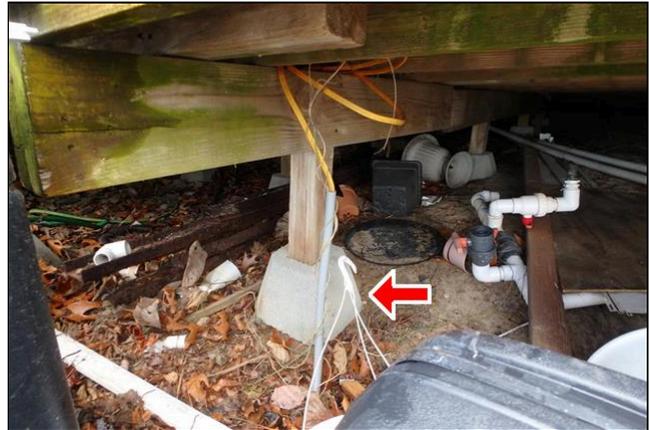
4.3 Item 2(Picture) The pool deck has no footings and is improperly supported

Having a qualified contractor evaluate and repair as needed is recommended,

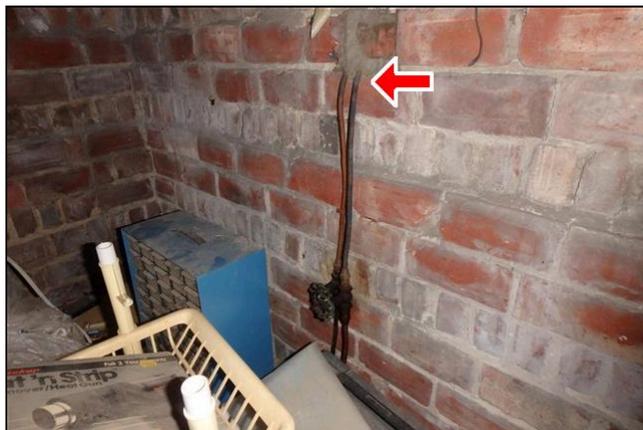
The inspector noticed signs of a buried oil tank and recommends obtaining a abandonment certificate. All abandoned in the ground oil tanks are required to be abandoned by a licensed contractor. Questioning the owner as to the status of the tank and certificate is recommended.

6.0 Item 1(Picture) The inspector noticed signs of a buried oil tank and recommends obtaining a abandonment certificate

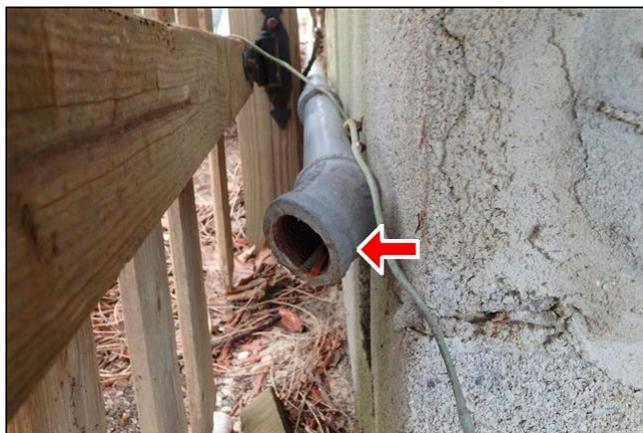
There is an open gas line on the east side of the exterior missing a cap. Capping it for safety sake is recommended,

6.3 Item 1(Picture) There is an open gas line on the east side of the exterior missing a cap

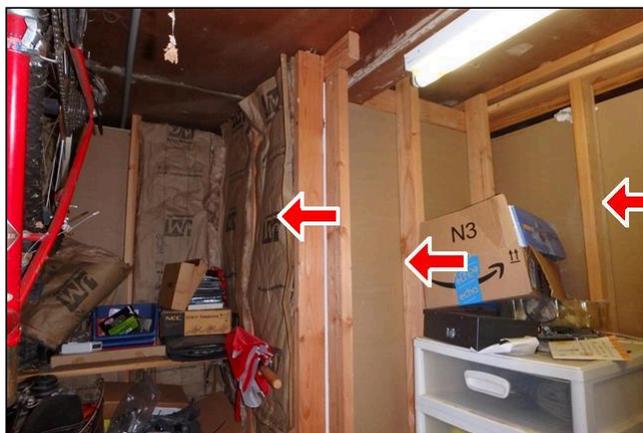
Backwards and missing insulation in the apartment walls in the apartment walls repairing the insulation is recommended

7.1 Item 1(Picture) Backwards and missing insulation in the apartment walls in the apartment walls

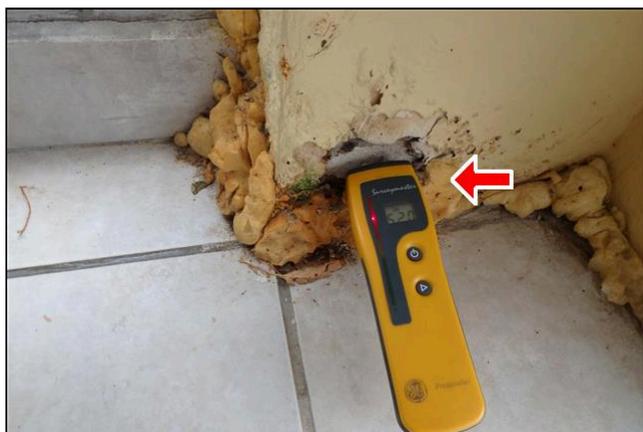
There is an active water leak at the base of the patio door on both walls. The sill plate on the right side is rotted. The extent of the damage cannot be determined without an invasive inspection.

7.1 Item 2(Picture) There is an active water leak at the base of the patio door on both walls.

Having a qualified contractor evaluate and repair as needed is recommended,

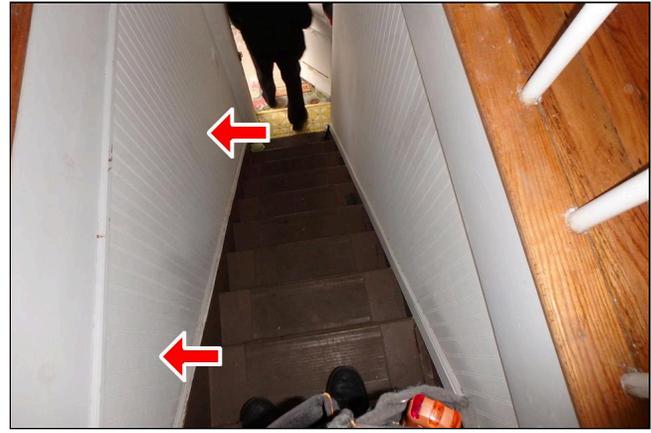
7.3 Item 2(Picture) There is also no handrail present on the stairway.

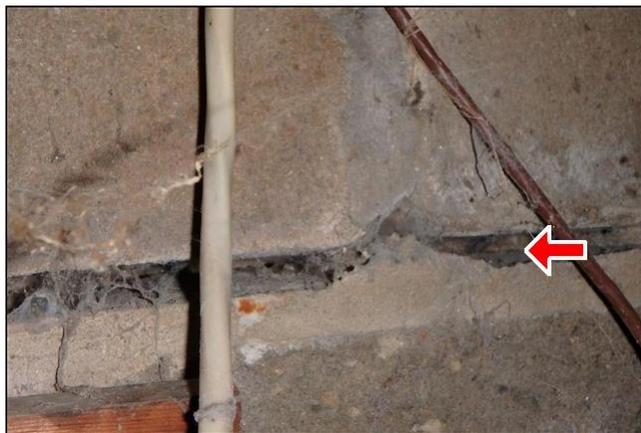
The north foundation wall in the guest house is failing. There is a bow in the wall and a large horizontal crack.

11.0 Item 1(Picture) The north foundation wall in the guest house is failing

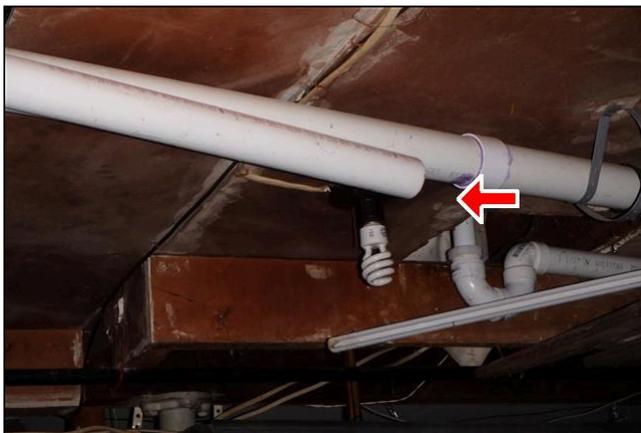
The inspector noticed that the ejection pump is not vented through the roof as required with a designated vent in the guest house. Contacting a qualified plumber to properly vent the pump is recommended.

12.4 Item 1(Picture) The inspector noticed that the ejection pump is not vented through the roof as required

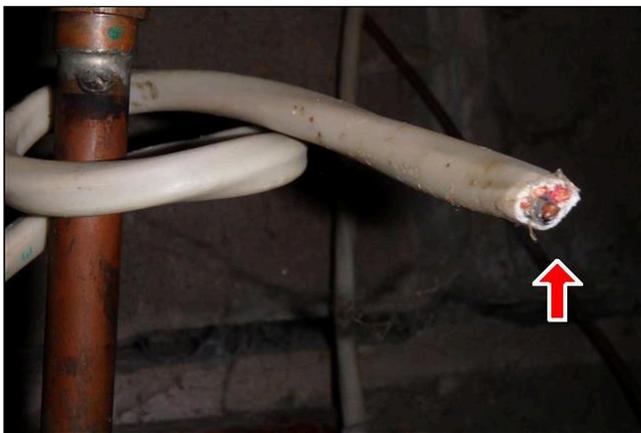
13.3 Item 1(Picture) There are terminated wires in the garage outside of a junction box

Having a licensed electrician evaluate and repair these items is recommended.

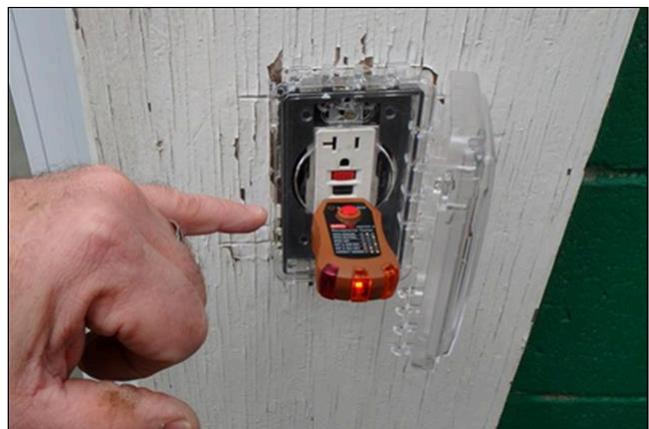
13.3 Item 13(Picture) The GFCI receptacle on the exterior by the patio door is defective

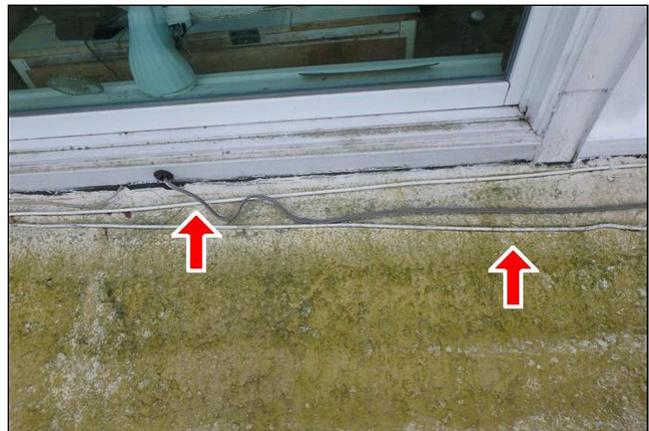
13.3 Item 16(Picture) There is a romex wire on the north lower roof outside of conduit and not secured

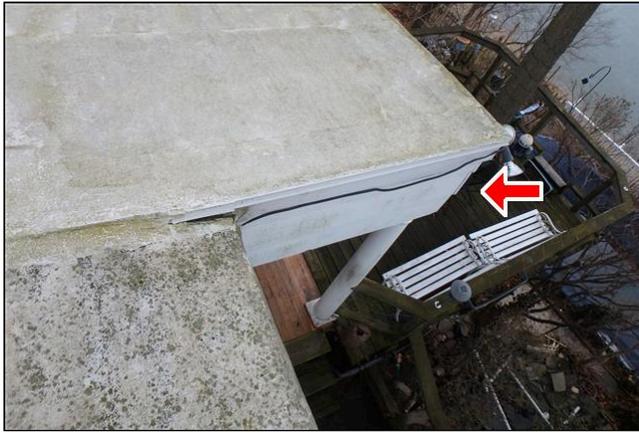
13.3 Item 17(Picture) There is exposed romex wires outside of conduit and improperly secured scattered throughout the main house

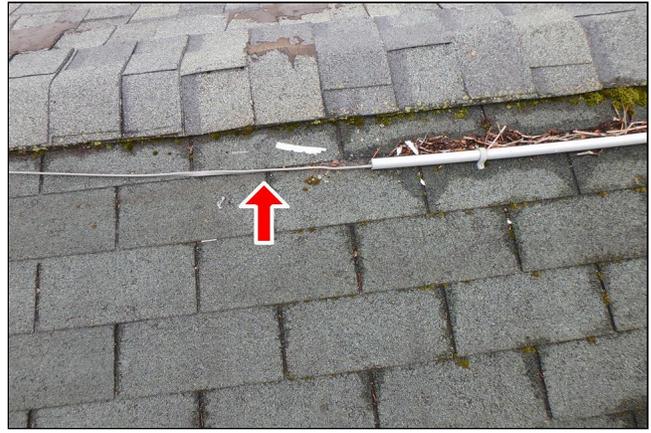
13.3 Item 18(Picture) There is exposed romex wire on the garage roof

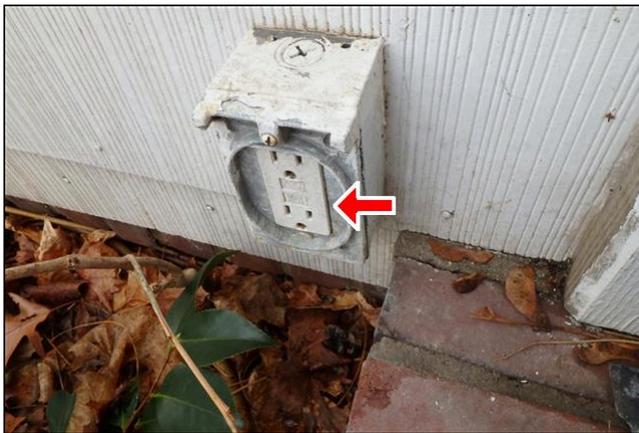
13.3 Item 19(Picture) The exterior GFCI receptacle is defective to the left of the front entrance and is missing a cover

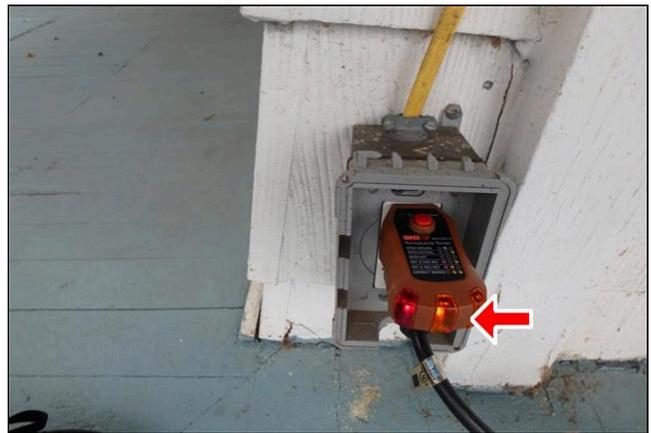
13.3 Item 20(Picture) Hot and neutral are reversed rendering the GFCI useless and is missing a cover on the porch

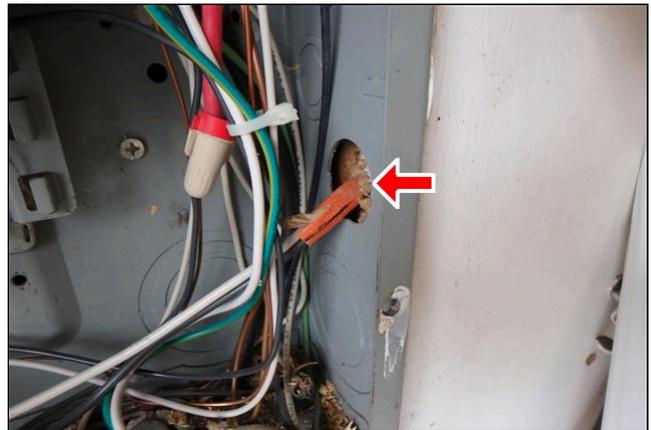
13.3 Item 22(Picture) There is a missing romex connector in the service panel

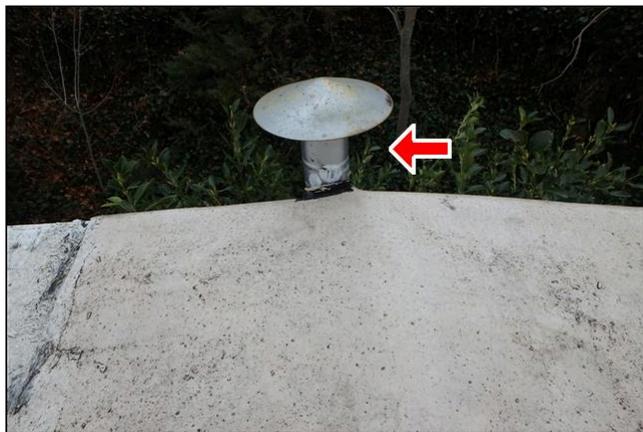
The hot water heater flu is too close to the roof. Having a qualified contractor evaluate and repair as needed is recommended,

14.4 Item 1(Picture) The hot water heater flu is too close to the roof

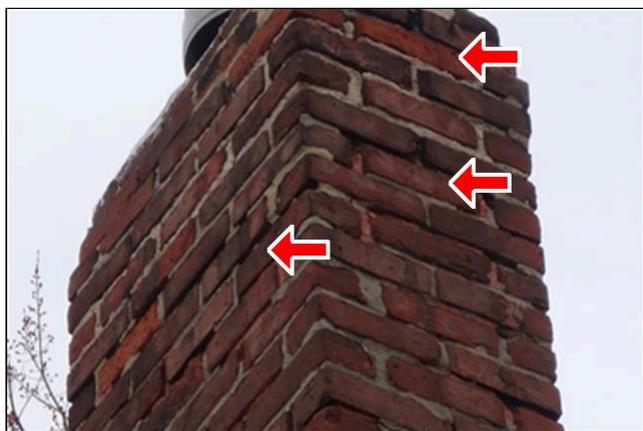
The chimney crown is cracked and the mortar/bricks are loose. Contacting a qualified mason is recommended to evaluate and repair the chimney is recommended.

14.4 Item 2(Picture) The chimney crown is cracked and the mortar/bricks are loose.

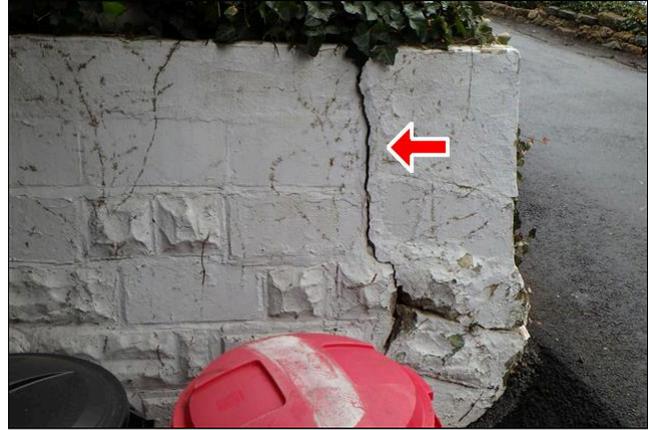
1.3 Item 2(Picture) Offset cracks in the retaining wall

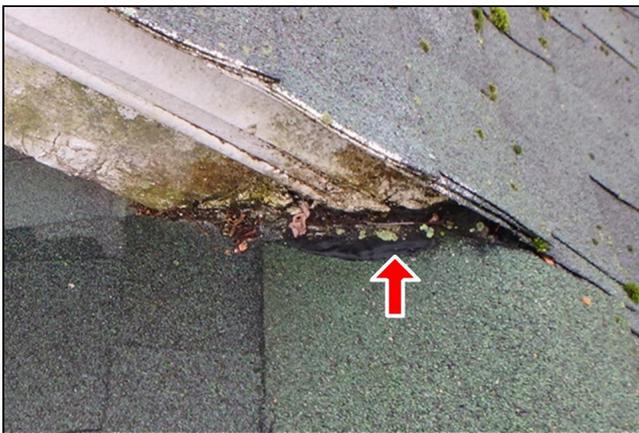
3.0 Item 1(Picture) There is deteriorated trim scattered around the house

Having a qualified contractor evaluate and repair as needed is recommended,

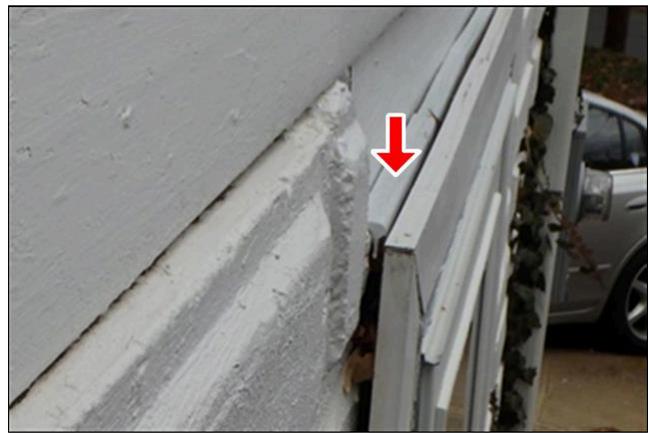
3.0 Item 2(Picture) The lower level apartment door is un-professionally installed

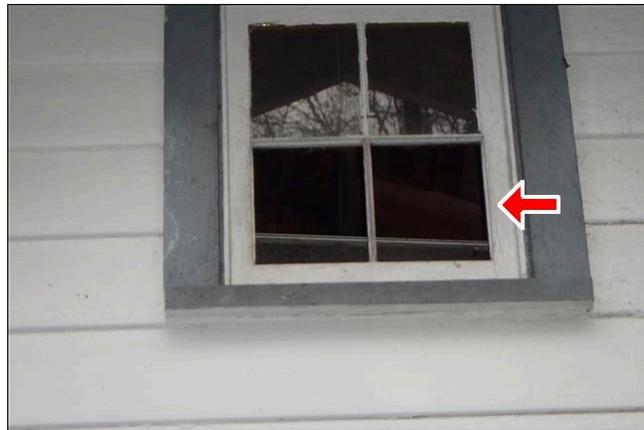
3.0 Item 4(Picture) There is no glass present in the attic window

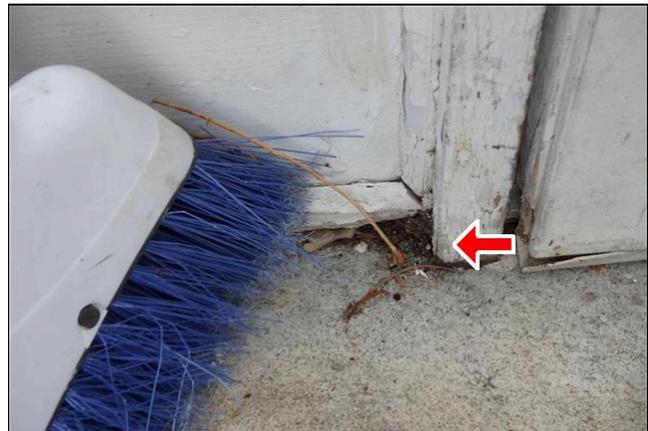
3.0 Item 7(Picture) The front entry door trim is rotted at the base

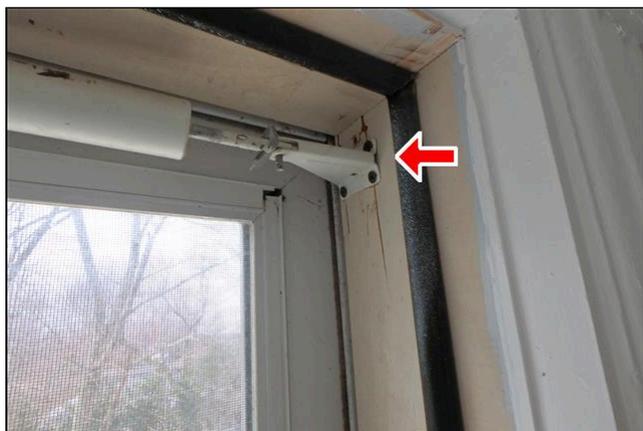
The inspector noticed a cracked door jamb on the west roof door and the rear den door is taped shut requiring repair by a qualified carpenter.

3.3 Item 1(Picture) The inspector noticed a cracked door jamb on the west roof door

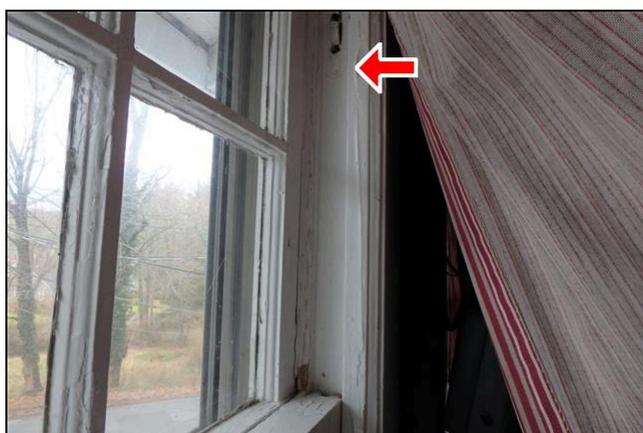
The inspector noticed broken window sash cords scattered around. This prevents the window from staying up. Having a qualified contractor evaluate and repair as needed is recommended,

3.5 Item 1(Picture) The inspector noticed broken window sash cords scattered around.

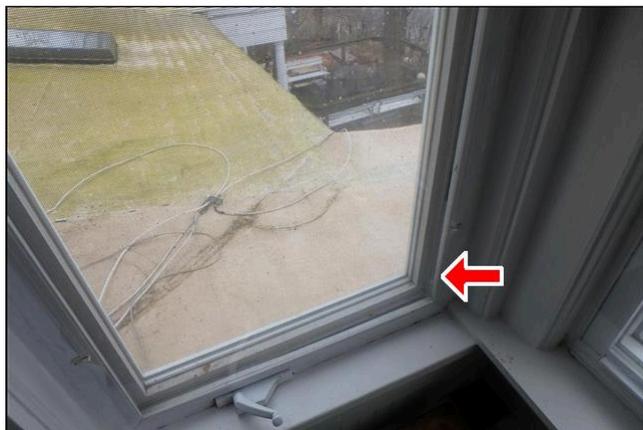
3.5 Item 2(Picture) The casement window on the west side will not lock

Having a qualified contractor evaluate and repair as needed.

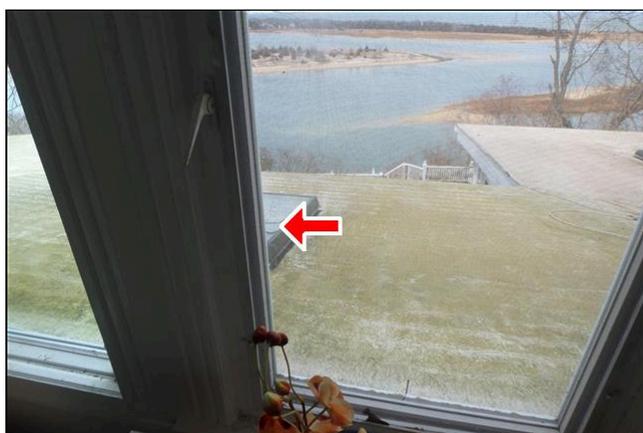
3.5 Item 3(Picture) The windows in the upper north bedroom would not open

Having a qualified contractor evaluate and repair as needed.

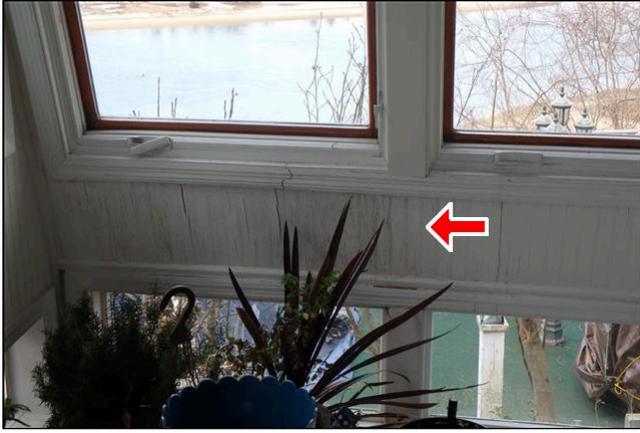
3.5 Item 5(Picture) There is an active leak in the bathroom windows on the 1st floor facing north

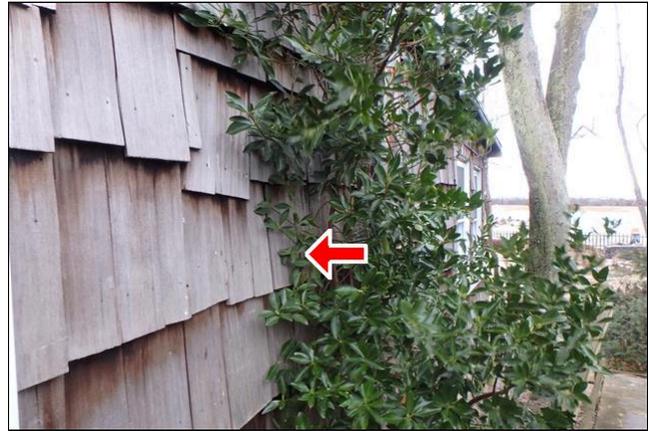
(1) The vegetation is too close to the structures. There should be no vegetation within 12 inches of the house. The tree limbs should be 6 feet away from the structure. Making the necessary corrections is recommended.

3.7 Item 1(Picture) The vegetation is too close to the structure.

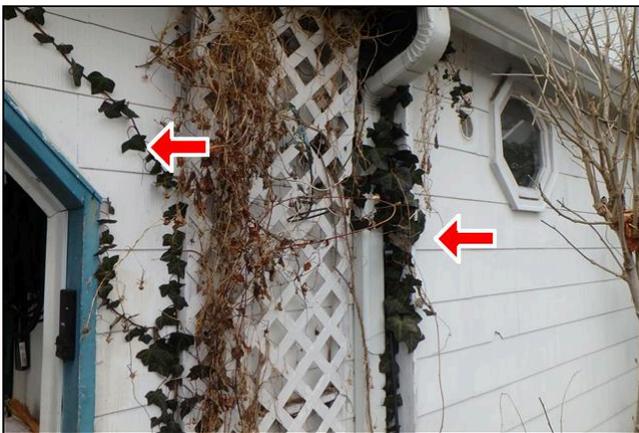
3.7 Item 3(Picture) Vegetation on the main house

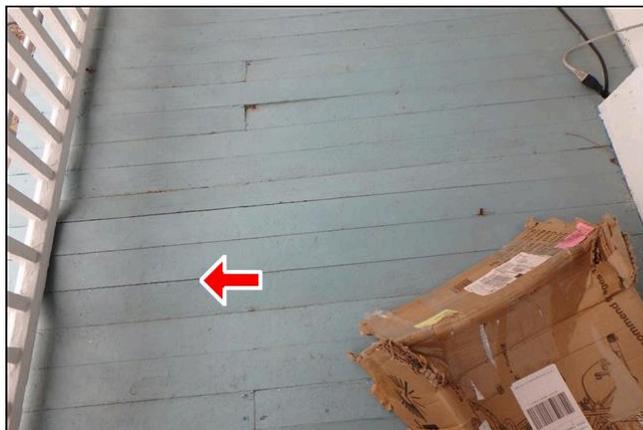
There are buckling and rotted deck boards on the front porch. Replacing the boards is recommended

4.1 Item 1(Picture) There are buckling and rotted deck boards on the front porch

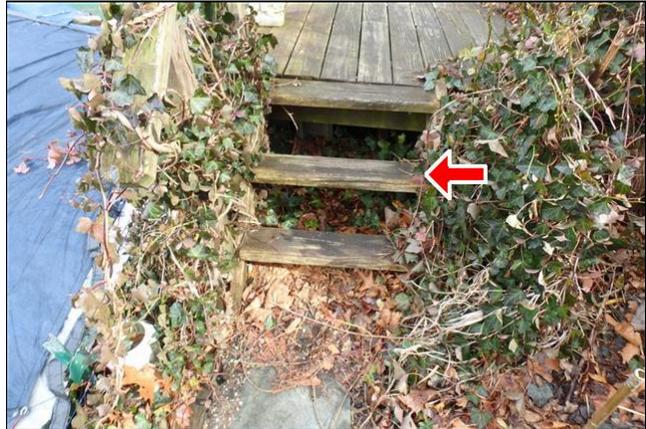
4.2 Item 2(Picture) The stairs on the pool are deteriorated and missing a railing

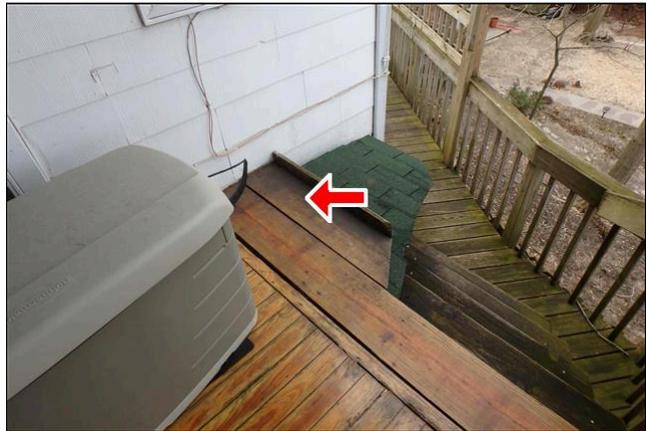
4.2 Item 4(Picture) Missing railing on the north west corner of the deck

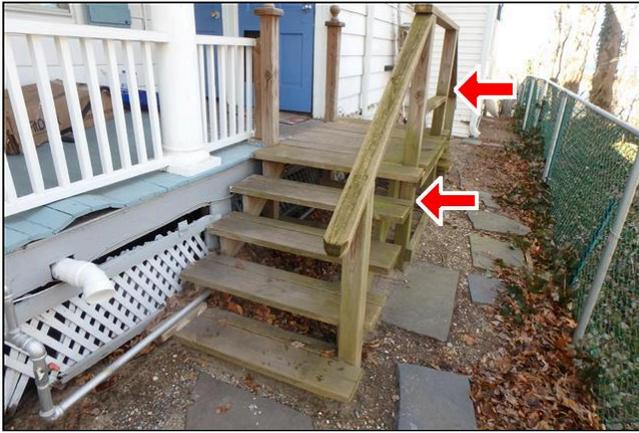
4.2 Item 5(Picture) The inspector noticed that the railing baluster spacing is beyond the current recommended 4 inch standard on the east side stairs

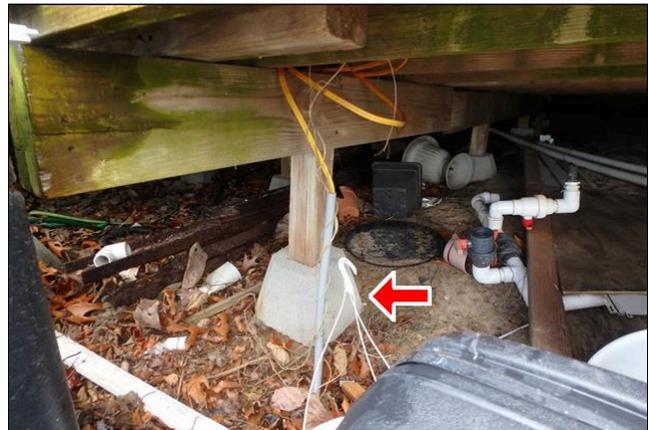
4.3 Item 2(Picture) The pool deck has no footings and is improperly supported

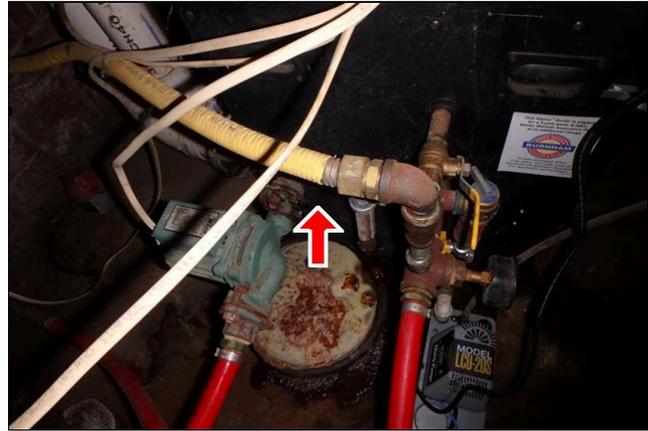
6.3 Item 2(Picture) The inspector noticed the presence of corrugated stainless steel tubing (CSST) used for gas service on the boiler.

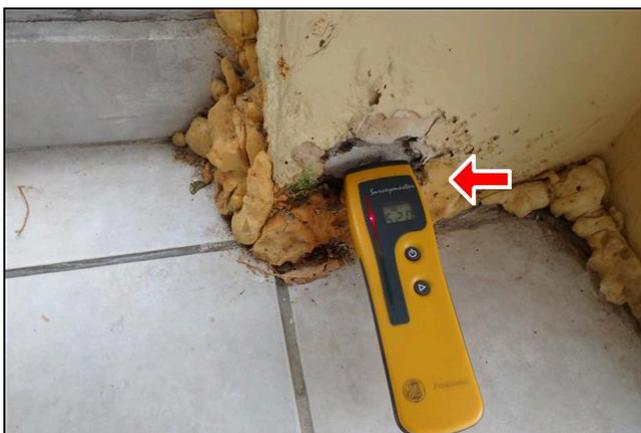
7.1 Item 2(Picture) There is an active water leak at the base of the patio door on both walls.

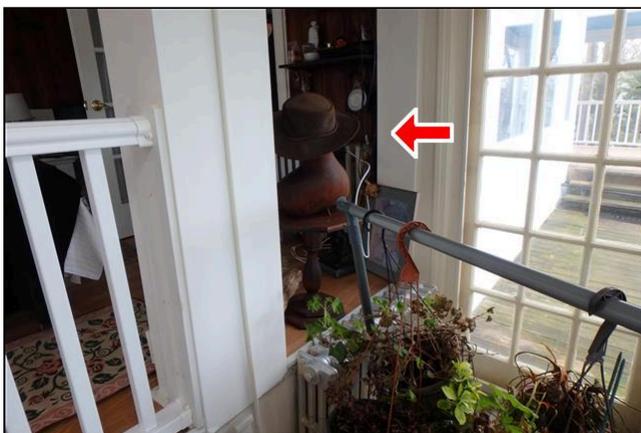
7.3 Item 3(Picture) There is no railing on the first floor bath

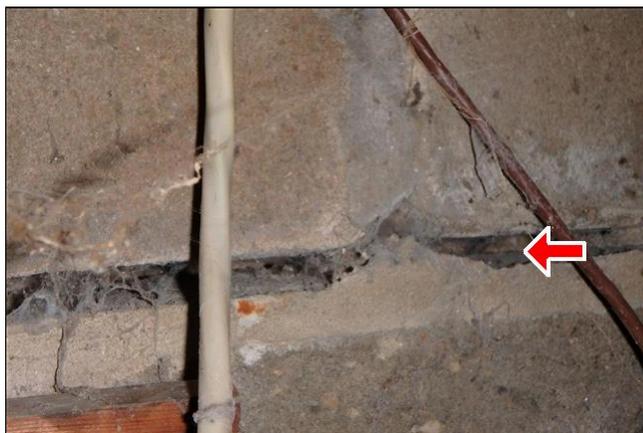
11.0 Item 1(Picture) The north foundation wall in the guest house is failing

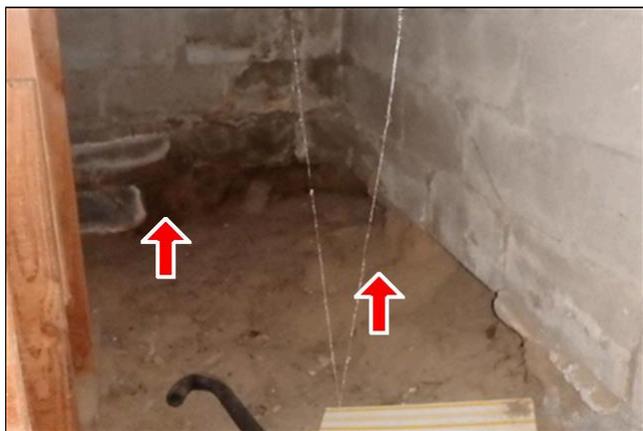
11.0 Item 2(Picture) The foundation in the southeast corner of the crawlspace has no footing and is being compromised

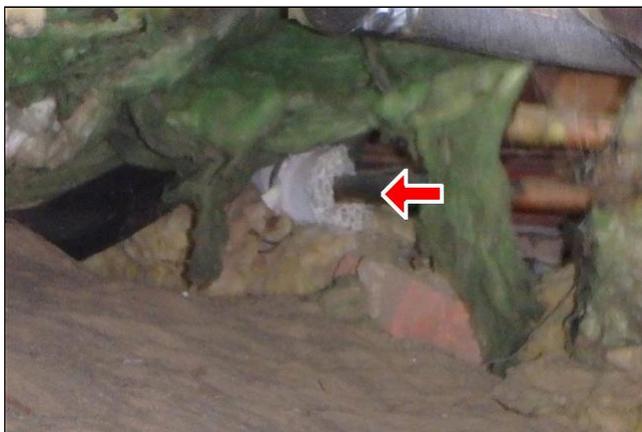
11.9 Item 1(Picture) There is evidence of pipe wrap known to contain asbestos in the the crawl space

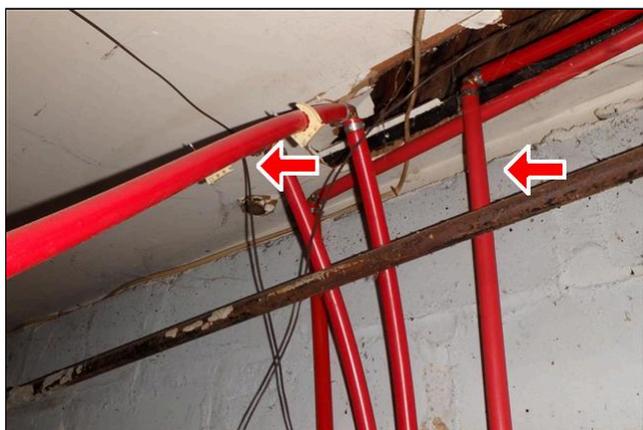
12.1 Item 1(Picture) The water supply lines in the garage are not properly secured

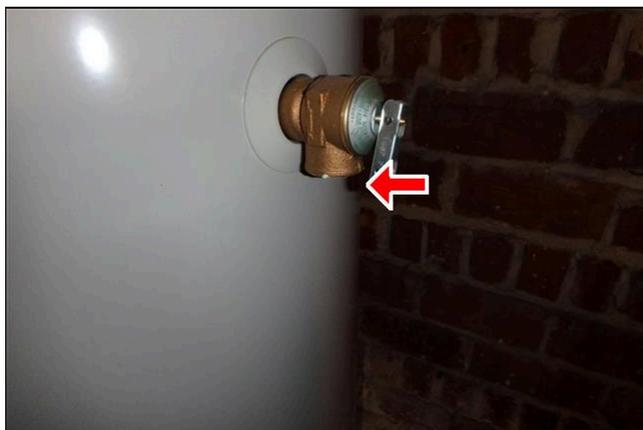
12.2 Item 1(Picture) he inspector notice no TPS tube.

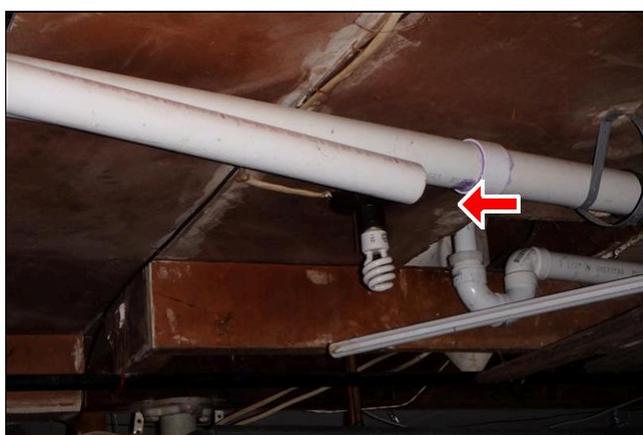
12.4 Item 1(Picture) The inspector noticed that the ejection pump is not vented through the roof as required

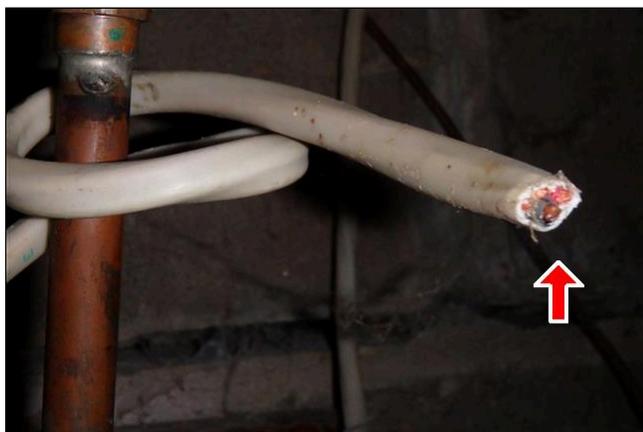
13.3 Item 1(Picture) There are terminated wires in the garage outside of a junction box

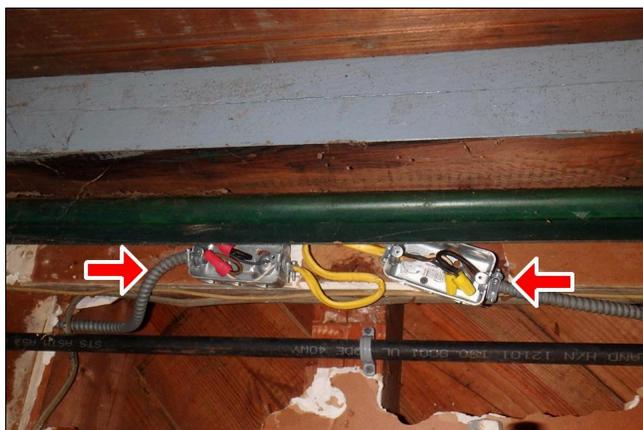
13.3 Item 3(Picture) Open junction boxes in the garage

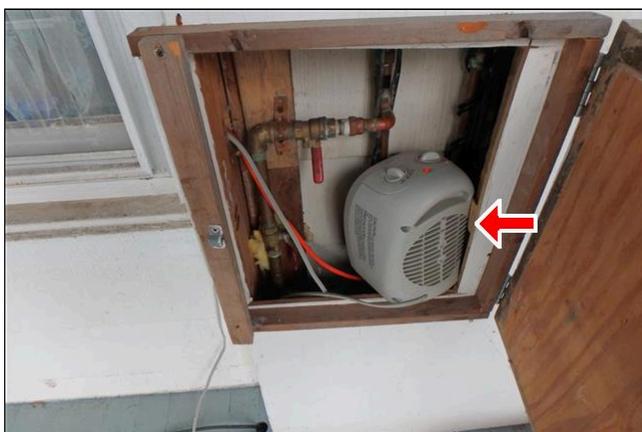
13.3 Item 15(Picture) There is a electric heater on the exterior to protect the water lines that is a fire hazard

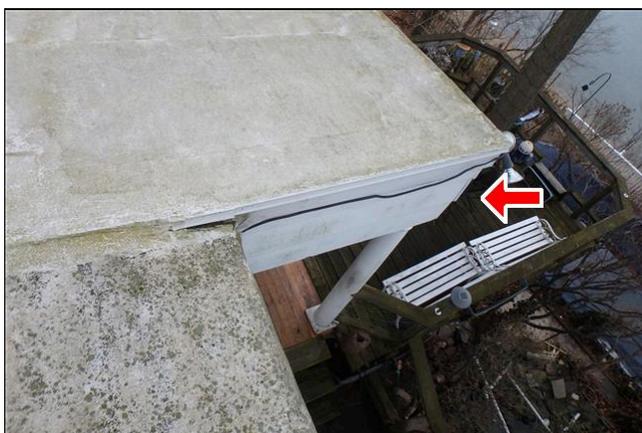
13.3 Item 17(Picture) There is exposed romex wires outside of conduit and improperly secured scattered through out the main house

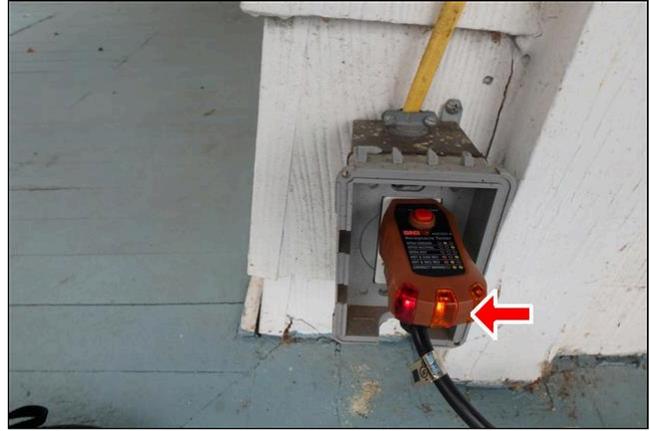
13.3 Item 20(Picture) Hot and neutral are reversed rendering the GFCI useless and is missing a cover on the porch

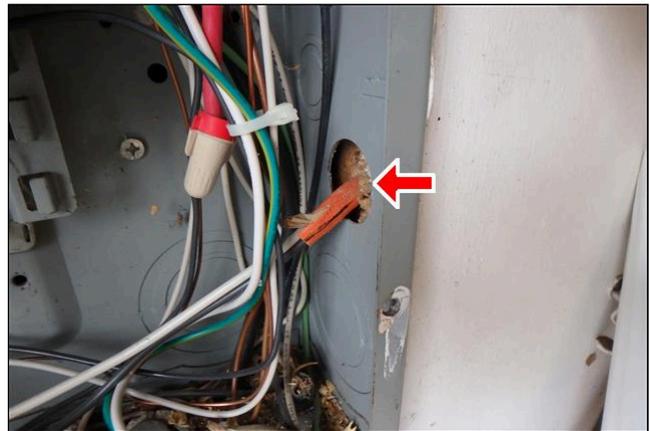
13.3 Item 22(Picture) There is a missing romex connector in the service panel

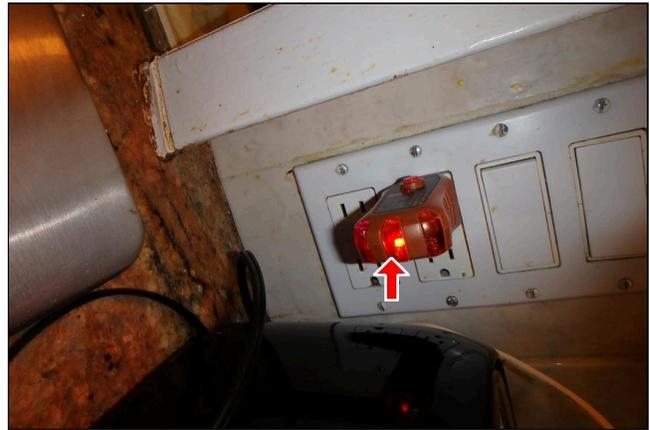
13.3 Item 24(Picture) There are ungrounded receptacles in the kitchen

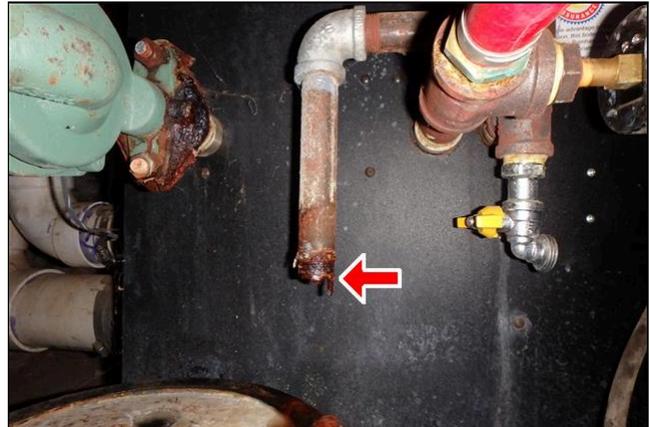
14.0 Item 2(Picture) leaking TPS valve

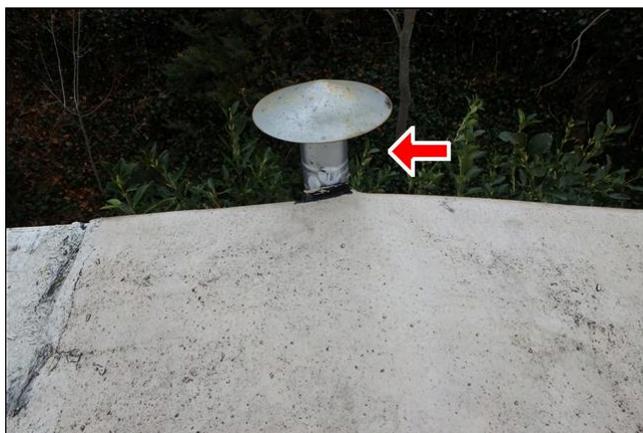
14.4 Item 1(Picture) The hot water heater flu is too close to the roof

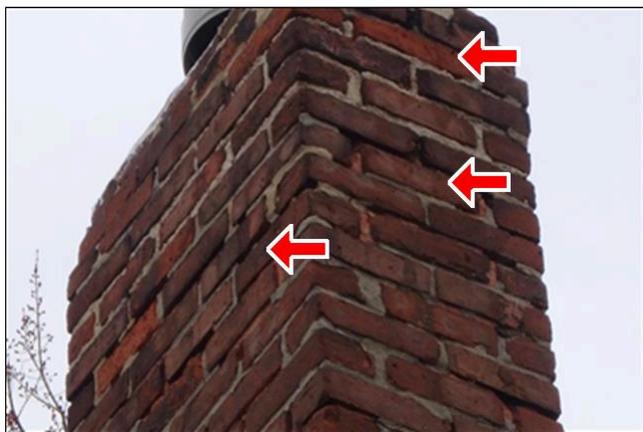
14.4 Item 2(Picture) The chimney crown is cracked and the mortar/bricks are loose.
