# Inspection Report

**Property Address:**  
1 New Home  
Heaven on earth NY 11111

**New Home Inspectors LLC**

<b>Date:</b> 9/4/2015	<b>Time:</b> 12:00 AM	<b>Report ID:</b>
<b>Property:</b> 1 New Home Heaven on earth NY 11111	<b>Customer:</b> John Donut	<b>Real Estate Professional:</b>

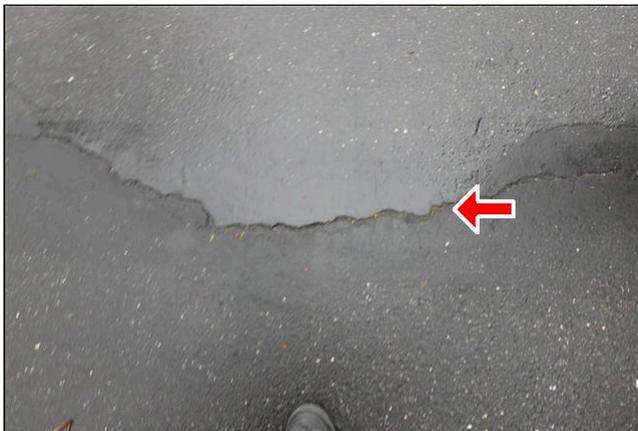
(1) There are cracks in the driveway that should be filled to prevent deterioration to the driveway. Water entering the cracks will lead to deterioration and repairing the cracks now will prevent further damage.

1.0 Item 1(Picture) There are cracks in the driveway that should be filled to prevent deterioration to the driveway.

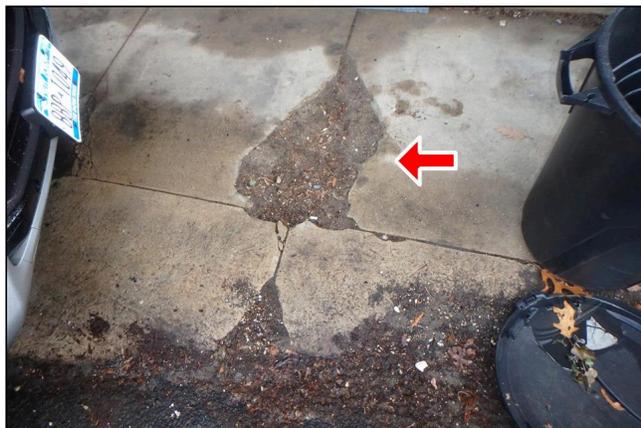
(2) The concrete driveway apron on the guest house is in a deteriorated state with broken concrete. Contacting a qualified mason to replace the driveway should be considered.

1.0 Item 2(Picture) The concrete driveway apron on the guest house is in a deteriorated state with broken concrete.

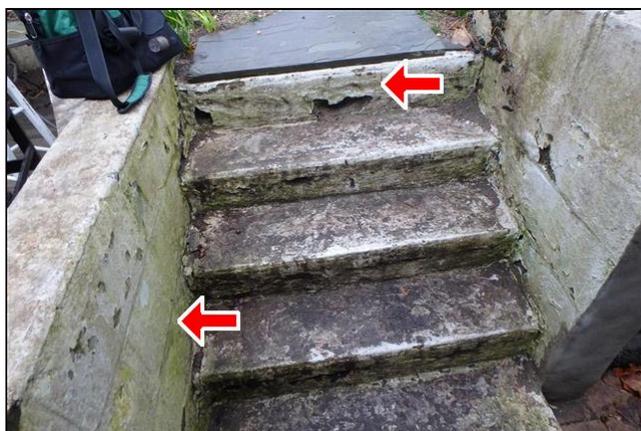
The north steps are deteriorated and missing a handrail installing one is recommended

1.1 Item 1(Picture) The north steps are deteriorated and missing a handrail

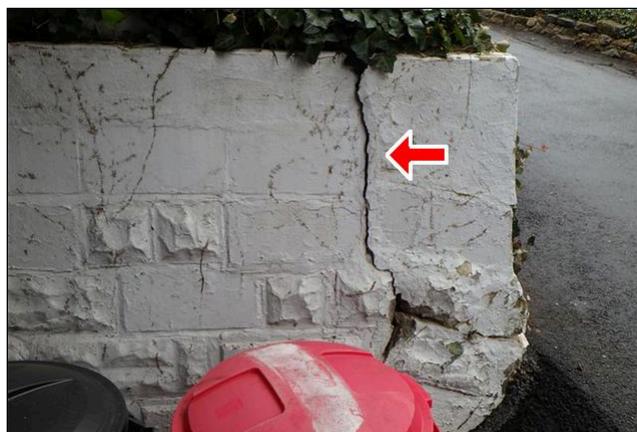
1.3 Item 2(Picture) Offset cracks in the retaining wall

Having a qualified contractor evaluate and repair as needed is recommended,

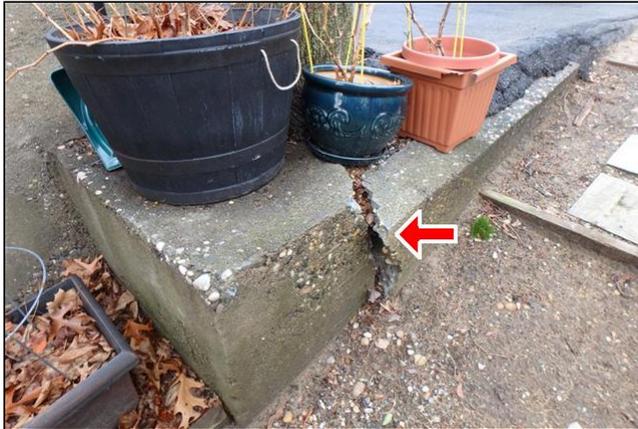
The retaining wall to the east side is deteriorated. Having a qualified contractor evaluate and repair as needed is recommended,

1.3 Item 4(Picture) The retaining wall to the east side is deteriorated

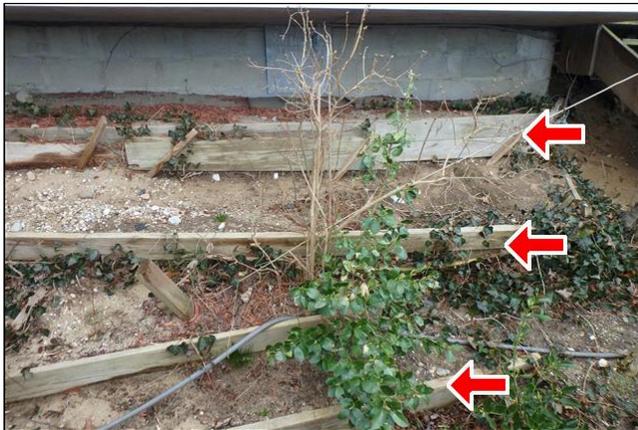
1. The retaining walls on the north side are deteriorated

1.3 Item 5(Picture) The retaining walls on the north side are deteriorated

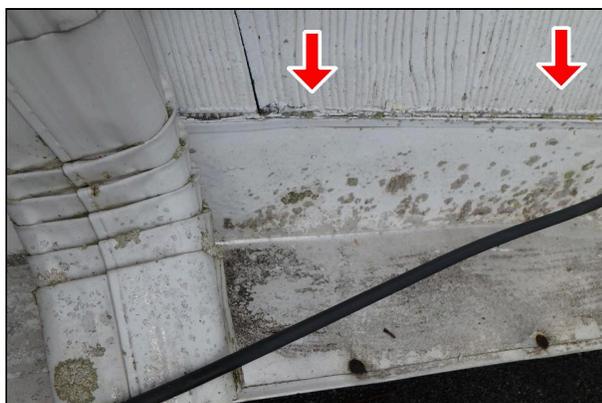
The flashing on the upper west wall is installed incorrectly. Having a qualified contractor evaluate and repair as needed is recommended,

2.2 Item 1(Picture) The flashing on the upper west wall is installed incorrectly.

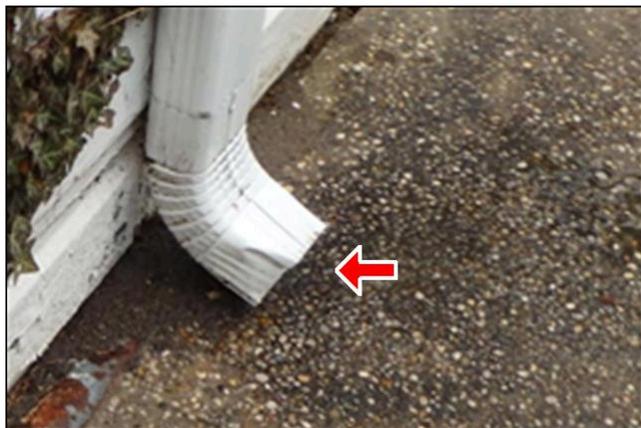
The gutter leaders are depositing water at the base of the foundation on all the houses. Water at the base of the foundation can penetrate the structure and cause water damage. Gutter leaders should extend 6 feet away from the structure.

2.4 Item 1(Picture) The gutter leaders are depositing water at the base of the foundation on all the houses.

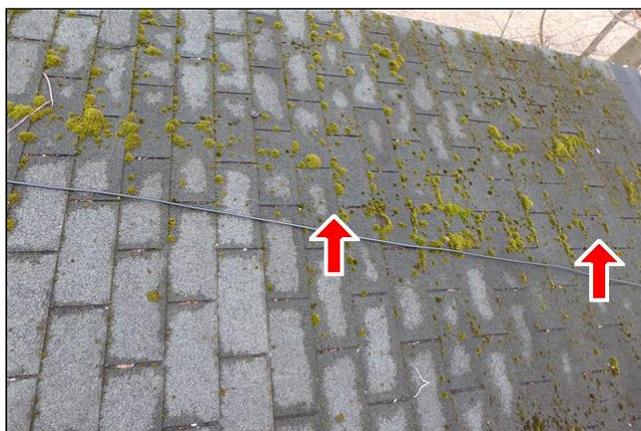
The inspector noticed moss/lichen growth on the roof and black algae streaks. Lichen can cause mineral loss on the roof shingles. The growth can be cleaned off by a qualified professional.

2.5 Item 1(Picture) The inspector noticed moss/lichen growth on the roof and black algae streaks

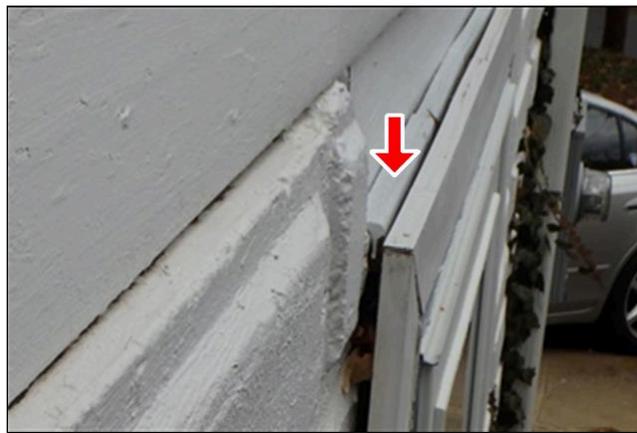
3.0 Item 2(Picture) The lower level apartment door is un-professionally installed

Having a qualified contractor evaluate and repair as needed is recommended,

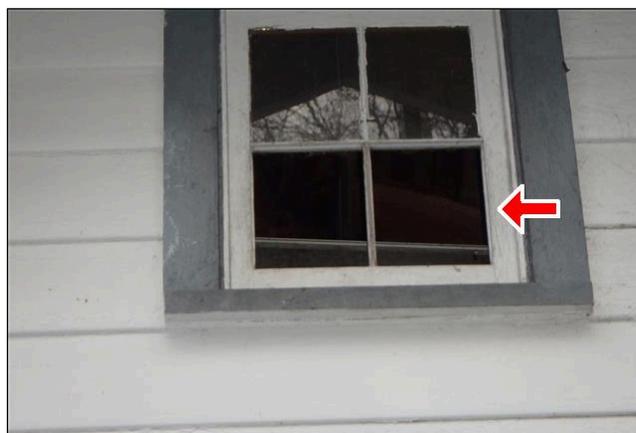
3.0 Item 4(Picture) There is no glass present in the attic window

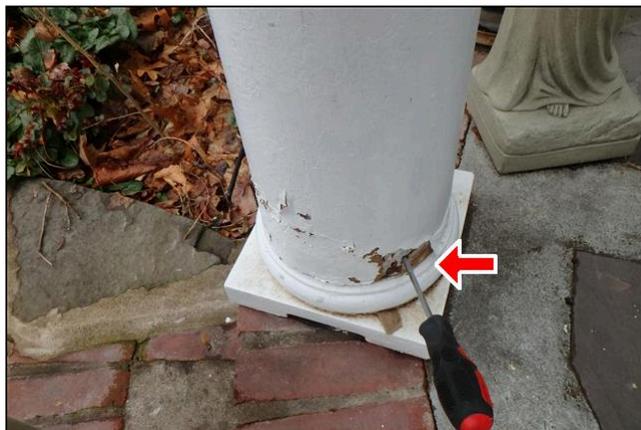
3.0 Item 6(Picture) The columns by the front entrance are deteriorated at the base

Having a qualified contractor evaluate and repair as needed is recommended,

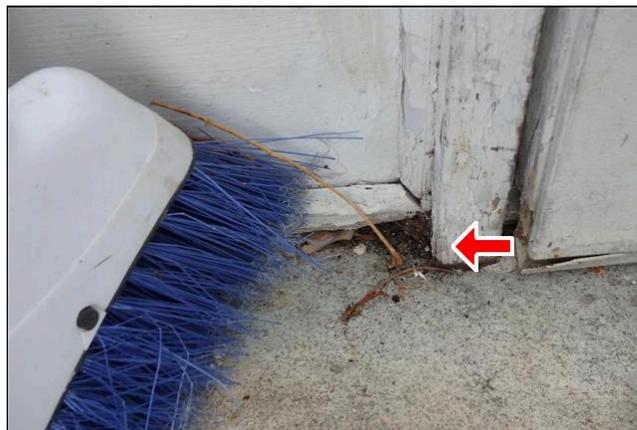
3.0 Item 7(Picture) The front entry door trim is rotted at the base

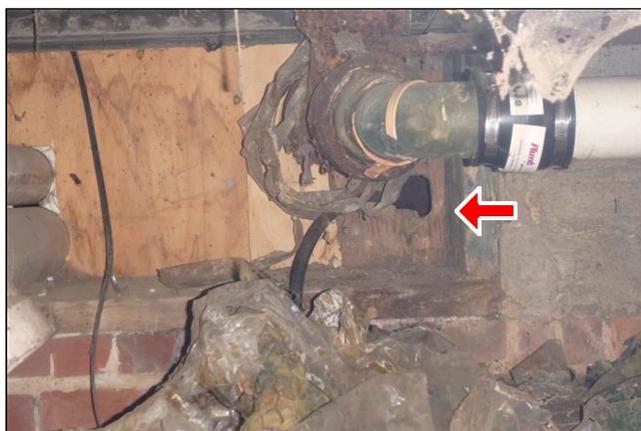
3.0 Item 8(Picture) There are opening in the plywood in the basement window allowing infestation

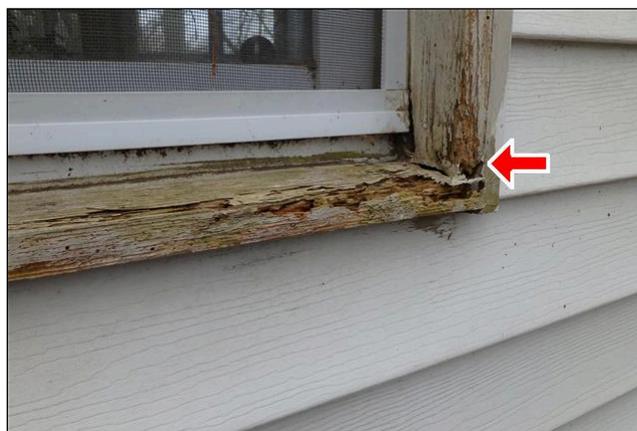
3.0 Item 9(Picture) There is scattered trim rotted around the house

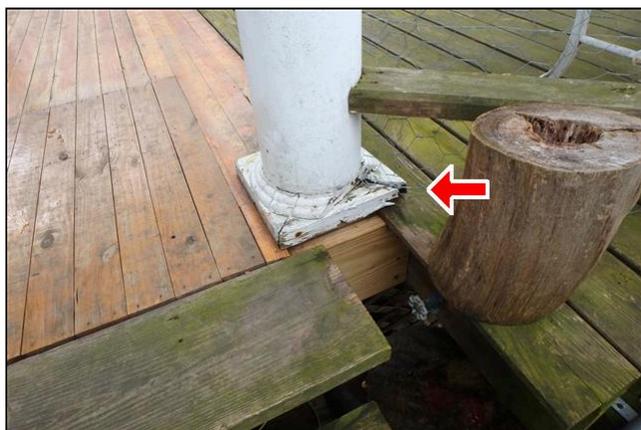
3.0 Item 10(Picture) The column on the north deck is rotted

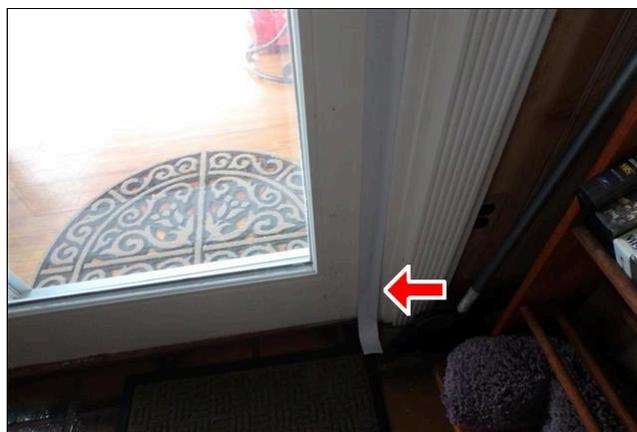
The inspector noticed a cracked door jamb on the west roof door and the rear den door is taped shut requiring repair by a qualified carpenter.

3.3 Item 2(Picture) the rear den door is taped shut

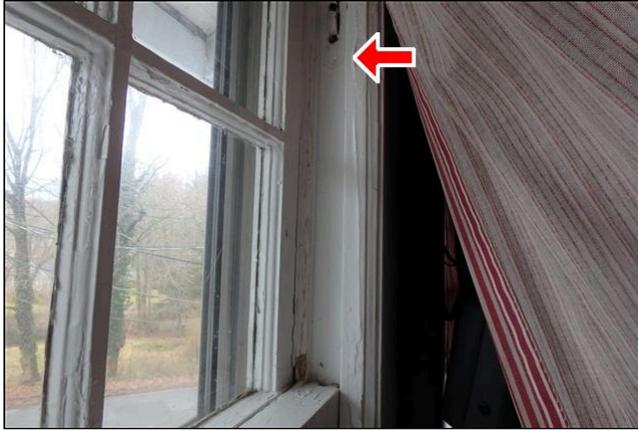
The inspector noticed broken window sash cords scattered around. This prevents the window from staying up. Having a qualified contractor evaluate and repair as needed is recommended,

3.5 Item 1(Picture) The inspector noticed broken window sash cords scattered around.

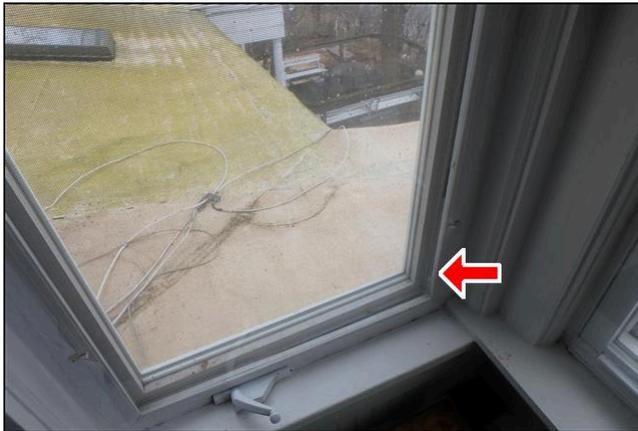
3.5 Item 2(Picture) The casement window on the west side will not lock

Having a qualified contractor evaluate and repair as needed.

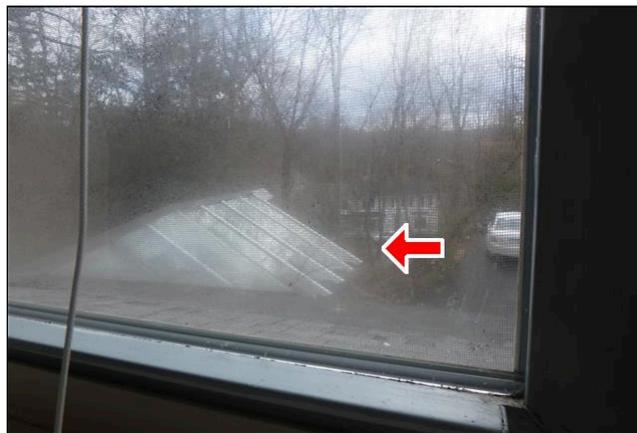
1. The windows in the upper north bedroom would not open
2. The inspector noticed broken window seals scattered throughout the house. This milky condition can only be repaired by replacing the window glass or window itself. Contacting a qualified glazier is recommended.
3. There is an active leak in the bathroom windows on the 1st floor facing north

3.5 Item 4(Picture) The inspector noticed broken window seals scattered throughout the house

Having a qualified contractor evaluate and repair as needed.

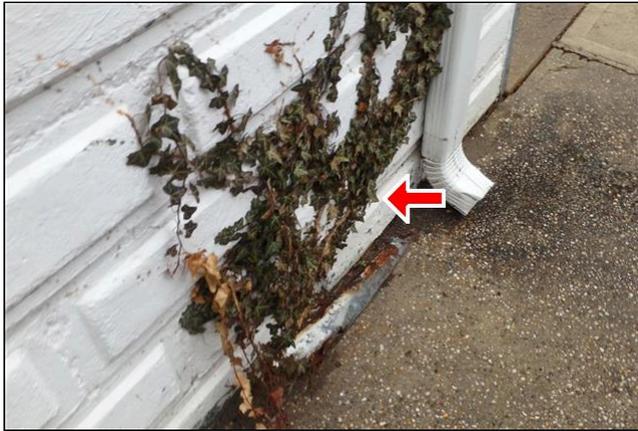
(1) The vegetation is too close to the structures. There should be no vegetation within 12 inches of the house. The tree limbs should be 6 feet away from the structure. Making the necessary corrections is recommended.

3.7 Item 1(Picture) The vegetation is too close to the structure.

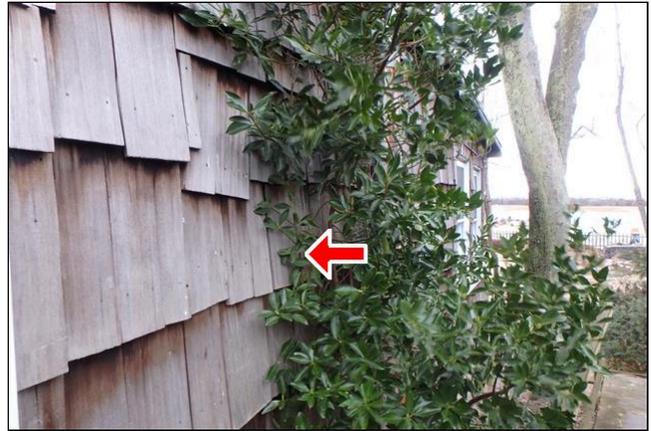
3.7 Item 2(Picture) Vegetation too close to the cottage

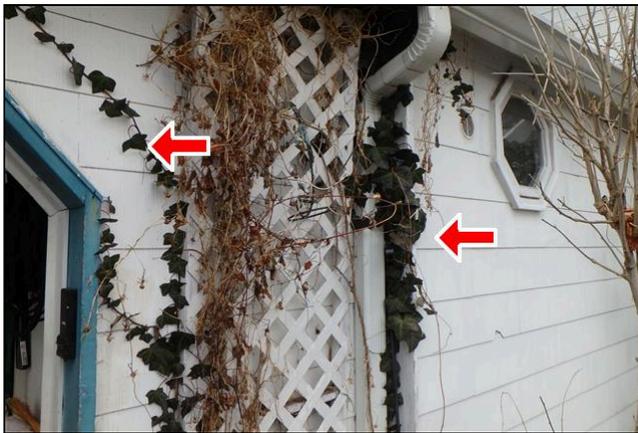
3.7 Item 3(Picture) Vegetation on the main house

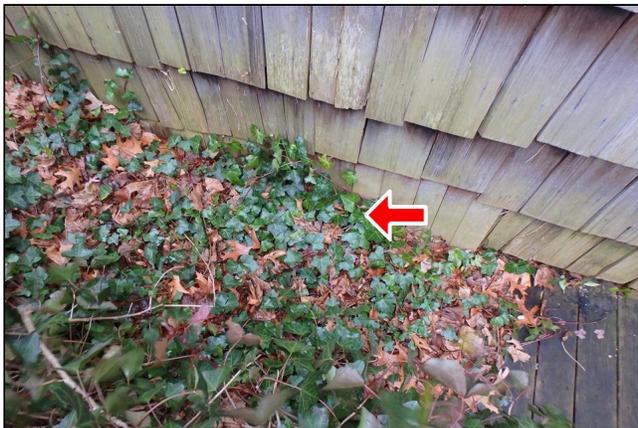
(2) It is recommended that the soil be 6 inches below the siding to prevent damage to the structure and inspect infestation. There should be no earth to wood contact. Creating a 6 inch clearance is recommended.

3.7 Item 4(Picture) It is recommended that the soil be 6 inches below the siding to prevent damage to the structure and inspect infestation on the cottage and main house

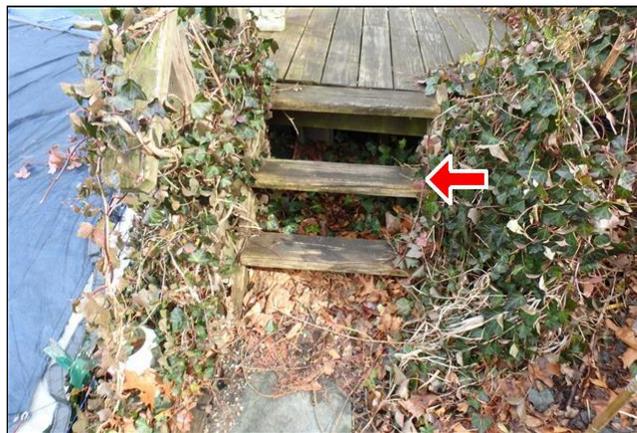
4.2 Item 2(Picture) The stairs on the pool are deteriorated and missing a railing

Contacting a qualified carpenter to evaluate and repair the railing is recommended.

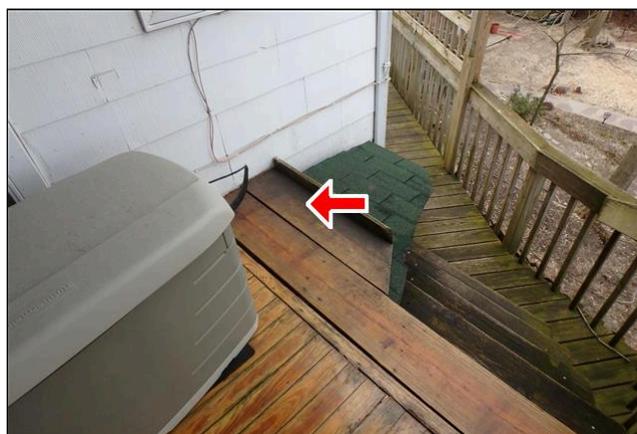
4.2 Item 4(Picture) Missing railing on the north west corner of the deck

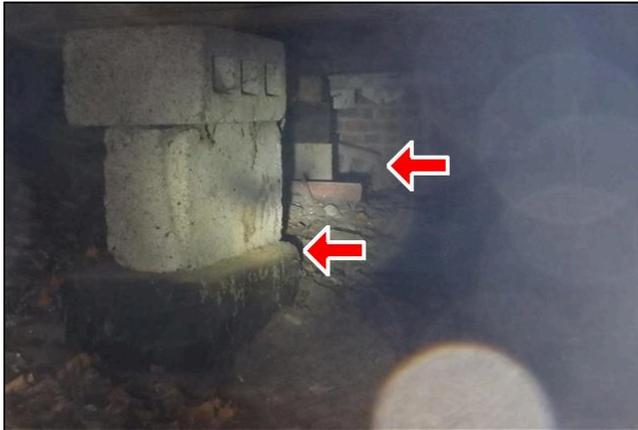
4.3 Item 1(Picture) The porch is not properly supported and requires further evaluation

Having a qualified contractor evaluate and repair as needed is recommended,

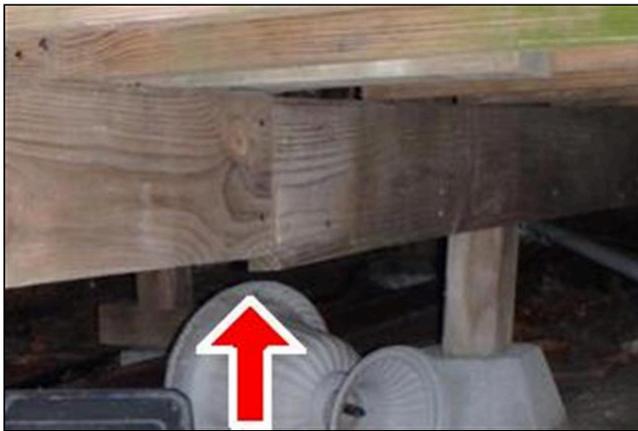
4.3 Item 3(Picture) The girder on the pool deck is separating at the seam due to lack of support

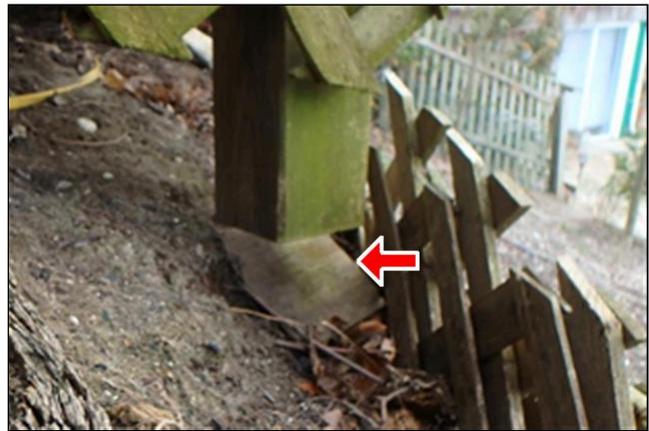
4.3 Item 4(Picture) Some deck support posts are not making contract with the ground

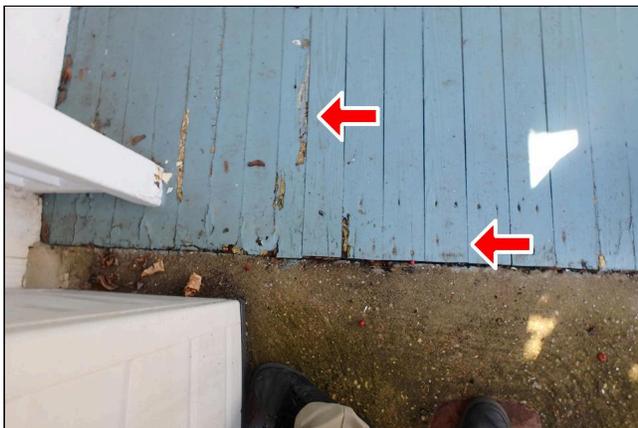
4.3 Item 5(Picture) Many boards are deteriorated on the porch

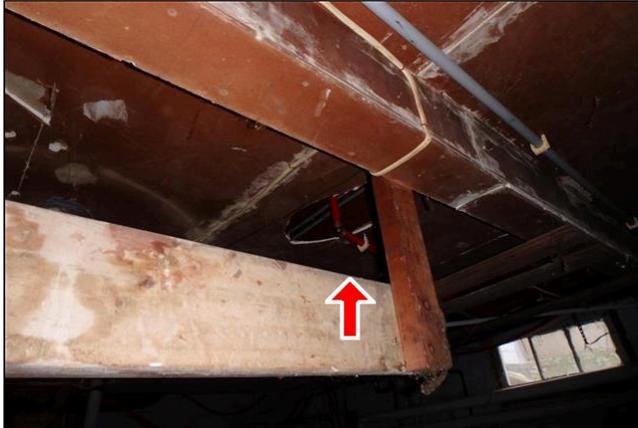
The garage in the guest house is missing fire retardant sheet rock in sections in the garage. Replacing the missing sheet rock with 5/8 fire retardant sheet rock is recommended.

5.0 Item 1(Picture) The garage in the guest house is missing fire retardant sheet rock in sections in the garage

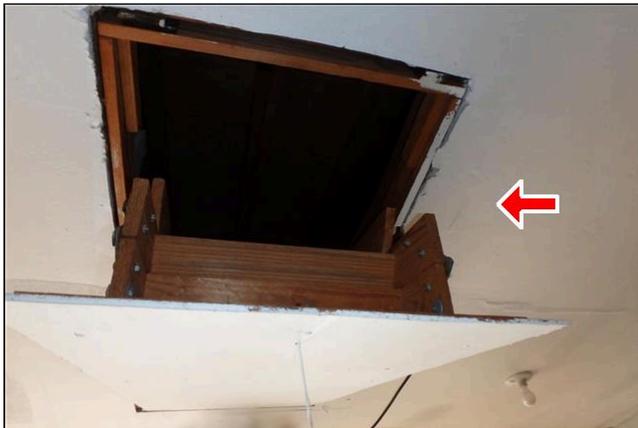
The installation of wood attic stairs is a breach in the fire rock. There are stairs that have a fire rating. Consideration to replacing the stairs with the proper stairs is recommended.

5.0 Item 2(Picture) The installation of wood attic stairs is a breach in the fire rock

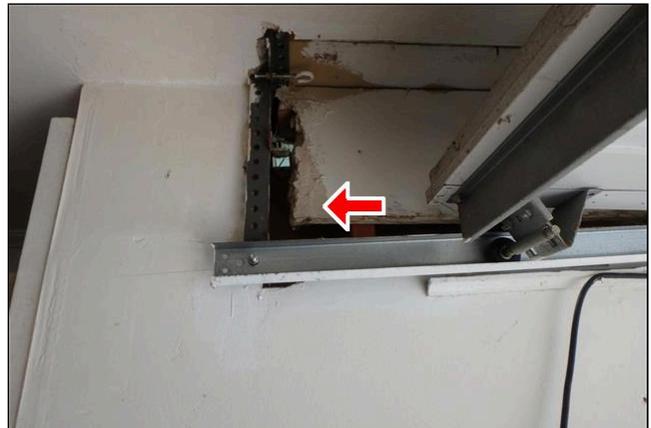
There are holes in the sheetrock in the garage.

5.0 Item 3(Picture) There are holes in the sheetrock in the garage

Having a qualified contractor evaluate and repair as needed is recommended,

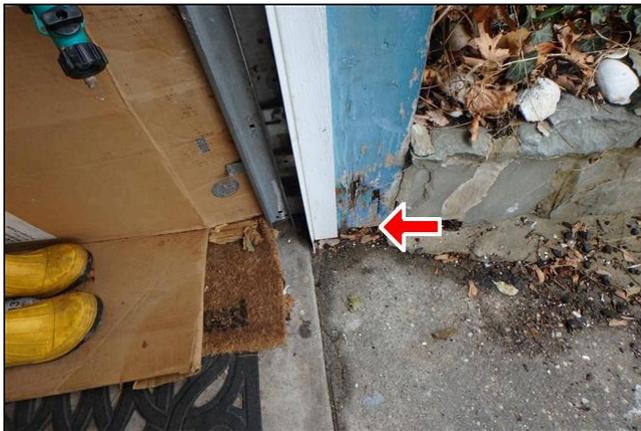
The inspector noticed rot on the door jamb on base of the garage door. Contacting a qualified handy person the repair the door jamb is recommended.

5.2 Item 1(Picture) The inspector noticed rot on the door jamb on base of the garage door.

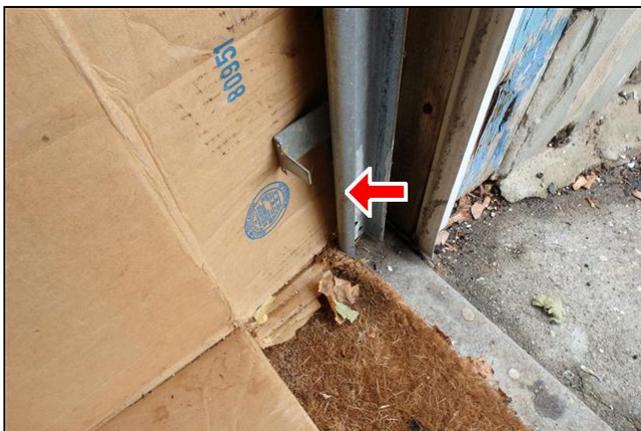
The garage door opener was operational but does not have safety beams. It is recommended to upgrade the opener to a newer model for safety sake.

5.3 Item 1(Picture) The garage door opener was operational but does not have safety beams

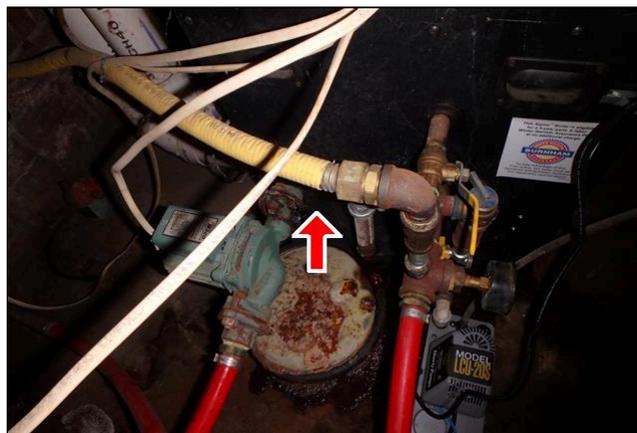
The inspector noticed the presence of corrugated stainless steel tubing (CSST) used for gas service on the boiler. This product has had some problems with leaking after remote lightning strikes in the area. The manufacturer recommends that the gas service be bonded (grounded) for safety sake. Contacting a qualified electrician is recommended.

6.3 Item 2(Picture) The inspector noticed the presence of corrugated stainless steel tubing (CSST) used for gas service on the boiler.

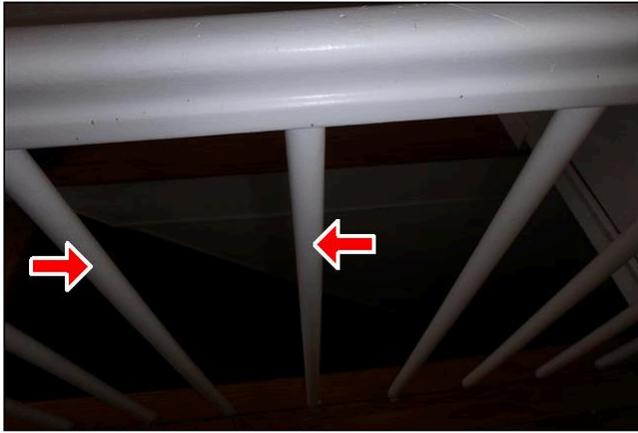
The interior hand rail and baluster spacing is beyond the current 4 inch requirement. Modifying the hand rail is recommended.

7.3 Item 1(Picture) The interior hand rail and baluster spacing is beyond the current 4 inch requirement.  
(2) Main House

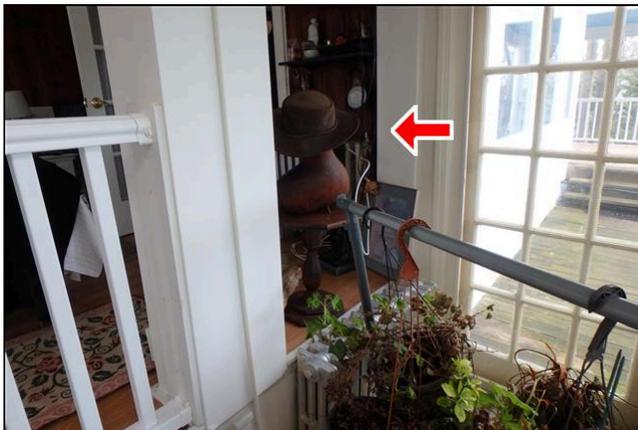
There is no railing on the first floor bath. Installing one is recommended

7.3 Item 3(Picture) There is no railing on the first floor bath

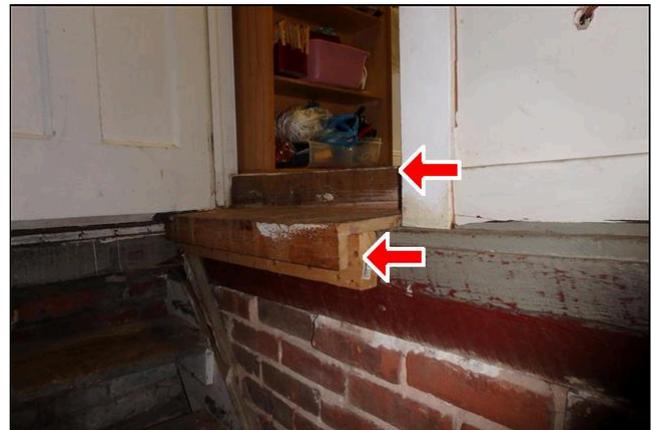
The basement stairs are a safety issue. There is missing steps at the top. Having a qualified contractor evaluate and repair as needed is recommended,

7.3 Item 4(Picture) The basement stairs are a safety issue.

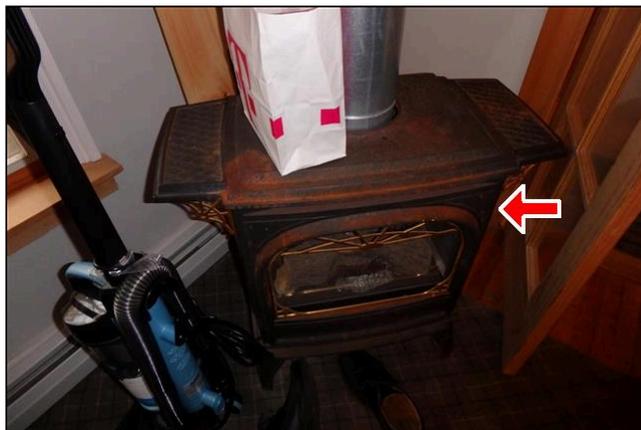
There is a wood burning stove in the guest house that is not properly installed. It does not have the proper clearance from combustible materials. Having a qualified contractor evaluate and repair as needed is recommended.

8.0 Item 1(Picture) It does not have the proper clearance from combustible materials

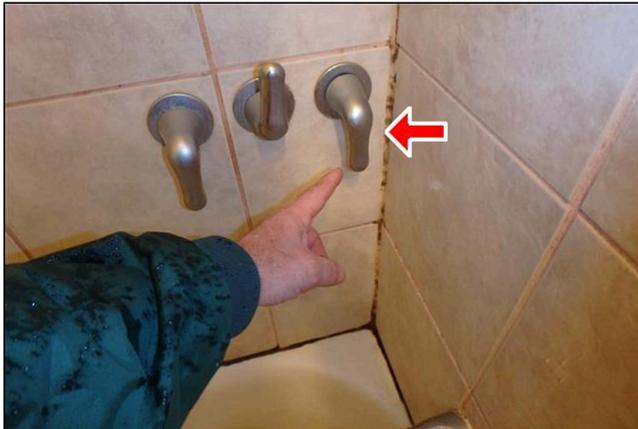
The bathroom cold water valve is defective. Having a licensed plumber evaluate and repair as needed is recommended,

10.3 Item 1(Picture) The bathroom cold water valve is defective.

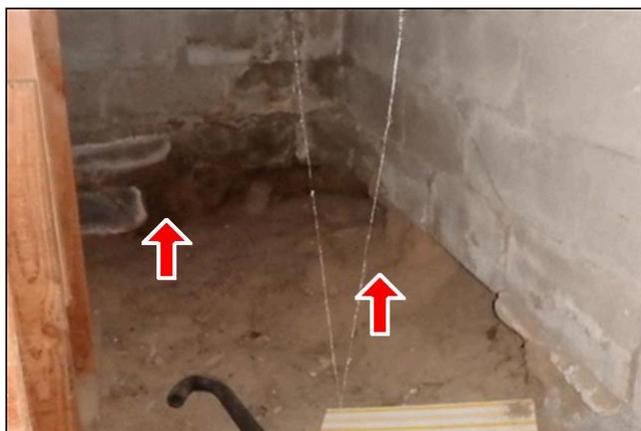
The foundation in the southeast corner of the crawlspace has no footing and is being compromised

11.0 Item 2(Picture) The foundation in the southeast corner of the crawlspace has no footing and is being compromised

Having a structural engineer evaluate further is recommended

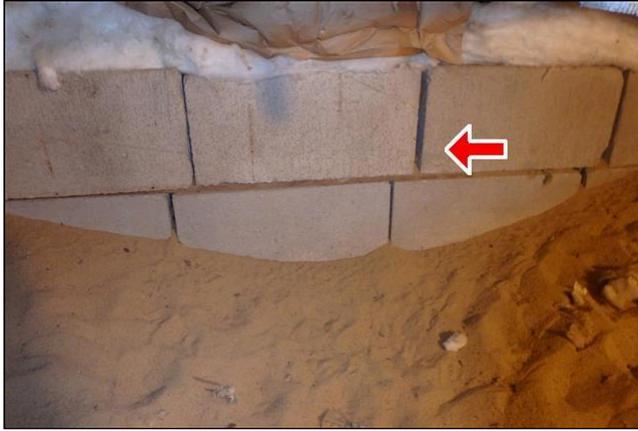
The foundation on the north wall in the wine cellar are not properly constructed. Having a structural engineer evaluate is recommended,

11.0 Item 3(Picture) The foundation on the north wall in the wine cellar are not properly constructed

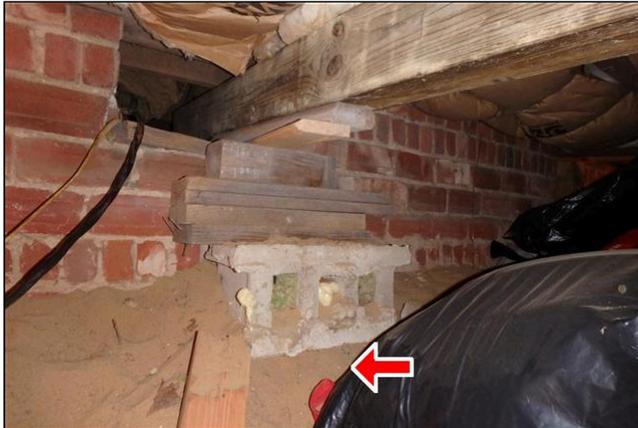
There are no footings under many of the columns in the wine cellar in the main house. Having them evaluated by a qualified contractor is recommended,

11.2 Item 1(Picture) There are no footings under many of the columns in the wine cellar

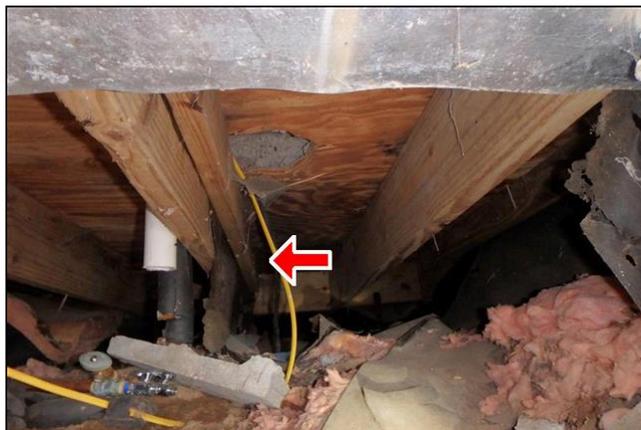
11.3 Item 1(Picture) The floor joist in the crawlspace under the bathroom on the north 1st floor has been compromised

Having a qualified contractor evaluate and repair as needed is recommended

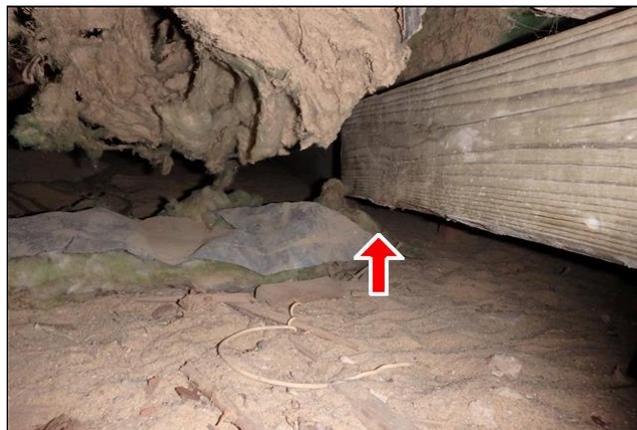
11.3 Item 2(Picture) The girder under the living room is not supported (seen from the wine cellar)

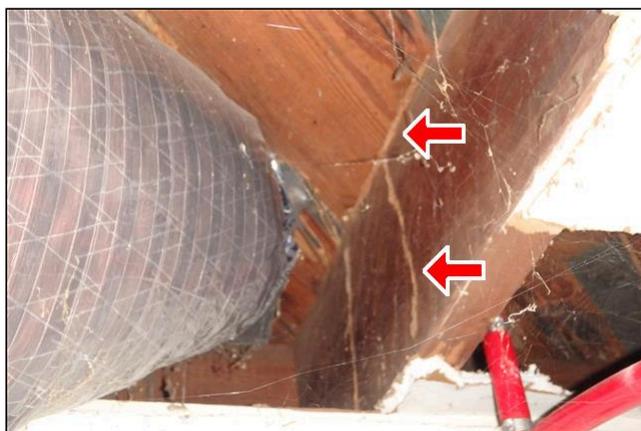
The inspector noticed termite activity in the guest house floor joists on the north wall requiring treatment from a qualified pesticide applicator. The total extent of the damage if any could not be determined without an invasive inspection.

11.7 Item 1(Picture) The inspector noticed termite activity in the guest house floor joists on the north wall

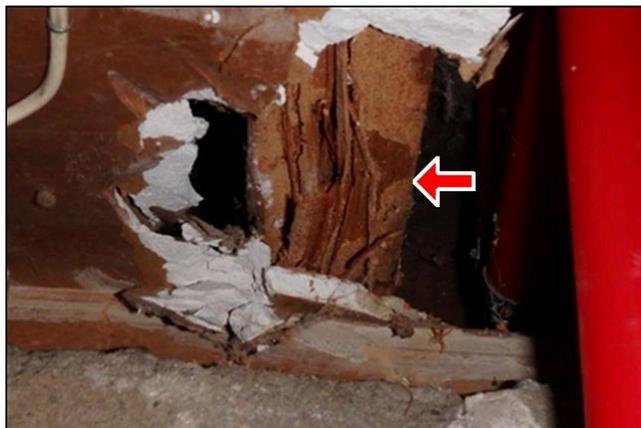
The floor joists in the guest house on the north wall have been effected by termites requiring repair by a qualified contractor. The total extent of the damage could not be determined without an invasive inspection. Having a qualified contractor evaluate and repair as needed is recommended.

11.8 Item 1(Picture) The floor joists in the guest house on the north wall have been effected by termites

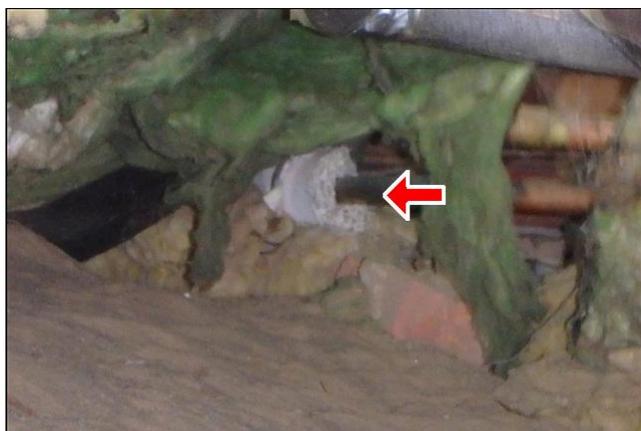
Asbestos material sampling is not within the scope of a home inspection and there are hundreds of building materials that may contain asbestos in them that were not tested by the inspector. There is evidence of pipe wrap known to contain asbestos in the the crawl space . Contacting a qualified contractor to address the pipe wrap is recommended.

11.9 Item 1(Picture) There is evidence of pipe wrap known to contain asbestos in the the crawl space

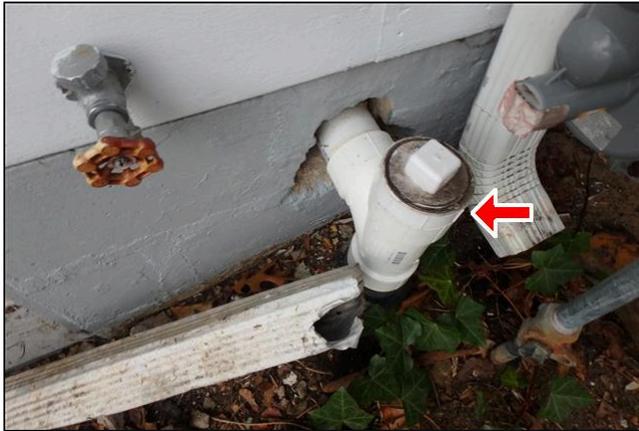
12.0 Item 1(Picture) There is no presents of a fresh air intake on the septic system

Having a licensed plumber evaluate and repair as needed is recommended,

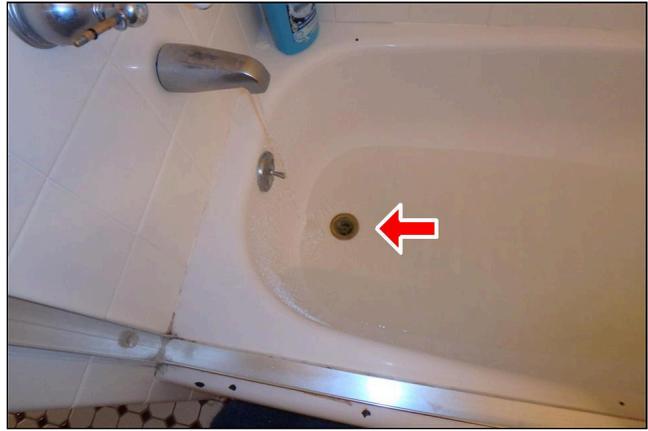
12.0 Item 2(Picture) The tub drain is slow in the hall bath

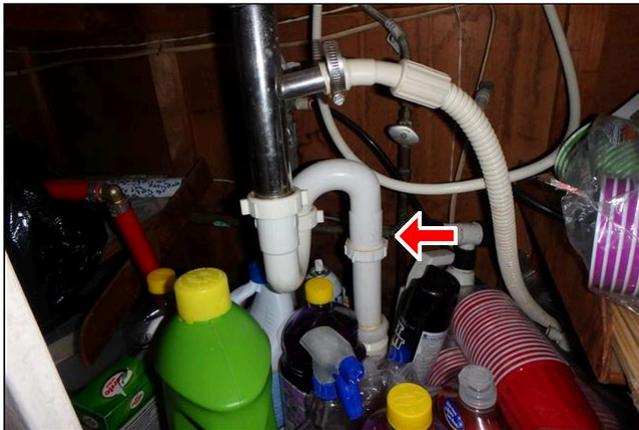
12.0 Item 3(Picture) The inspector noticed a "S" trap under the kitchen sink

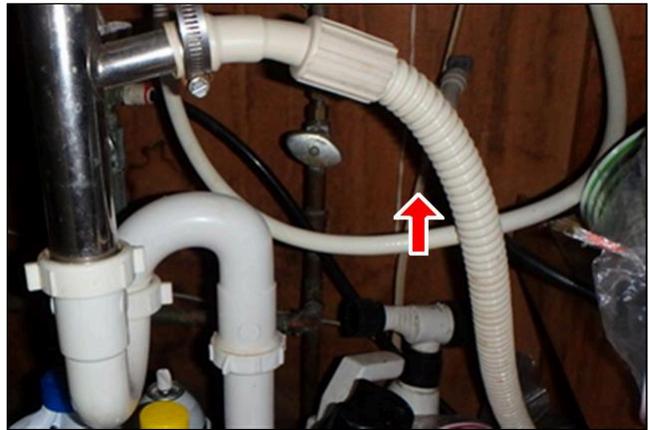
12.0 Item 4(Picture) No air gap on the dishwasher

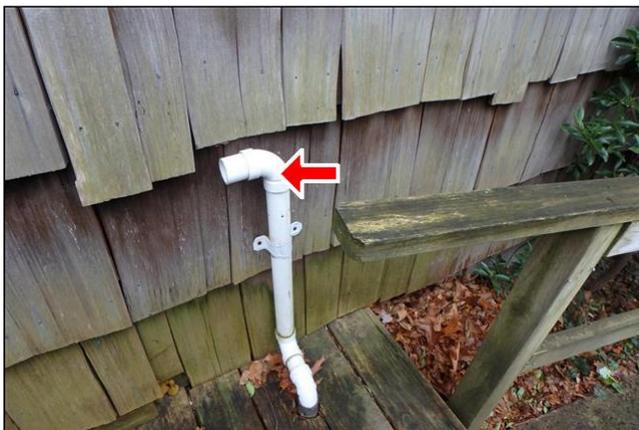
12.0 Item 5(Picture) There is a plumbing vent on the east side of the cottage that origin is unknown

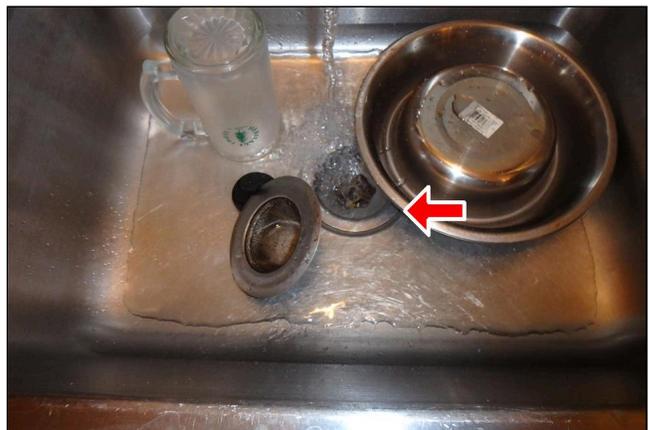
12.0 Item 6(Picture) The inspector noticed that the kitchen sink syphons when draining from poor ventilation.

Contacting a qualified plumber to evaluate and repair the sink drain is recommended.

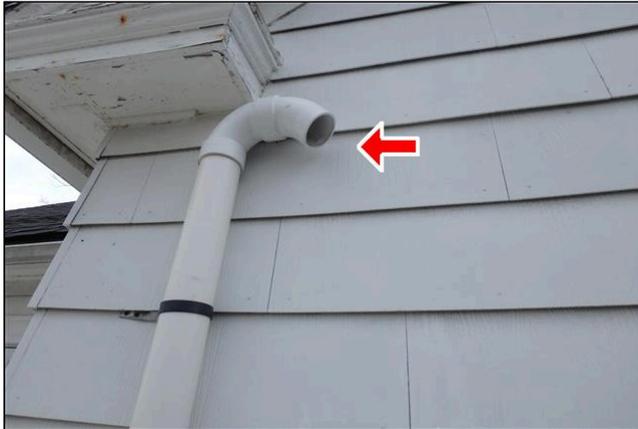
12.0 Item 7(Picture) There is a plumbing vent stack on the west side of the house that is too close to the structure and window openings

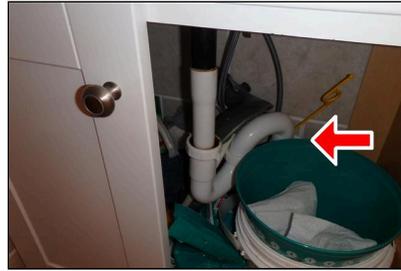
12.0 Item 8(Picture) There is an "S-Trap" in the 1st floor bath on the north side

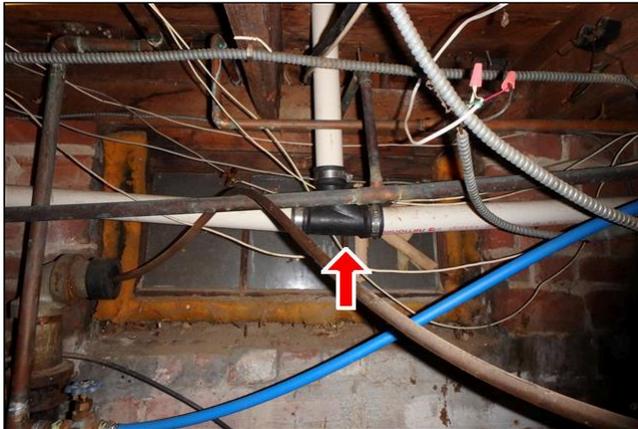
12.0 Item 9(Picture) The drain for the kitchen sink and washing machine has a negative pitch

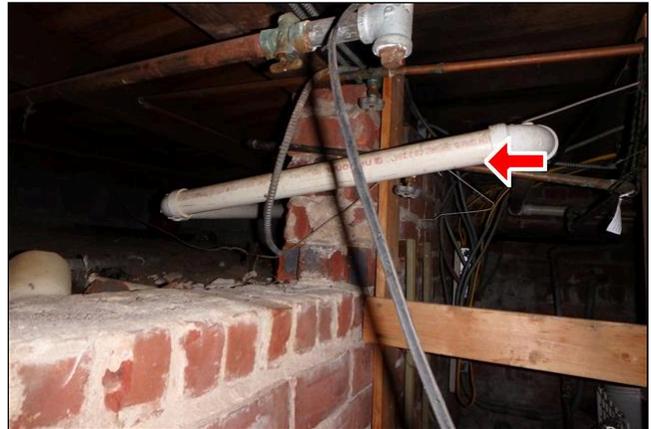
12.0 Item 10(Picture) Washing machine drain pitched backwards

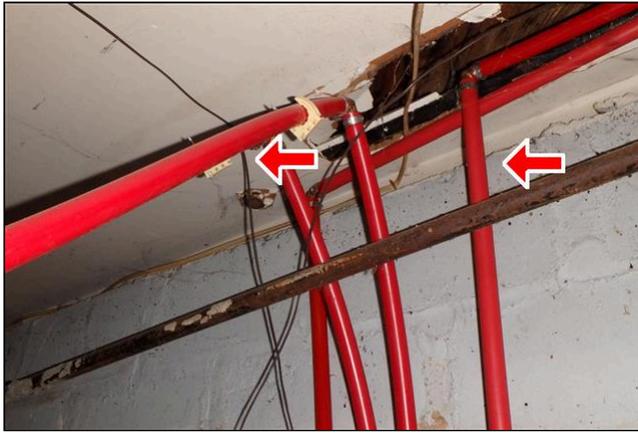
The water supply lines in the garage are not properly secured. Securing the line is recommended

12.1 Item 1(Picture) The water supply lines in the garage are not properly secured

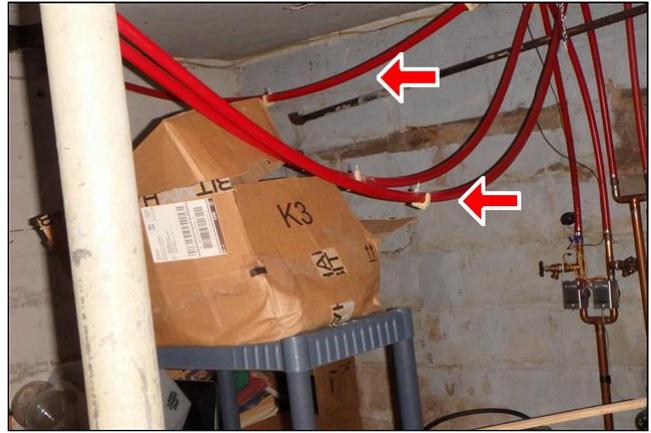
12.1 Item 2(Picture) un-secured water supply lines

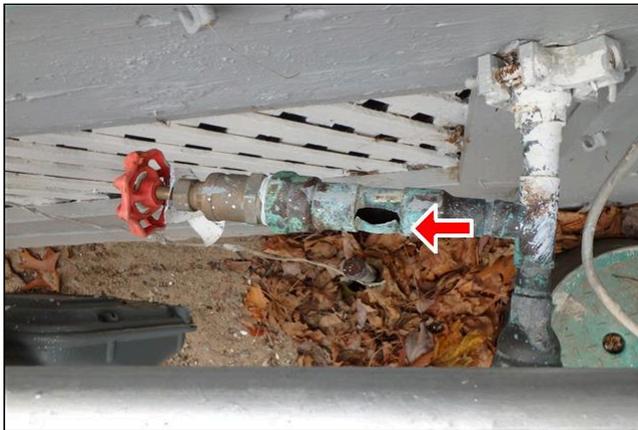
12.1 Item 3(Picture) The water faucet supply line burst on the east side of the exterior

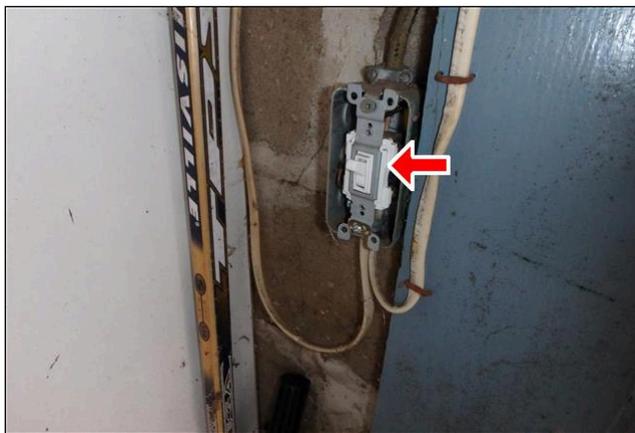
13.3 Item 2(Picture) There is missing cover plates for the switches and outlets scattered through out the house

Having a licensed electrician evaluate and repair these items is recommended.

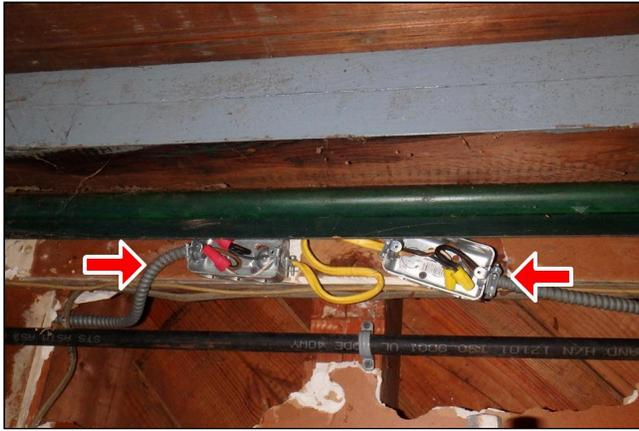
13.3 Item 3(Picture) Open junction boxes in the garage

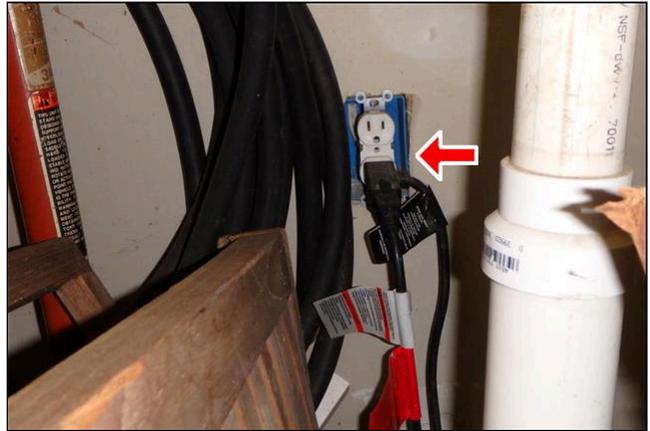
13.3 Item 4(Picture) The sewage ejector pump is not GFCI protected

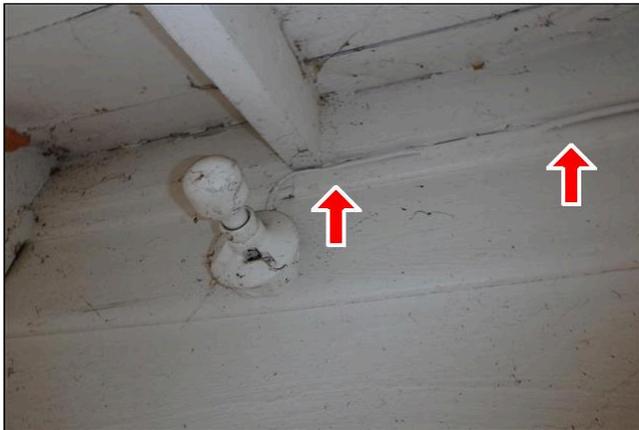
13.3 Item 5(Picture) Exposed romex on the exterior by the entrance door

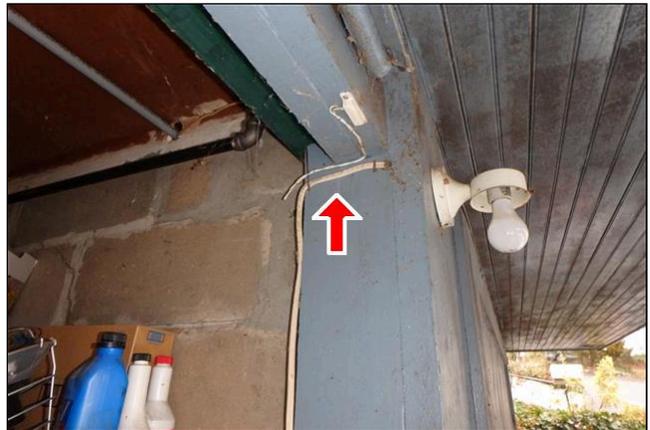
13.3 Item 6(Picture) Exposed romex by the garage door entrance

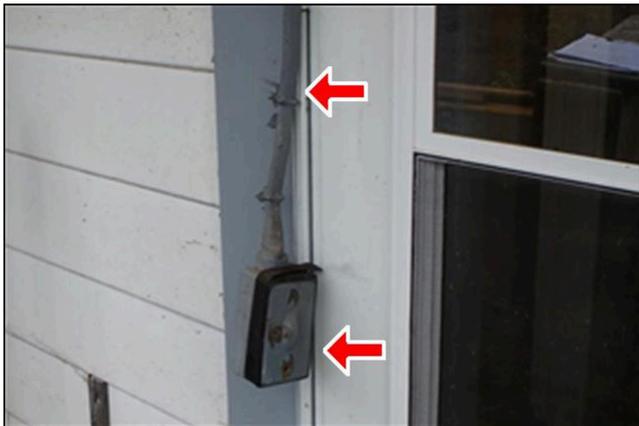
13.3 Item 7(Picture) Exposed romex and unsecured light switch by the exterior front door

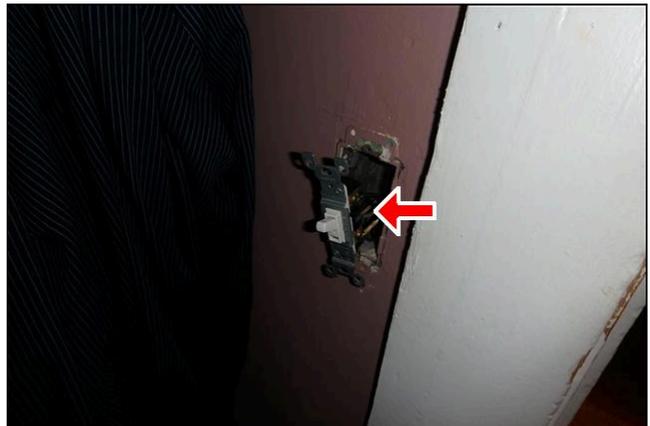
13.3 Item 8(Picture) The light switch in the master bedroom is not properly installed

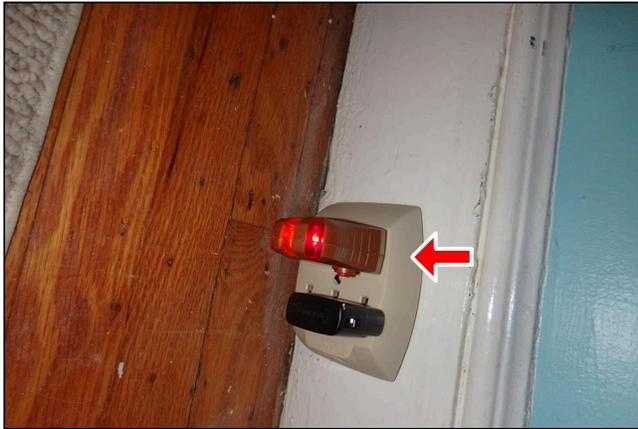
13.3 Item 9(Picture) The inspector noticed hot and neutral reversed receptacles scattered through out the house

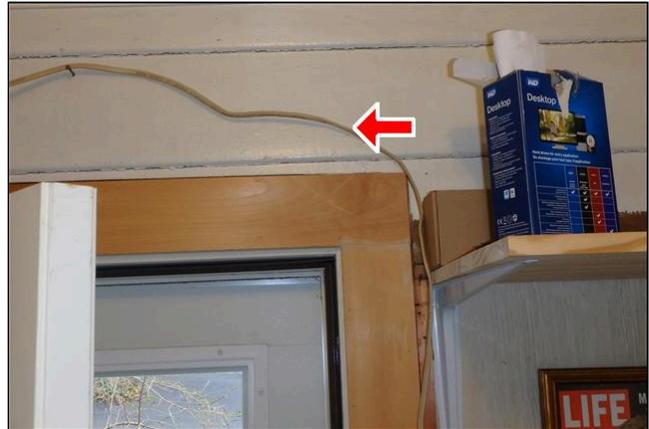
13.3 Item 10(Picture) Exposed romex wire in the office area
