# Inspection Report

**Property Address:**  
1 New Home  
Heaven on earth NY 11111

**New Home Inspectors LLC**

<b>Date:</b> 9/4/2015	<b>Time:</b> 12:00 AM	<b>Report ID:</b>
<b>Property:</b> 1 New Home Heaven on earth NY 11111	<b>Customer:</b> John Donut	<b>Real Estate Professional:</b>

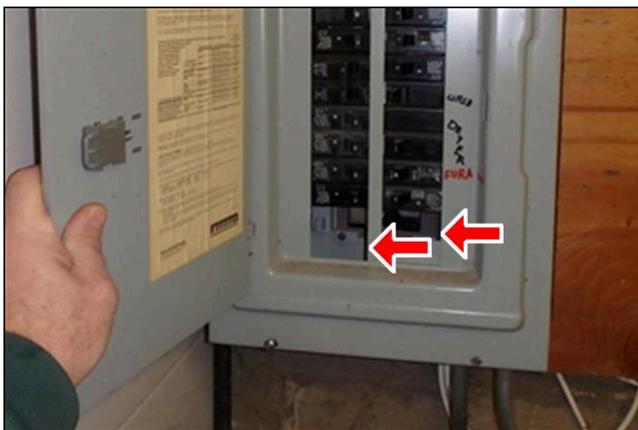
13.3 Item 11(Picture) Missing circuit breaker knockout blanks

Having a licensed electrician evaluate and repair these items is recommended.

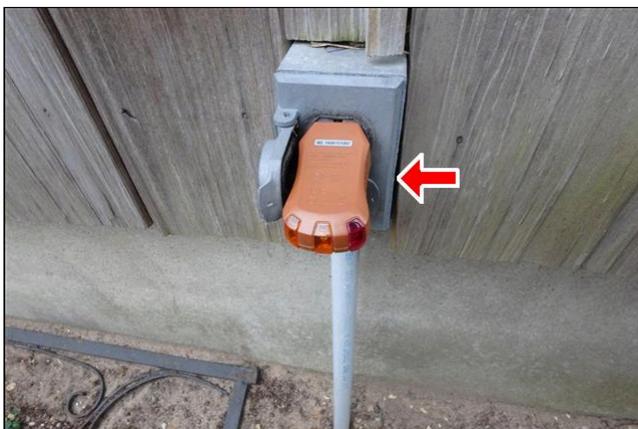
13.3 Item 12(Picture) There is no power at the exterior receptacle on the north wall

Having a licensed electrician evaluate and repair these items is recommended.

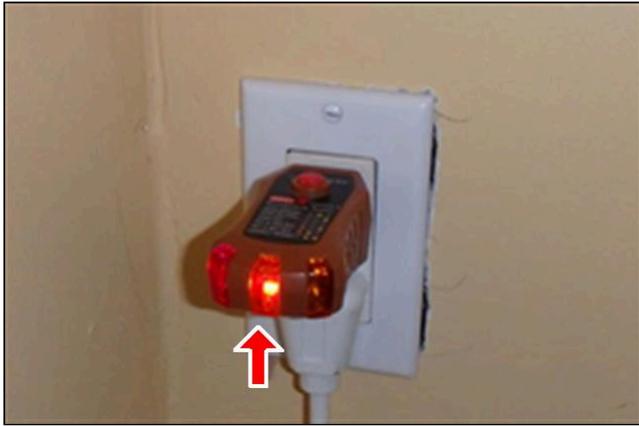
13.3 Item 14(Picture) The inspector noticed hot and neutral reversed receptacles scattered through out the house

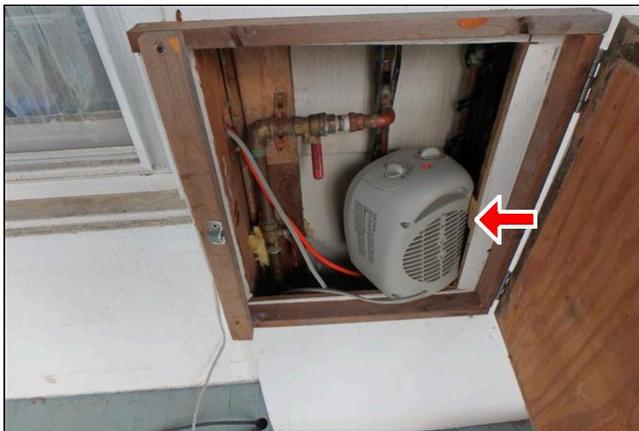
13.3 Item 15(Picture) There is a electric heater on the exterior to protect the water lines that is a fire hazard

Having a licensed electrician evaluate and repair these items is recommended.

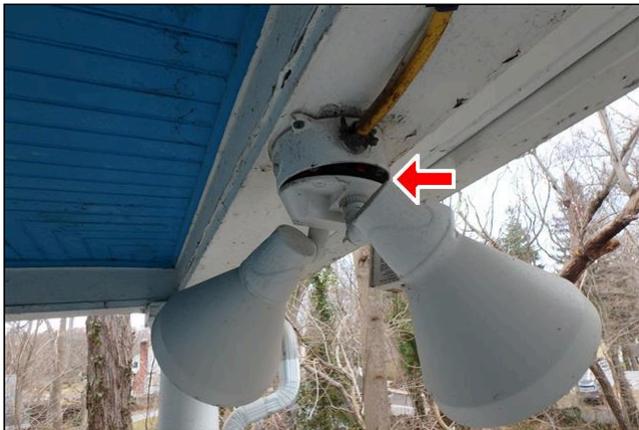
13.3 Item 21(Picture) The spot light on the porch is not properly secured

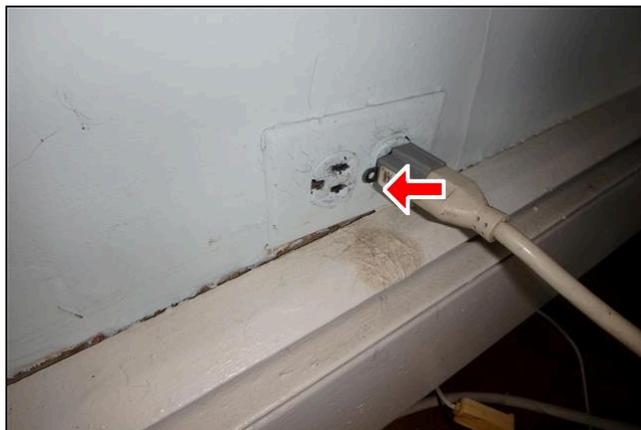
13.3 Item 23(Picture) There are painted over outlets scattered throughout that should be replaced

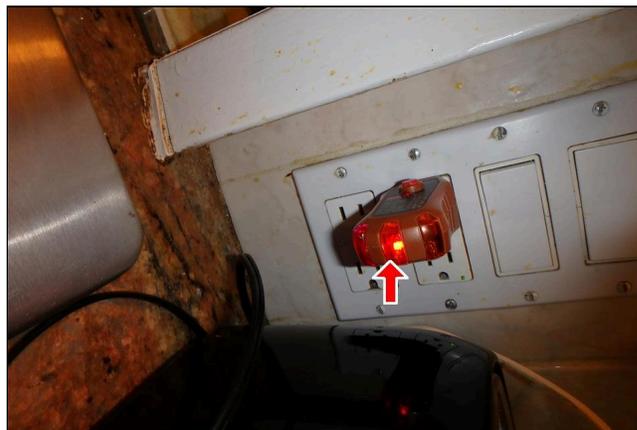
13.3 Item 24(Picture) There are ungrounded receptacles in the kitchen

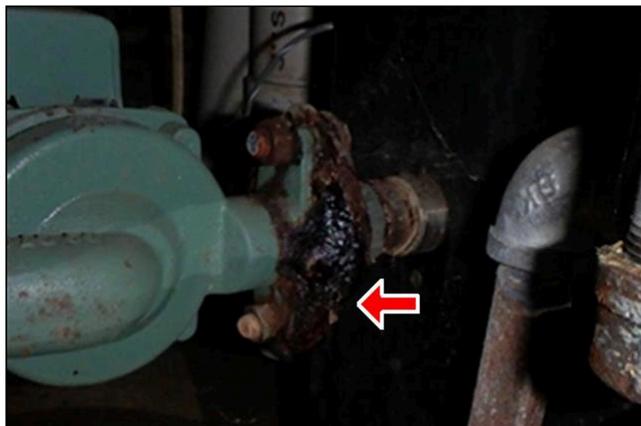
The circulator gasket is leaking and the TPS valve is also leaking. Having a licensed plumber evaluate and repair as needed is recommended

14.0 Item 1(Picture) Leaking gasket

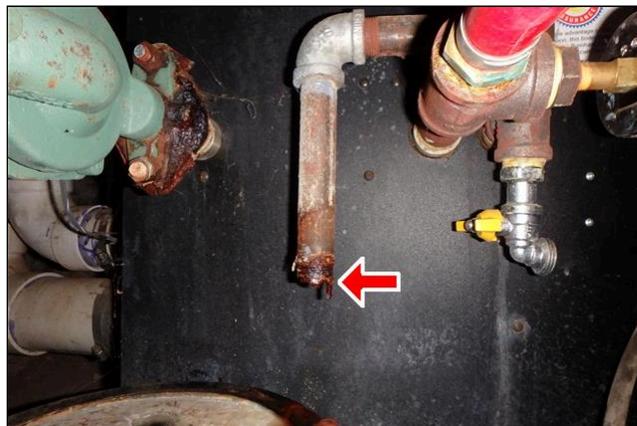
14.0 Item 2(Picture) leaking TPS valve

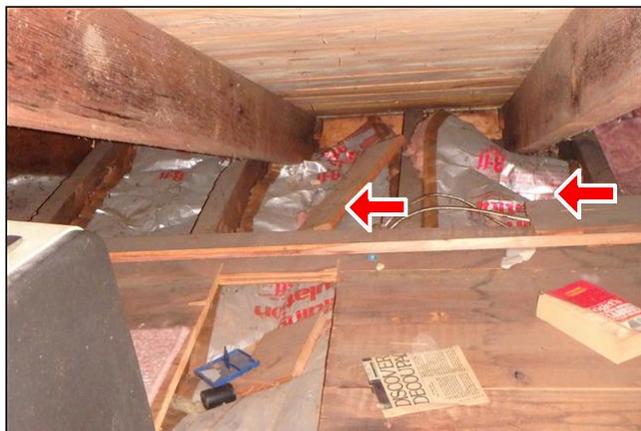
The insulation was installed backwards with the vapor barrier facing away from the heated sections of the house. Reversing the insulation is recommended.

15.0 Item 1(Picture) The insulation was installed backwards with the vapor barrier facing away from the heated sections of the house

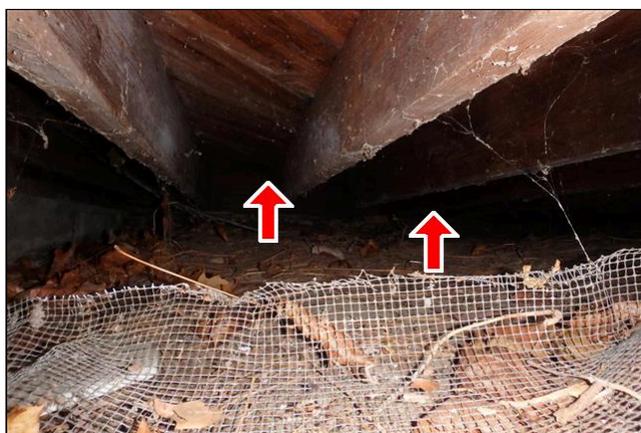
The floor of the office is not insulated or protected from weather or infestation. Heat loss can occur more on this home than one that is properly insulated.

15.1 Item 1(Picture) The floor of the office is not insulated or protected from weather or infestation

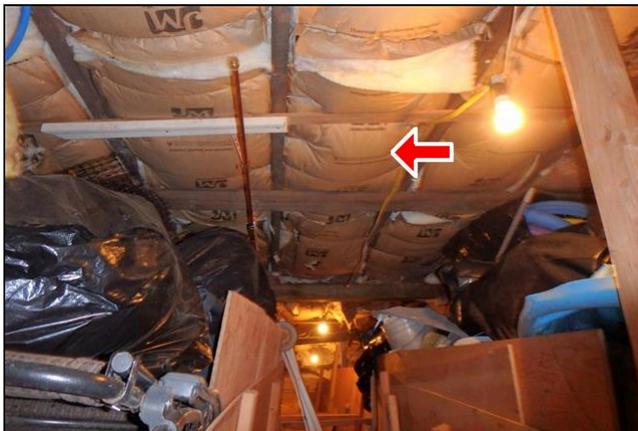
1. The floor system is not insulated under the first floor bath on the north side. Heat loss can occur more on this home than one that is properly insulated.
2. The insulation was installed backwards with the vapor barrier facing away from the heated sections of the house. Reversing the insulation is recommended.

17.1 Item 1(Picture) The insulation was installed backwards with the vapor barrier facing away from the heated sections of the house

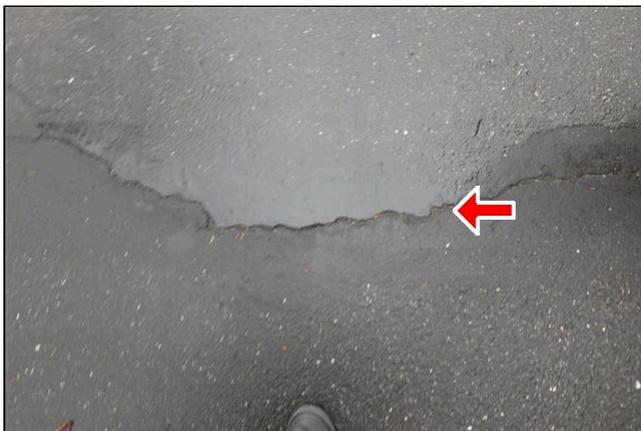
(1) There are cracks in the driveway that should be filled to prevent deterioration to the driveway. Water entering the cracks will lead to deterioration and repairing the cracks now will prevent further damage.

1.0 Item 1(Picture) There are cracks in the driveway that should be filled to prevent deterioration to the driveway.

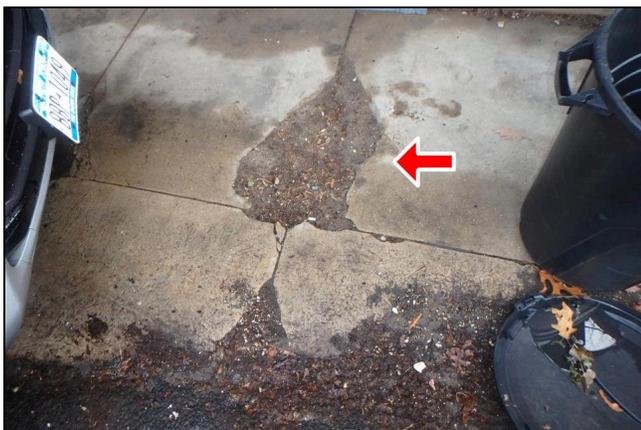
(2) The concrete driveway apron on the guest house is in a deteriorated state with broken concrete. Contacting a qualified mason to replace the driveway should be considered.

1.0 Item 2(Picture) The concrete driveway apron on the guest house is in a deteriorated state with broken concrete.

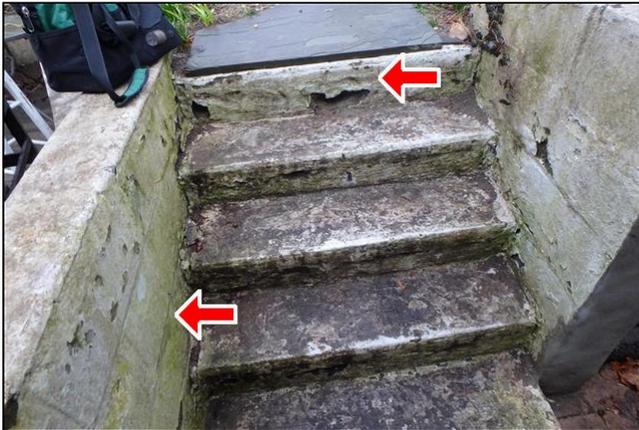
The north steps are deteriorated and missing a handrail installing one is recommended

1.1 Item 1(Picture) The north steps are deteriorated and missing a handrail

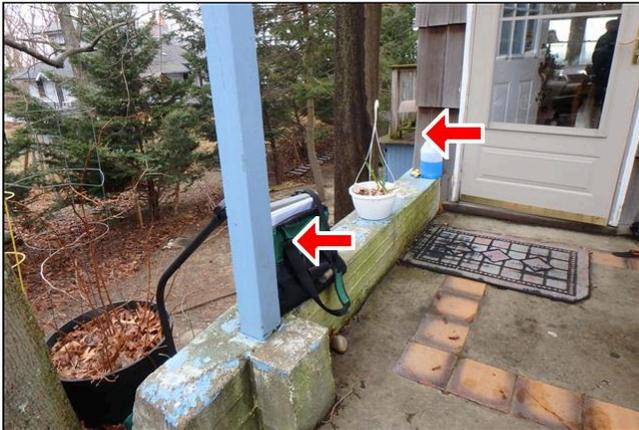
Missing railing on the front porch. Installing one for safety sake is recommended,

1.2 Item 1(Picture) Missing railing on the front porch

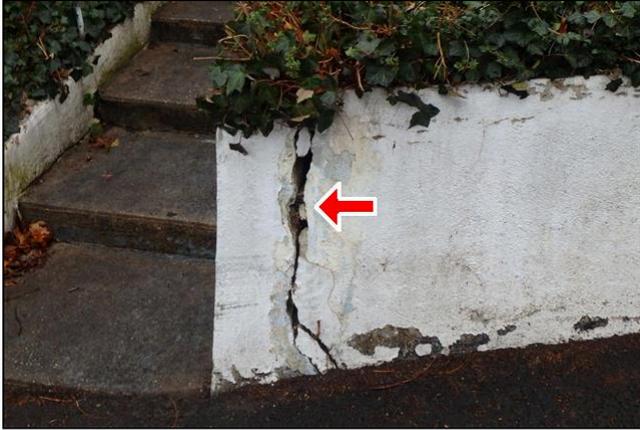
1.3 Item 1(Picture) Retaining walls are deteriorated

Having a qualified contractor evaluate and repair as needed is recommended,

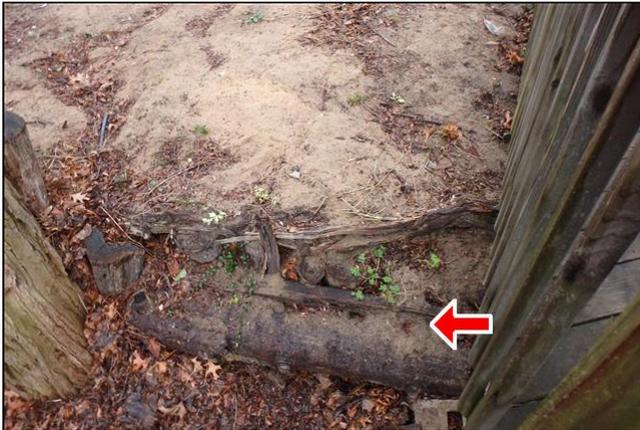
1.3 Item 3(Picture) The wood retaining wall is rotted to the left of the deck

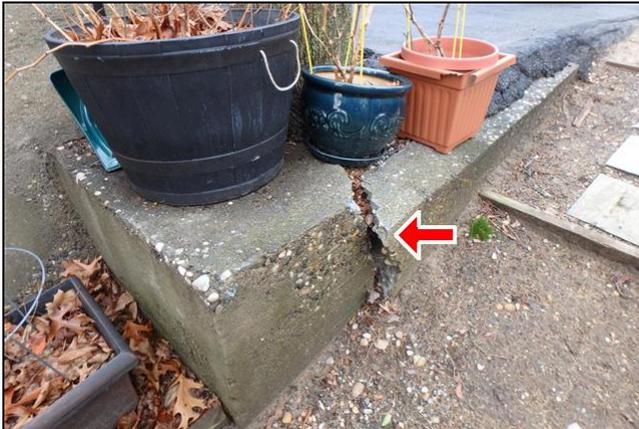
The retaining wall to the east side is deteriorated. Having a qualified contractor evaluate and repair as needed is recommended,

1.3 Item 4(Picture) The retaining wall to the east side is deteriorated

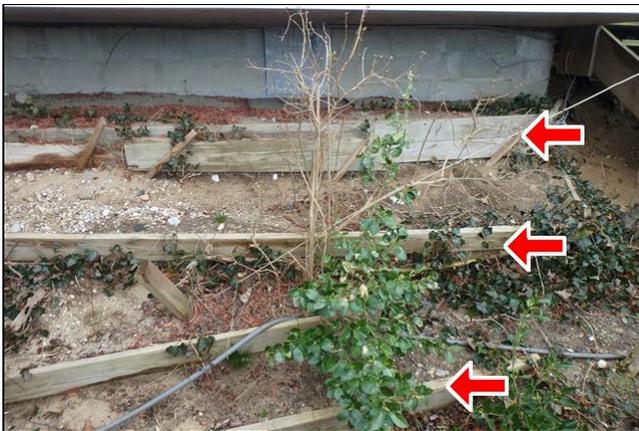
1. The retaining walls on the north side are deteriorated

1.3 Item 5(Picture) The retaining walls on the north side are deteriorated

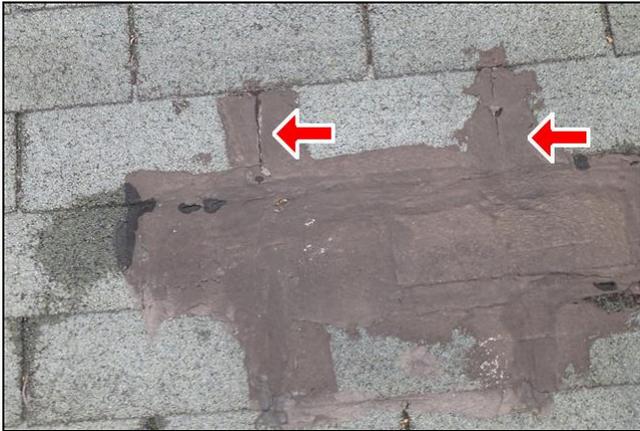
There are some tared repairs to the roof that are deteriorated and need to be evaluated and corrected by a qualified roofer.

2.0 Item 1(Picture) There are some tared repairs to the roof that are deteriorated

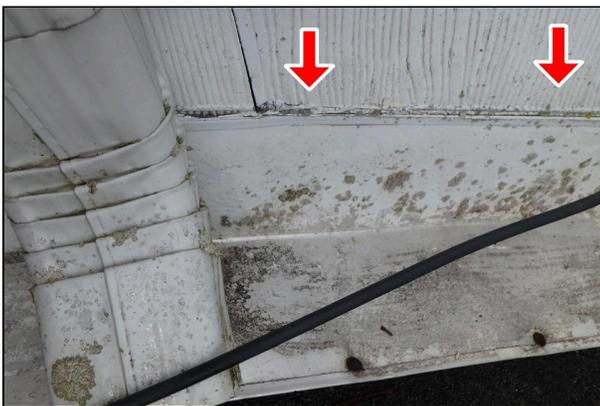
The flashing on the upper west wall is installed incorrectly. Having a qualified contractor evaluate and repair as needed is recommended,

2.2 Item 1(Picture) The flashing on the upper west wall is installed incorrectly.

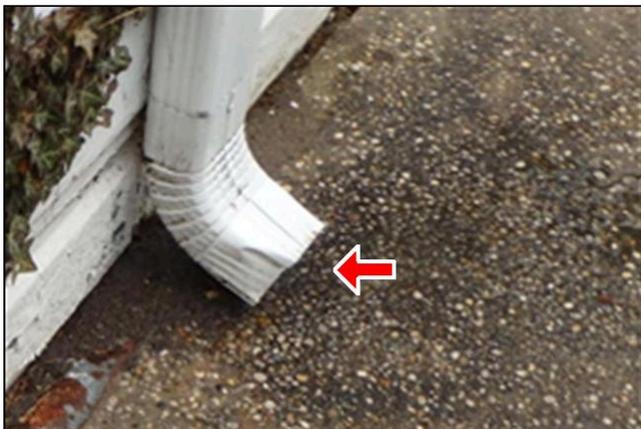
The gutter leaders are depositing water at the base of the foundation on all the houses. Water at the base of the foundation can penetrate the structure and cause water damage. Gutter leaders should extend 6 feet away from the structure.

2.4 Item 1(Picture) The gutter leaders are depositing water at the base of the foundation on all the houses.

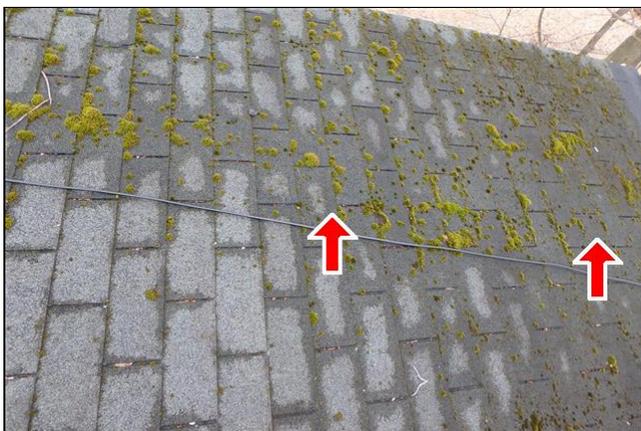
The inspector noticed moss/lichen growth on the roof and black algae streaks. Lichen can cause mineral loss on the roof shingles. The growth can be cleaned off by a qualified professional.

2.5 Item 1(Picture) The inspector noticed moss/lichen growth on the roof and black algae streaks

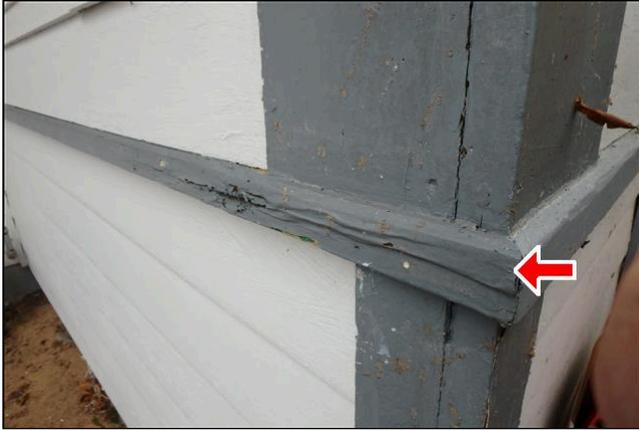
3.0 Item 5(Picture) Deteriorated trim on the south east corner of the house

Having a qualified contractor evaluate and repair as needed is recommended,

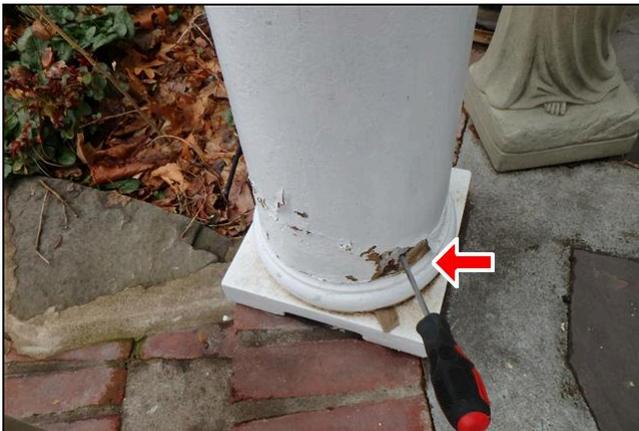
3.0 Item 6(Picture) The columns by the front entrance are deteriorated at the base

Having a qualified contractor evaluate and repair as needed is recommended,

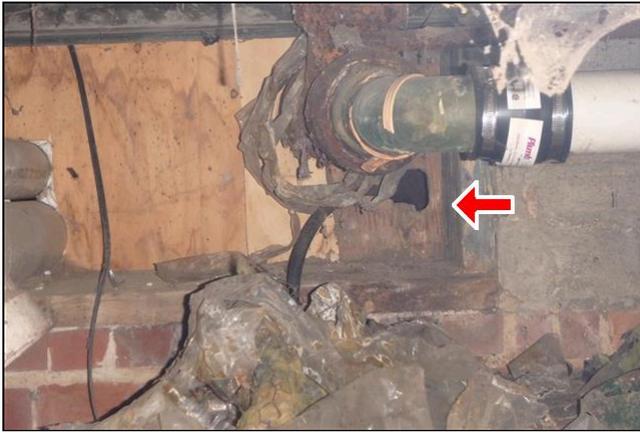
3.0 Item 8(Picture) There are opening in the plywood in the basement window allowing infestation

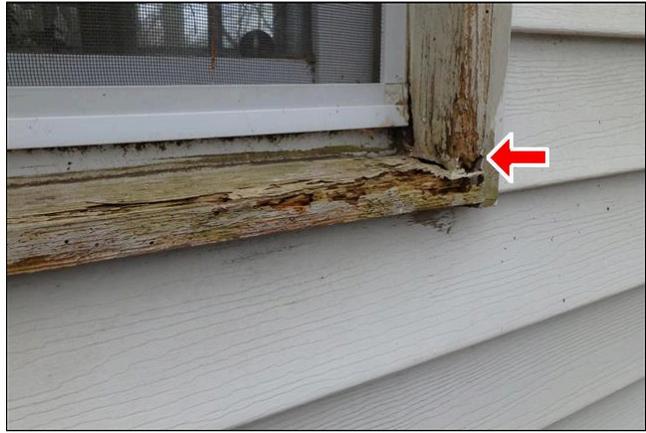
3.0 Item 9(Picture) There is scattered trim rotted around the house

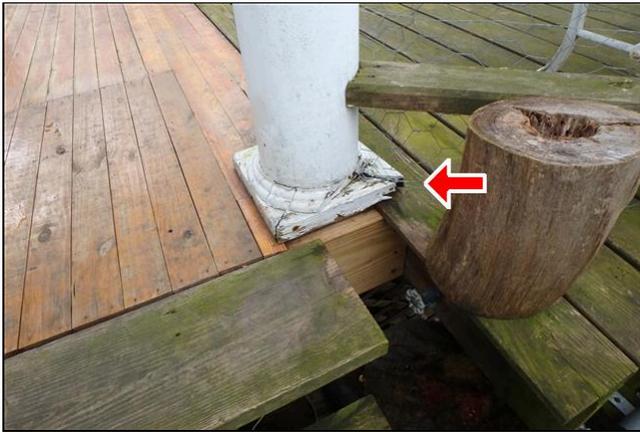
3.0 Item 10(Picture) The column on the north deck is rotted

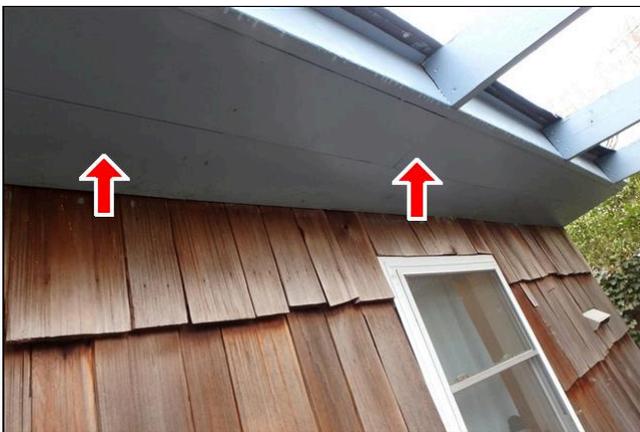
The inspector noticed a lack of soffit vents around the house. Installing soffit vents is recommended to help increase attic ventilation and increase roof life.

3.1 Item 1(Picture) The inspector noticed a lack of soffit vents around the house.

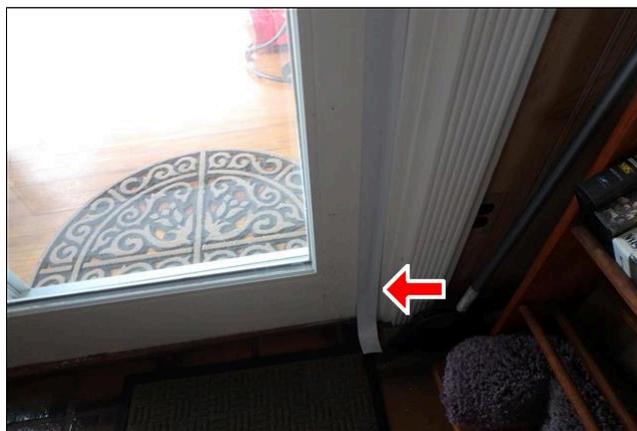
The inspector noticed a cracked door jamb on the west roof door and the rear den door is taped shut requiring repair by a qualified carpenter.

3.3 Item 2(Picture) the rear den door is taped shut

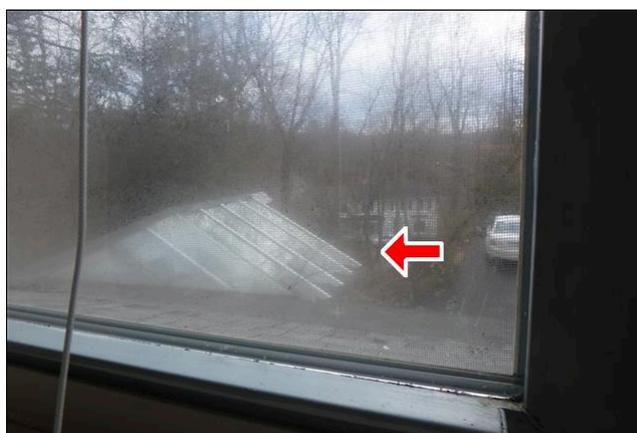
3.5 Item 4(Picture) The inspector noticed broken window seals scattered throughout the house

Having a qualified contractor evaluate and repair as needed.

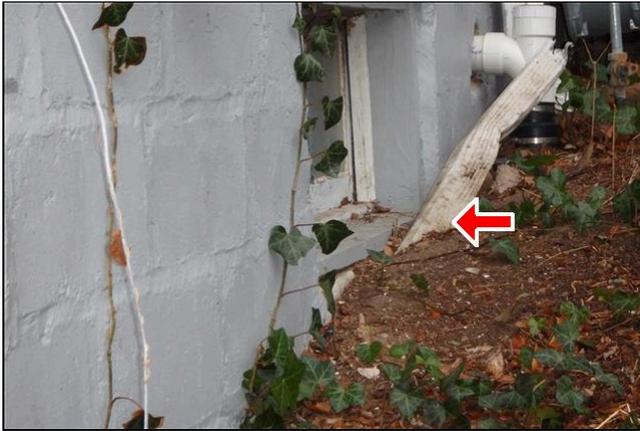
Installing window wells on the guest house to create the 6 inch soil clearance is recommended. This will help prevent water infiltration and insect damage.

3.6 Item 1(Picture) Installing window wells on the guest house to create the 6 inch soil clearance is recommended.

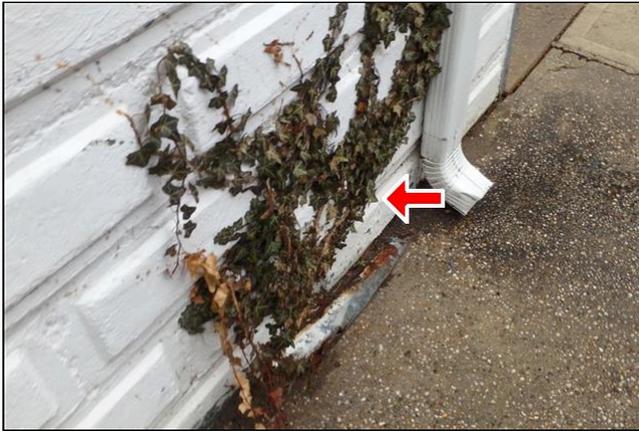
(1) The vegetation is too close to the structures. There should be no vegetation within 12 inches of the house. The tree limbs should be 6 feet away from the structure. Making the necessary corrections is recommended.

3.7 Item 1(Picture) The vegetation is too close to the structure.

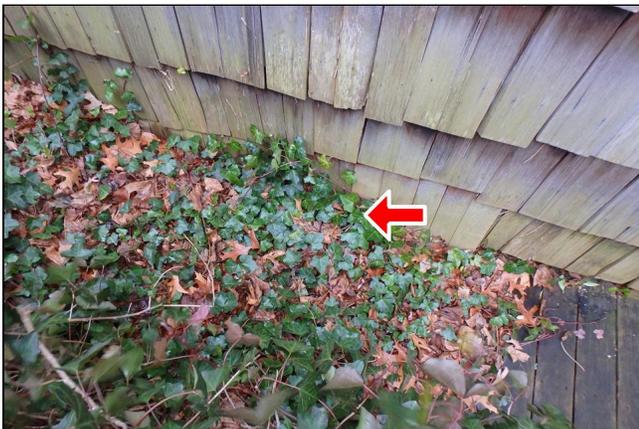
(2) It is recommended that the soil be 6 inches below the siding to prevent damage to the structure and inspect infestation. There should be no earth to wood contact. Creating a 6 inch clearance is recommended.

3.7 Item 4(Picture) It is recommended that the soil be 6 inches below the siding to prevent damage to the structure and inspect infestation on the cottage and main house

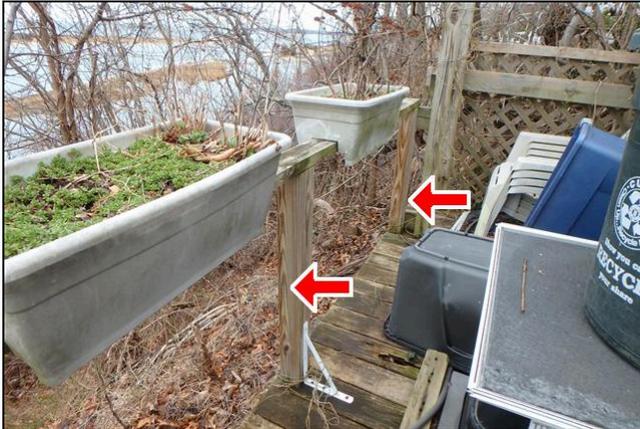
4.2 Item 1(Picture) The inspector noticed that the railing baluster spacing is beyond the current recommended 4 inch standard.

Contacting a qualified carpenter to evaluate and repair the railing is recommended.

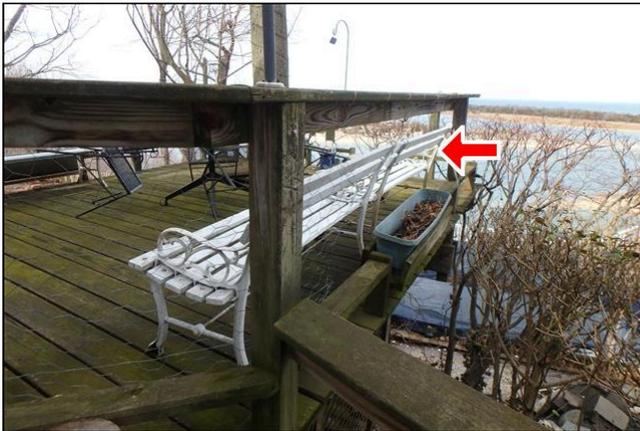
4.2 Item 3(Picture) The inspector noticed that the railing baluster spacing is beyond the current recommended 4 inch standard.

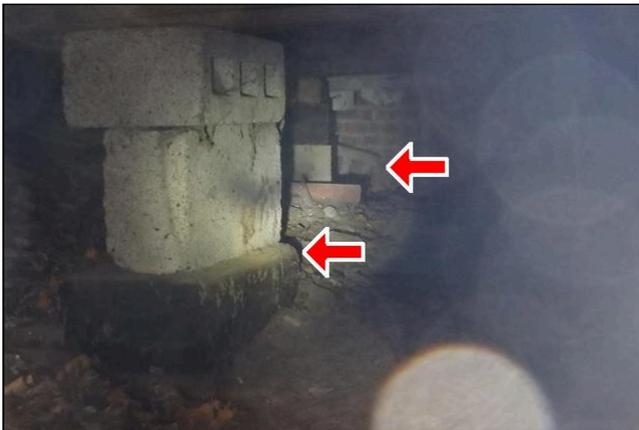
4.3 Item 1(Picture) The porch is not properly supported and requires further evaluation

Having a qualified contractor evaluate and repair as needed is recommended,

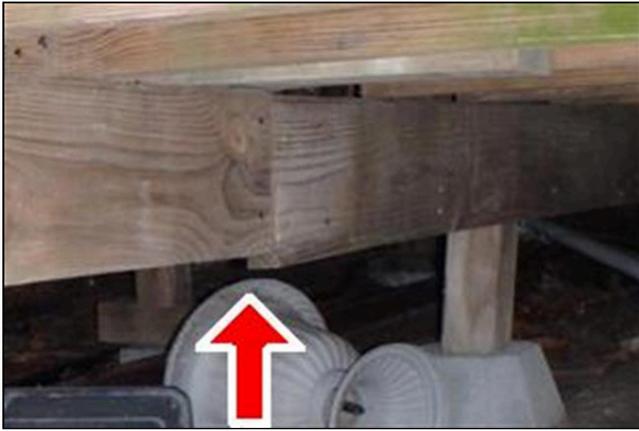
4.3 Item 3(Picture) The girder on the pool deck is separating at the seam due to lack of support

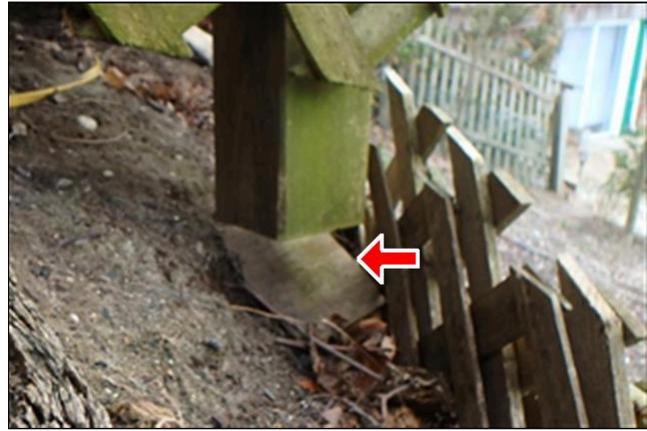
4.3 Item 4(Picture) Some deck support posts are not making contact with the ground

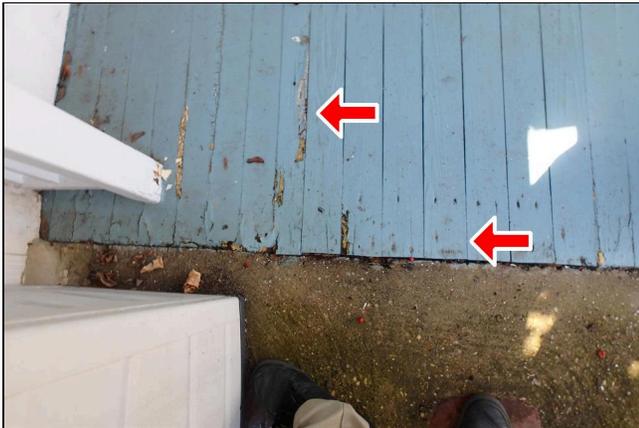
4.3 Item 5(Picture) Many boards are deteriorated on the porch

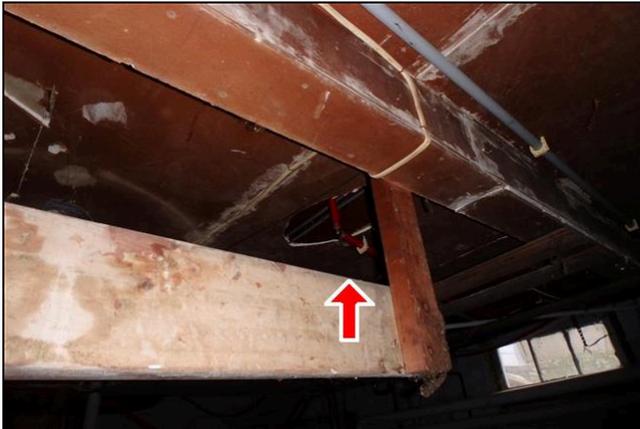
The garage in the guest house is missing fire retardant sheet rock in sections in the garage. Replacing the missing sheet rock with 5/8 fire retardant sheet rock is recommended.

5.0 Item 1(Picture) The garage in the guest house is missing fire retardant sheet rock in sections in the garage

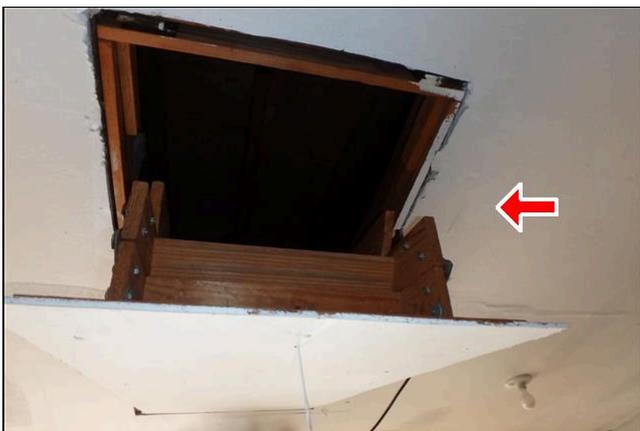
The installation of wood attic stairs is a breach in the fire rock. There are stairs that have a fire rating. Consideration to replacing the stairs with the proper stairs is recommended.

5.0 Item 2(Picture) The installation of wood attic stairs is a breach in the fire rock

Having a qualified contractor evaluate and repair as needed is recommended,

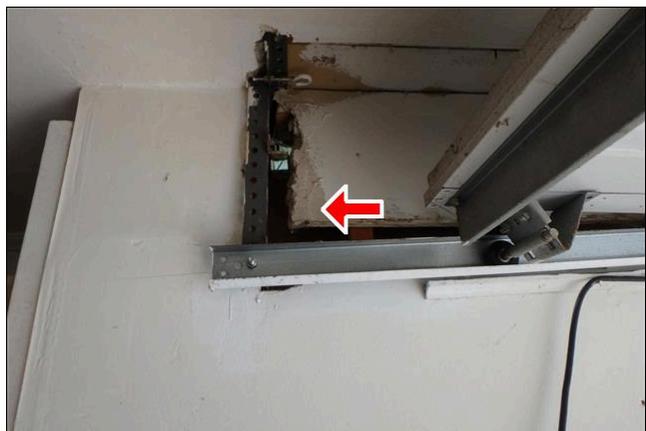
There are holes in the sheetrock in the garage.

5.0 Item 3(Picture) There are holes in the sheetrock in the garage

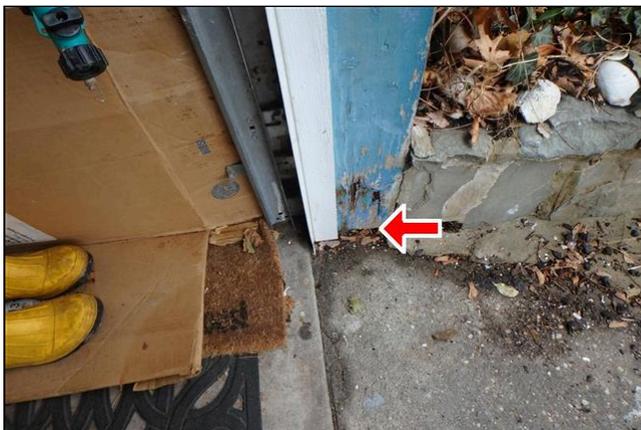
The inspector noticed rot on the door jamb on base of the garage door. Contacting a qualified handy person the repair the door jamb is recommended.

5.2 Item 1(Picture) The inspector noticed rot on the door jamb on base of the garage door.

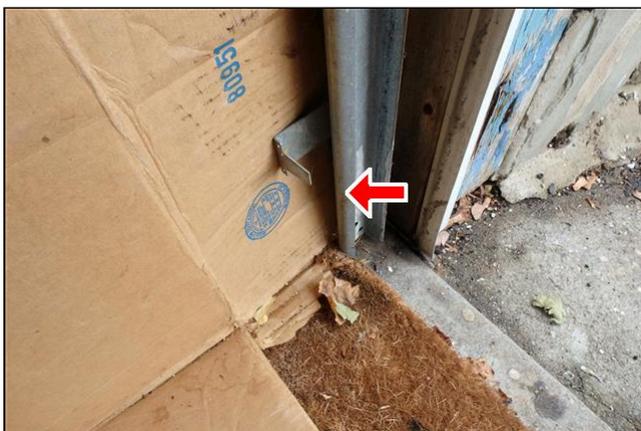
The garage door opener was operational but does not have safety beams. It is recommended to upgrade the opener to a newer model for safety sake.

5.3 Item 1(Picture) The garage door opener was operational but does not have safety beams

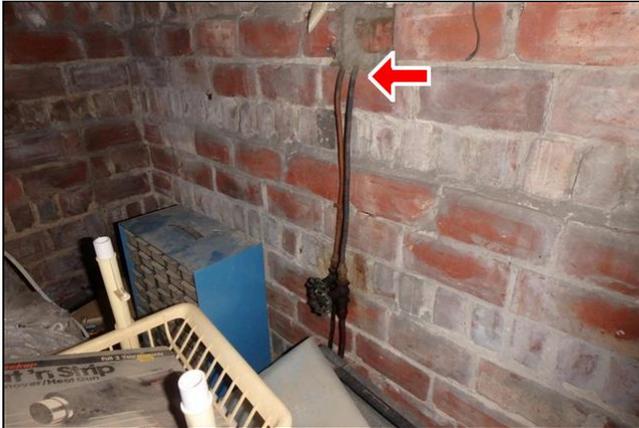
The inspector noticed signs of a buried oil tank and recommends obtaining a abandonment certificate. All abandoned in the ground oil tanks are required to be abandoned by a licensed contractor. Questioning the owner as to the status of the tank and certificate is recommended.

6.0 Item 1(Picture) The inspector noticed signs of a buried oil tank and recommends obtaining a abandonment certificate

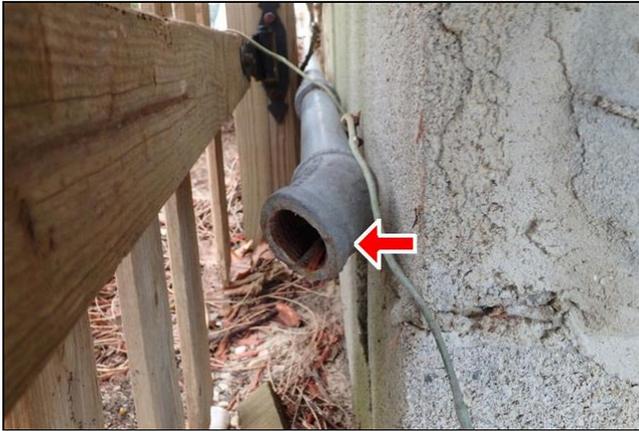
There is an open gas line on the east side of the exterior missing a cap. Capping it for safety sake is recommended,

6.3 Item 1(Picture) There is an open gas line on the east side of the exterior missing a cap

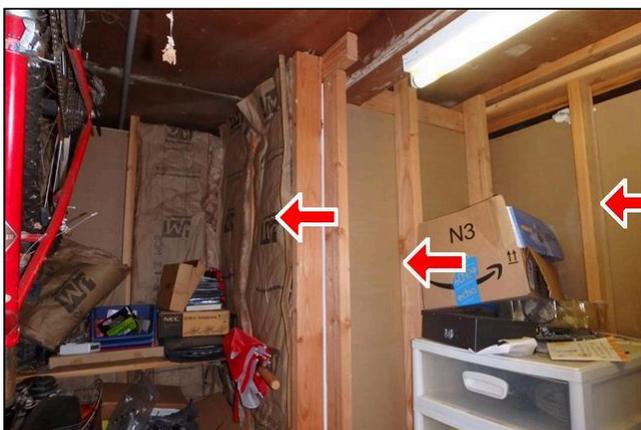
Backwards and missing insulation in the apartment walls in the apartment walls repairing the insulation is recommended

7.1 Item 1(Picture) Backwards and missing insulation in the apartment walls in the apartment walls

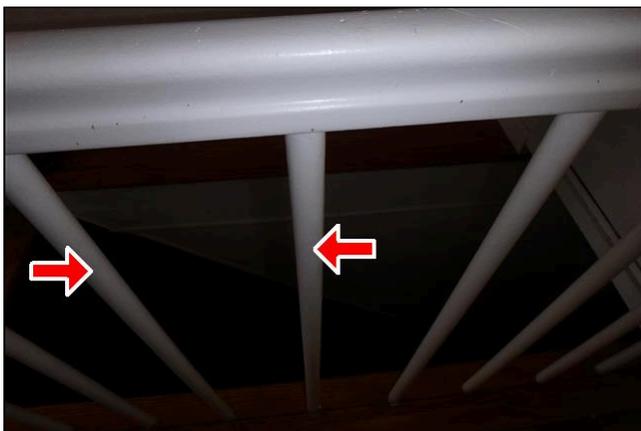
The interior hand rail and baluster spacing is beyond the current 4 inch requirement. Modifying the hand rail is recommended.

7.3 Item 1(Picture) The interior hand rail and baluster spacing is beyond the current 4 inch requirement.

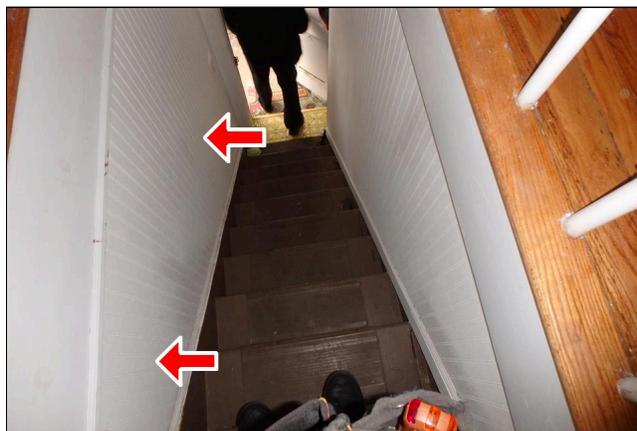
There is also no handrail present on the stairway. Installing one is recommended,

7.3 Item 2(Picture) There is also no handrail present on the stairway.

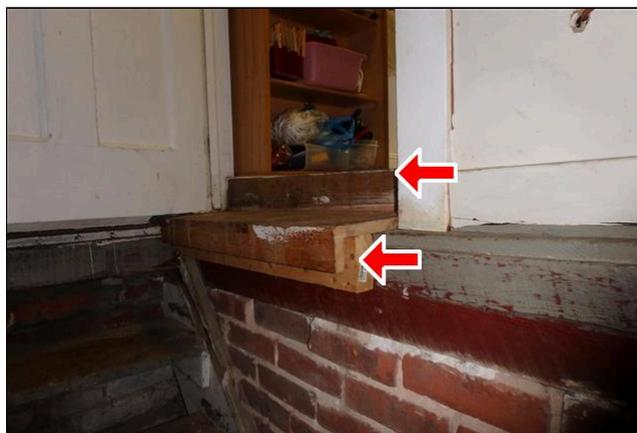
The basement stairs are a safety issue. There is missing steps at the top. Having a qualified contractor evaluate and repair as needed is recommended,

7.3 Item 4(Picture) The basement stairs are a safety issue.

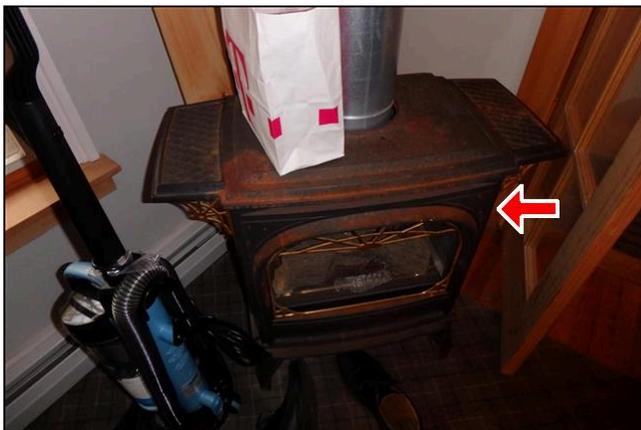
There is a wood burning stove in the guest house that is not properly installed. It does not have the proper clearance from combustible materials. Having a qualified contractor evaluate and repair as needed is recommended.

8.0 Item 1(Picture) It does not have the proper clearance from combustible materials

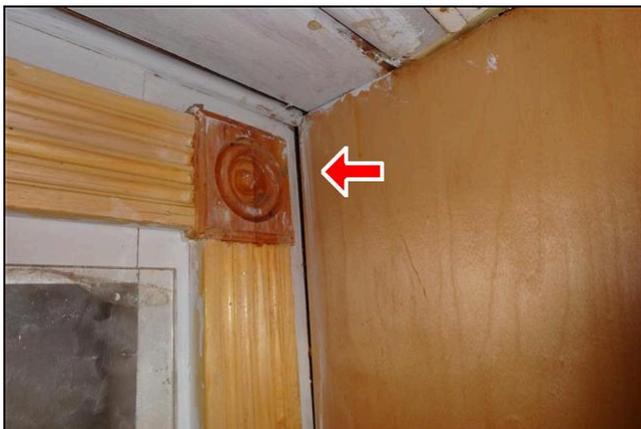
The upper cabinets appear to be pulling away from the wall. Having a qualified contractor evaluate and repair as needed is recommended,

9.2 Item 1(Picture) The upper cabinets appear to be pulling away from the wall

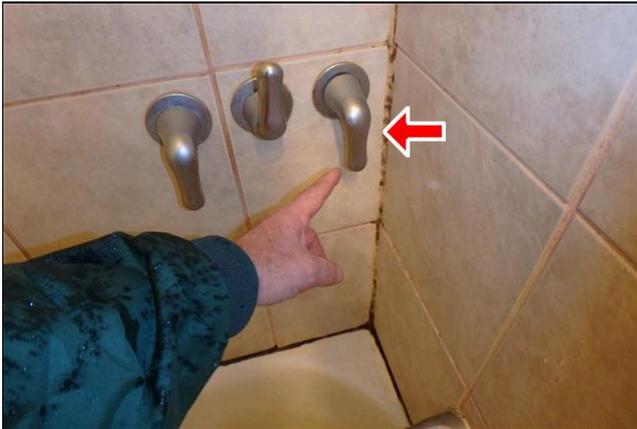
The bathroom cold water valve is defective. Having a licensed plumber evaluate and repair as needed is recommended,

10.3 Item 1(Picture) The bathroom cold water valve is defective.

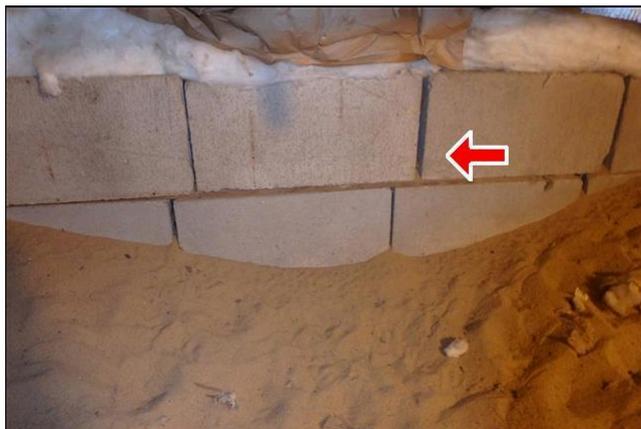
The foundation on the north wall in the wine cellar are not properly constructed. Having a structural engineer evaluate is recommended,

11.0 Item 3(Picture) The foundation on the north wall in the wine cellar are not properly constructed

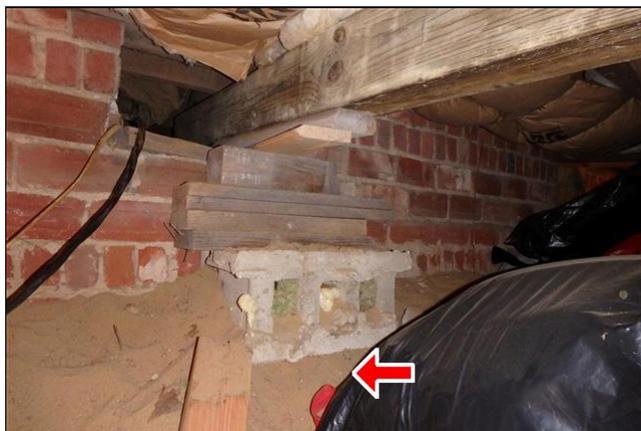
There are no footings under many of the columns in the wine cellar in the main house. Having them evaluated by a qualified contractor is recommended,

11.2 Item 1(Picture) There are no footings under many of the columns in the wine cellar

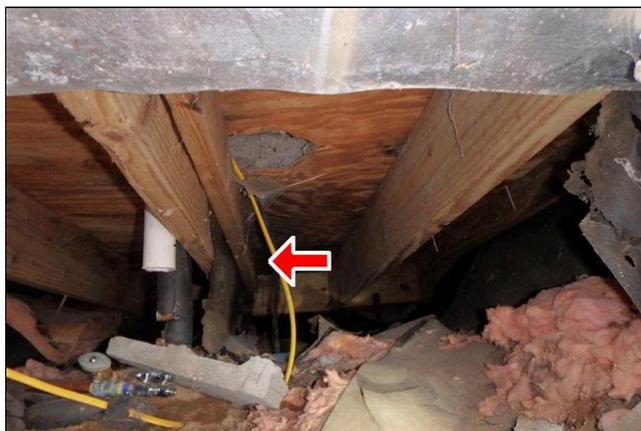
11.3 Item 1(Picture) The floor joist in the crawlspace under the bathroom on the north 1st floor has been compromised

Having a qualified contractor evaluate and repair as needed is recommended

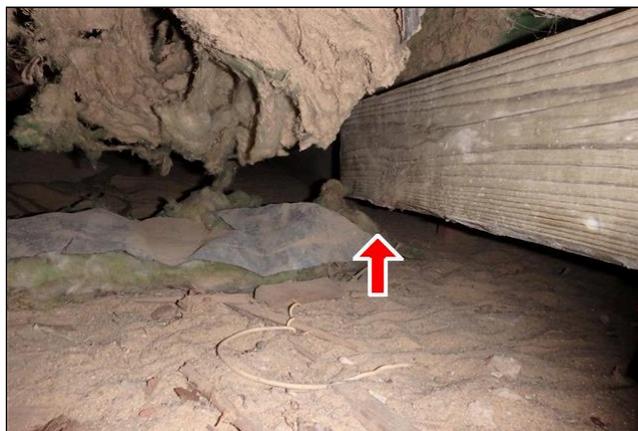
11.3 Item 2(Picture) The girder under the living room is not supported (seen from the wine cellar)

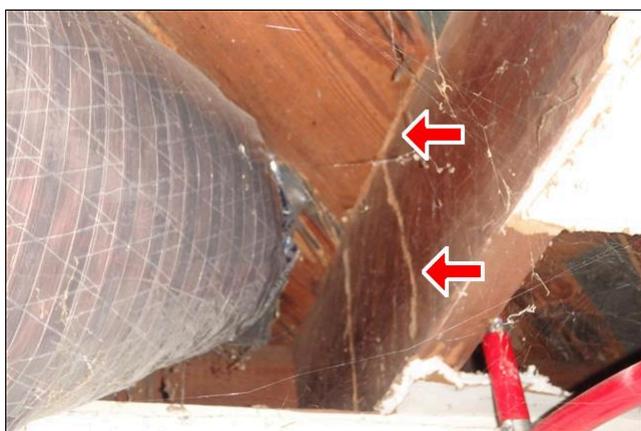
The inspector noticed termite activity in the guest house floor joists on the north wall requiring treatment from a qualified pesticide applicator. The total extent of the damage if any could not be determined without an invasive inspection.

11.7 Item 1(Picture) The inspector noticed termite activity in the guest house floor joists on the north wall

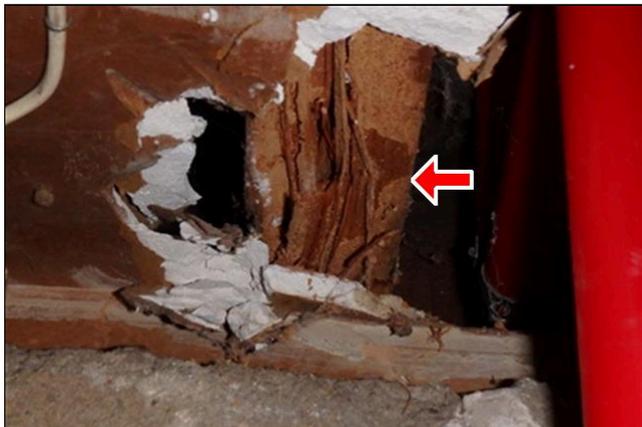
The floor joists in the guest house on the north wall have been effected by termites requiring repair by a qualified contractor. The total extent of the damage could not be determined without an invasive inspection. Having a qualified contractor evaluate and repair as needed is recommended.

11.8 Item 1(Picture) The floor joists in the guest house on the north wall have been effected by termites

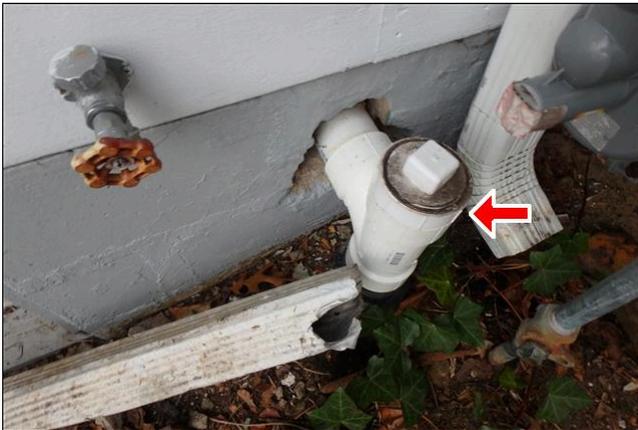
12.0 Item 1(Picture) There is no presents of a fresh air intake on the septic system

Having a licensed plumber evaluate and repair as needed is recommended,

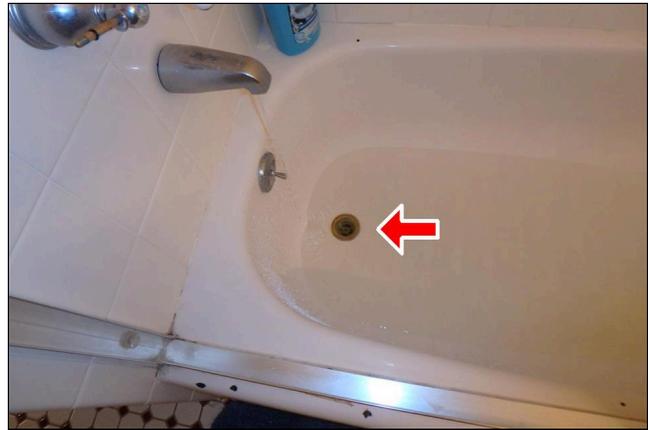
12.0 Item 2(Picture) The tub drain is slow in the hall bath

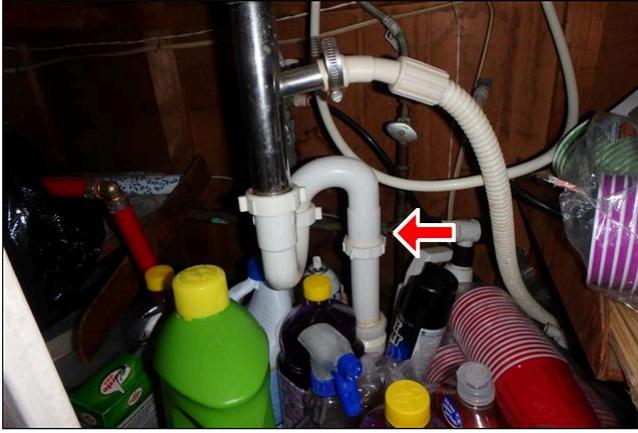
12.0 Item 3(Picture) The inspector noticed a "S" trap under the kitchen sink

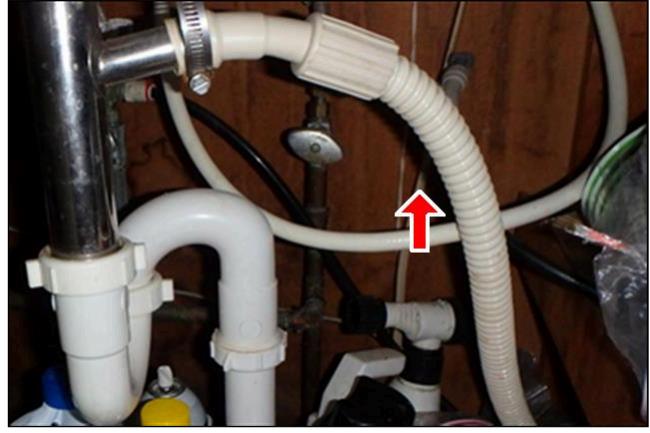
12.0 Item 4(Picture) No air gap on the dishwasher

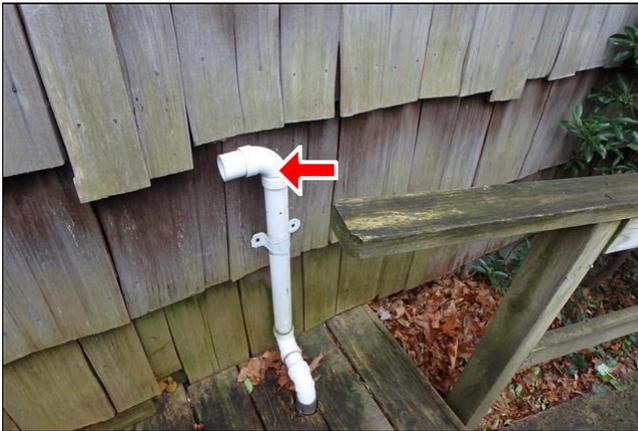
12.0 Item 5(Picture) There is a plumbing vent on the east side of the cottage that origin is unknown

Contacting a qualified plumber to evaluate and repair the sink drain is recommended.

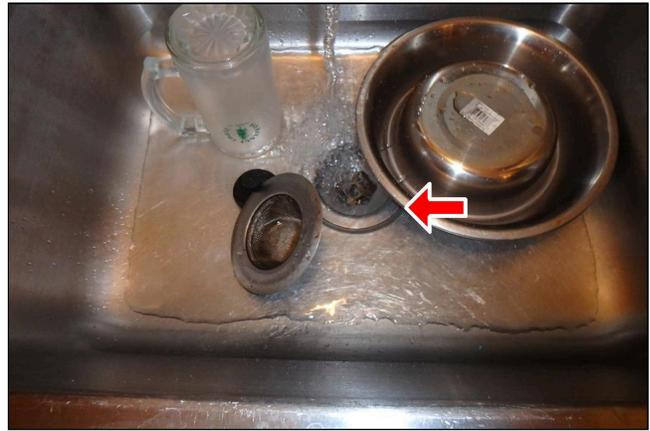
12.0 Item 6(Picture) The inspector noticed that the kitchen sink syphons when draining from poor ventilation.

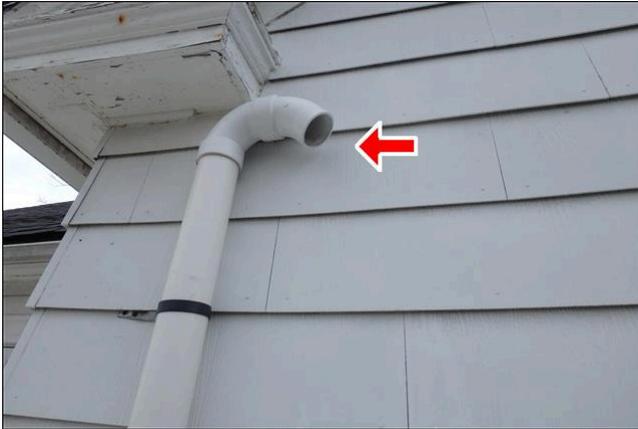
12.0 Item 7(Picture) There is a plumbing vent stack on the west side of the house that is too close to the structure and window openings

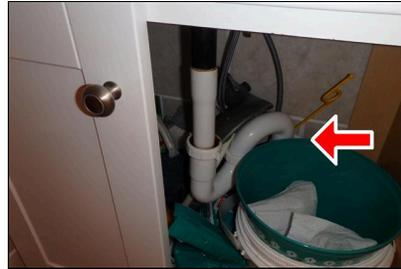
12.0 Item 8(Picture) There is an "S-Trap" in the 1st floor bath on the north side

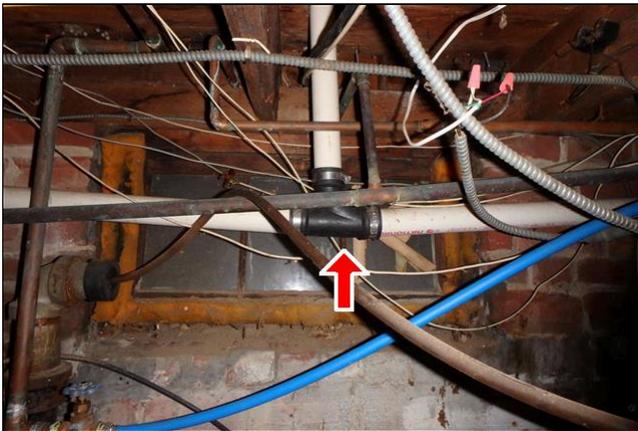
12.0 Item 9(Picture) The drain for the kitchen sink and washing machine has a negative pitch
