# Inspection Report

**Property Address:**  
1 New Home  
Heaven on earth NY 11111

**New Home Inspectors LLC**

<b>Date:</b> 9/4/2015	<b>Time:</b> 12:00 AM	<b>Report ID:</b>
<b>Property:</b> 1 New Home Heaven on earth NY 11111	<b>Customer:</b> John Donut	<b>Real Estate Professional:</b>

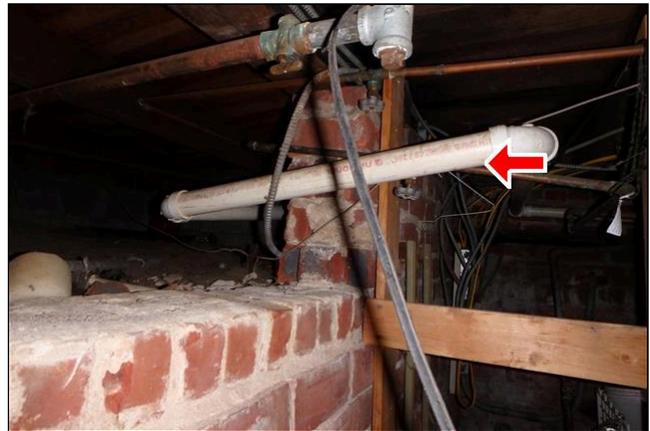
12.0 Item 10(Picture) Washing machine drain pitched backwards

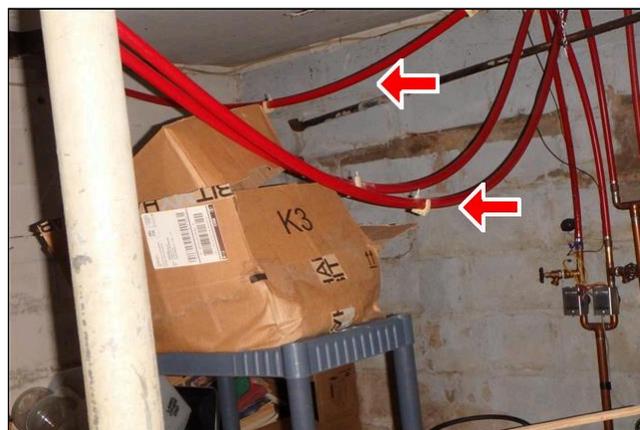
The water supply lines in the garage are not properly secured. Securing the line is recommended

12.1 Item 2(Picture) un-secured water supply lines

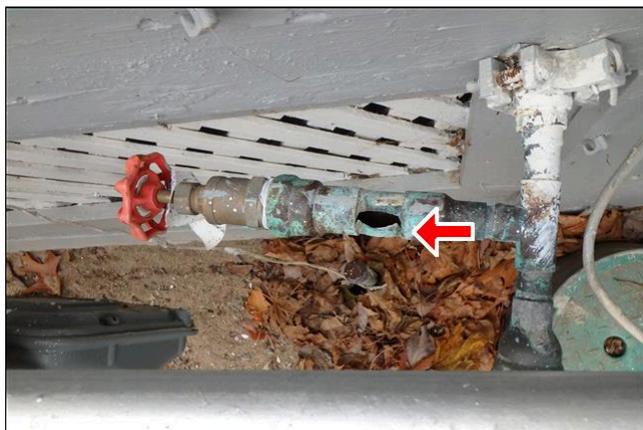
12.1 Item 3(Picture) The water faucet supply line burst on the east side of the exterior

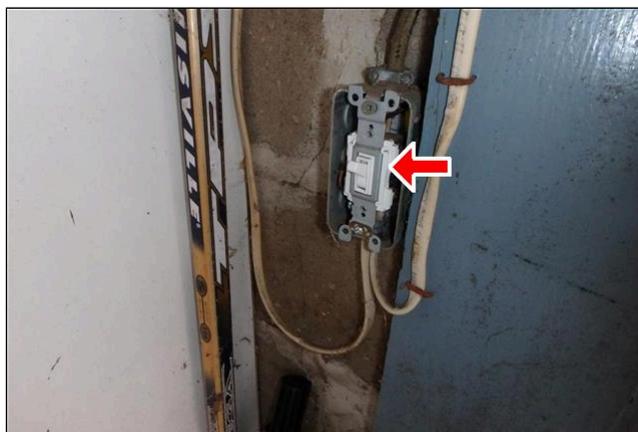
13.3 Item 2(Picture) There is missing cover plates for the switches and outlets scattered through out the house

Having a licensed electrician evaluate and repair these items is recommended.

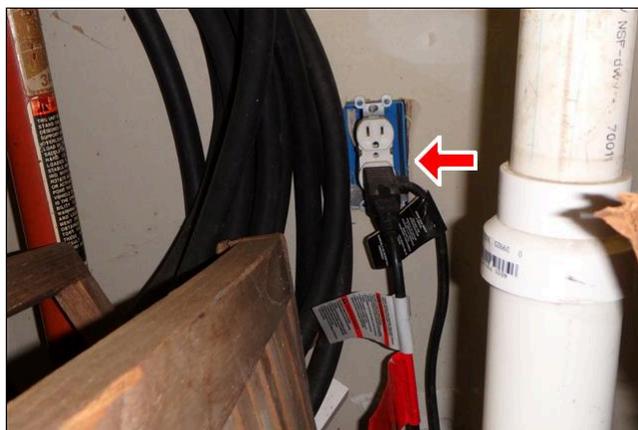
13.3 Item 4(Picture) The sewage ejection pump is not GFCI protected

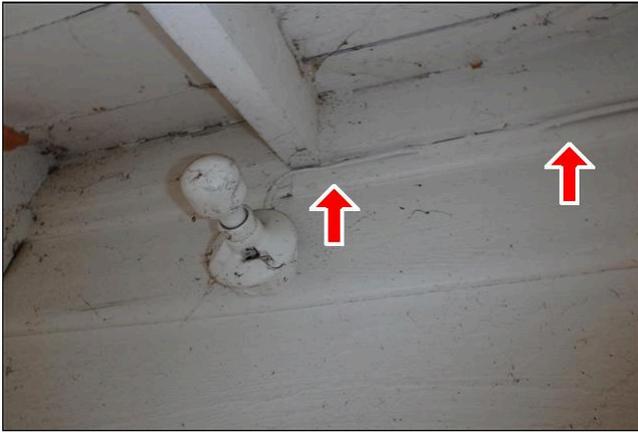
13.3 Item 5(Picture) Exposed romex on the exterior by the entrance door

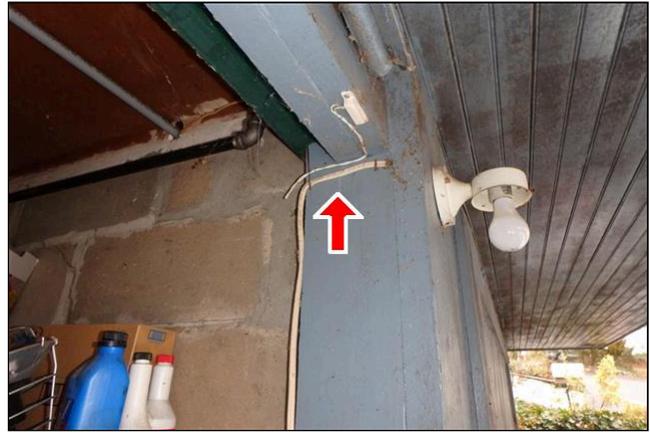
13.3 Item 6(Picture) Exposed romex by the garage door entrance

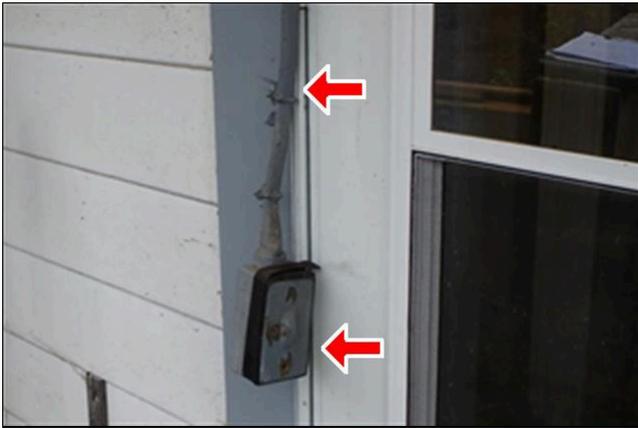
13.3 Item 7(Picture) Exposed romex and unsecured light switch by the exterior front door

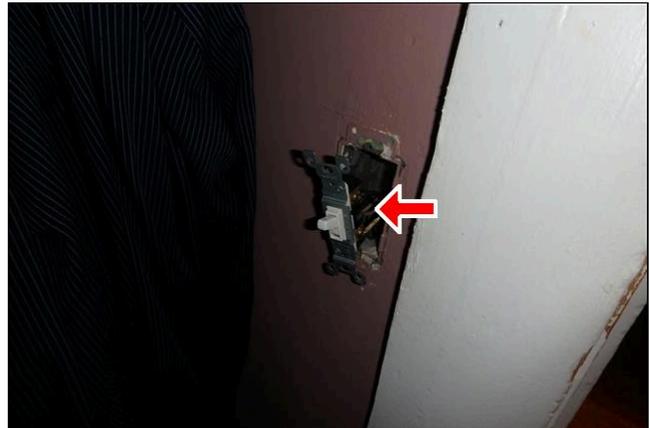
13.3 Item 8(Picture) The light switch in the master bedroom is not properly installed

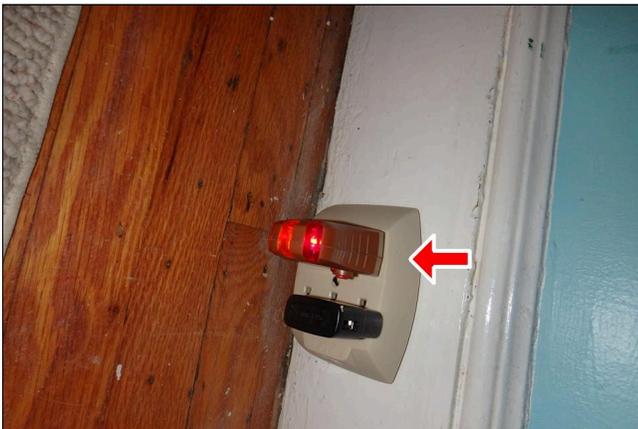
13.3 Item 9(Picture) The inspector noticed hot and neutral reversed receptacles scattered through out the house

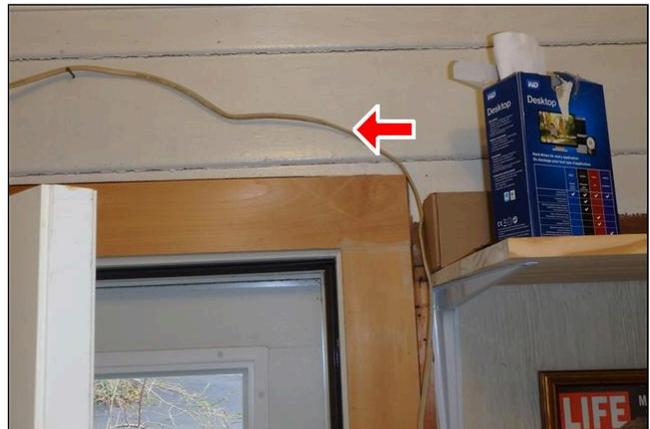
13.3 Item 10(Picture) Exposed romex wire in the office area

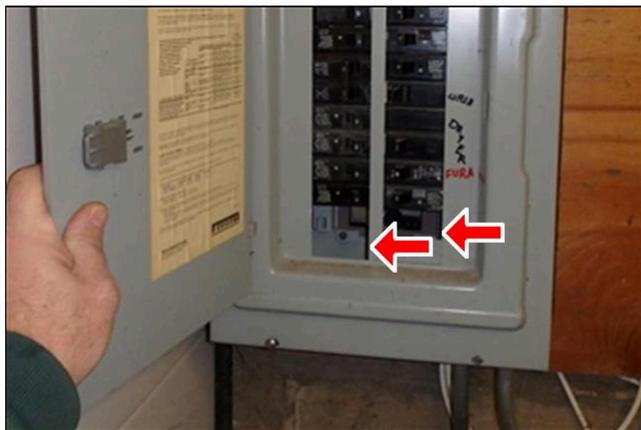
13.3 Item 11(Picture) Missing circuit breaker knockout blanks

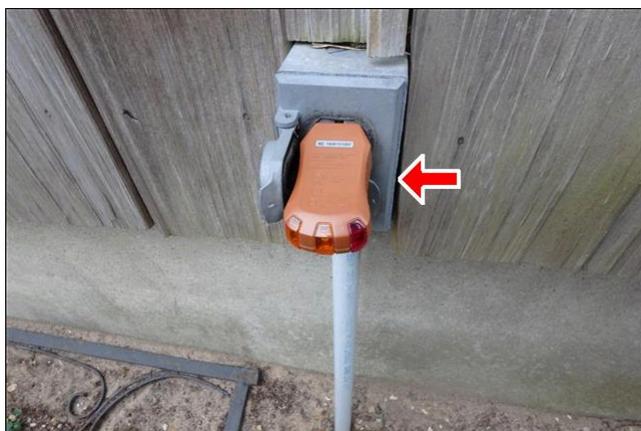
13.3 Item 12(Picture) There is no power at the exterior receptacle on the north wall

Having a licensed electrician evaluate and repair these items is recommended.

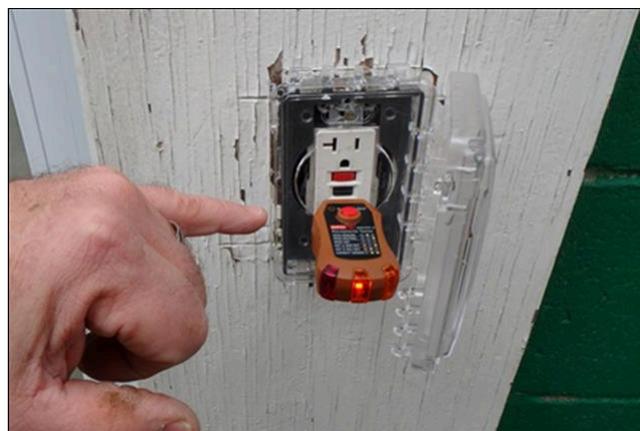
13.3 Item 13(Picture) The GFCI receptacle on the exterior by the patio door is defective

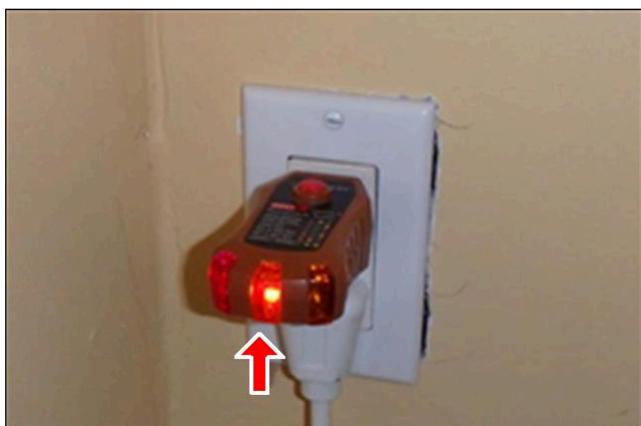
13.3 Item 14(Picture) The inspector noticed hot and neutral reversed receptacles scattered through out the house

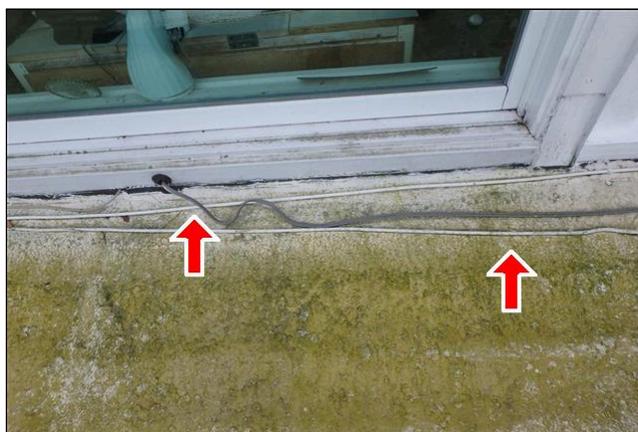
13.3 Item 16(Picture) There is a romex wire on the north lower roof outside of conduit and not secured

Having a licensed electrician evaluate and repair these items is recommended.

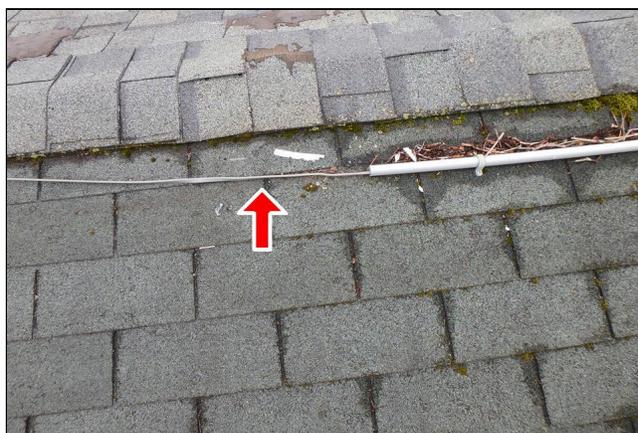
13.3 Item 18(Picture) There is exposed romex wire on the garage roof

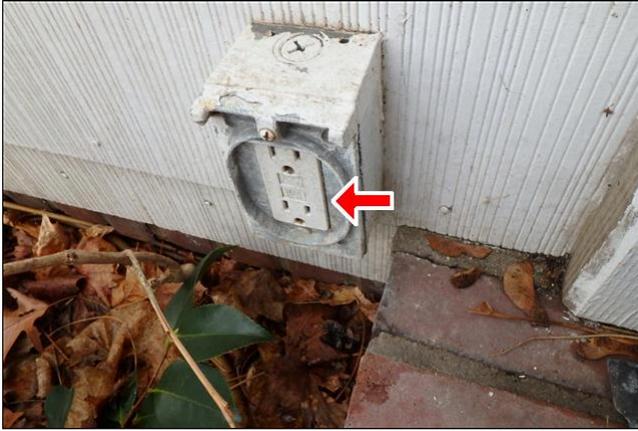
13.3 Item 19(Picture) The exterior GFCI receptacle is defective to the left of the front entrance and is missing a cover

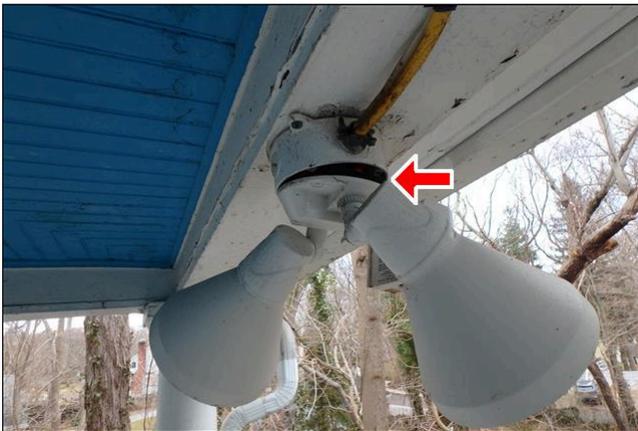
13.3 Item 21(Picture) The spot light on the porch is not properly secured

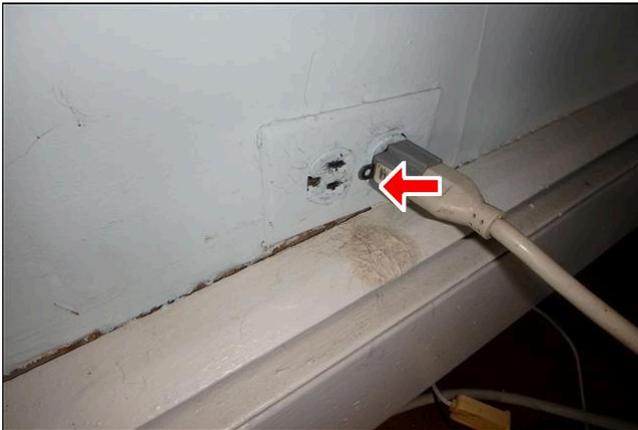
13.3 Item 23(Picture) There are painted over outlets scattered throughout that should be replaced

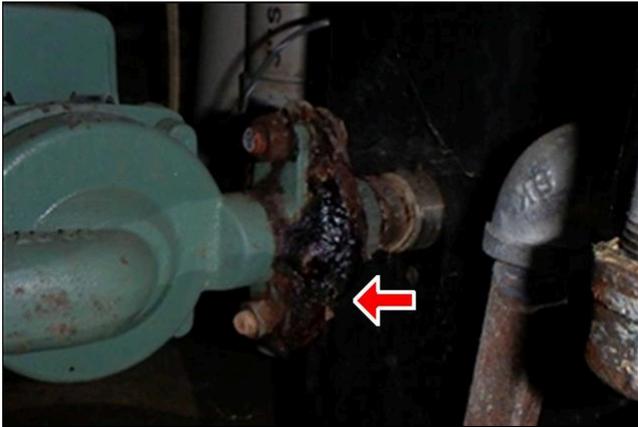
The circulator gasket is leaking and the TPS valve is also leaking. Having a licensed plumber evaluate and repair as needed is recommended

14.0 Item 1(Picture) Leaking gasket

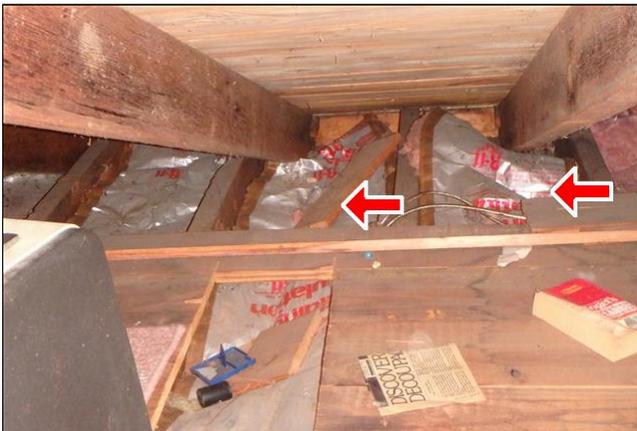
The insulation was installed backwards with the vapor barrier facing away from the heated sections of the house. Reversing the insulation is recommended.

15.0 Item 1(Picture) The insulation was installed backwards with the vapor barrier facing away from the heated sections of the house

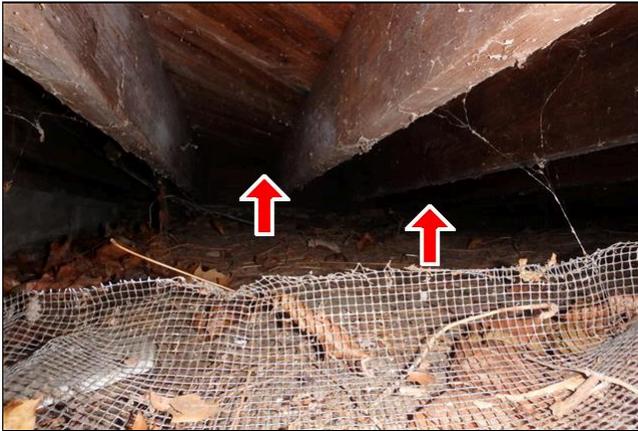
The floor of the office is not insulated or protected from weather or infestation. Heat loss can occur more on this home than one that is properly insulated.

15.1 Item 1(Picture) The floor of the office is not insulated or protected from weather or infestation

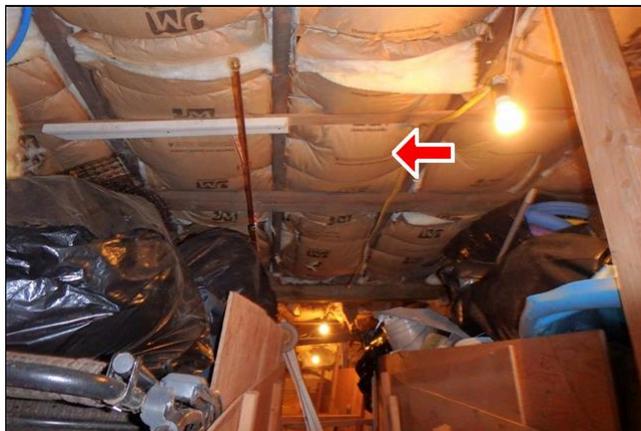
1. The floor system is not insulated under the first floor bath on the north side. Heat loss can occur more on this home than one that is properly insulated.
2. The insulation was installed backwards with the vapor barrier facing away from the heated sections of the house. Reversing the insulation is recommended.

17.1 Item 1(Picture) The insulation was installed backwards with the vapor barrier facing away from the heated sections of the house
